Manta Ray Viewing Boating Operations and Safety Assessment

*Prepared for the Hawaii Coral Reef Initiative Research
Program (HCRI-RP) on September 6th, 2015*

by Marine Science Consulting LLC

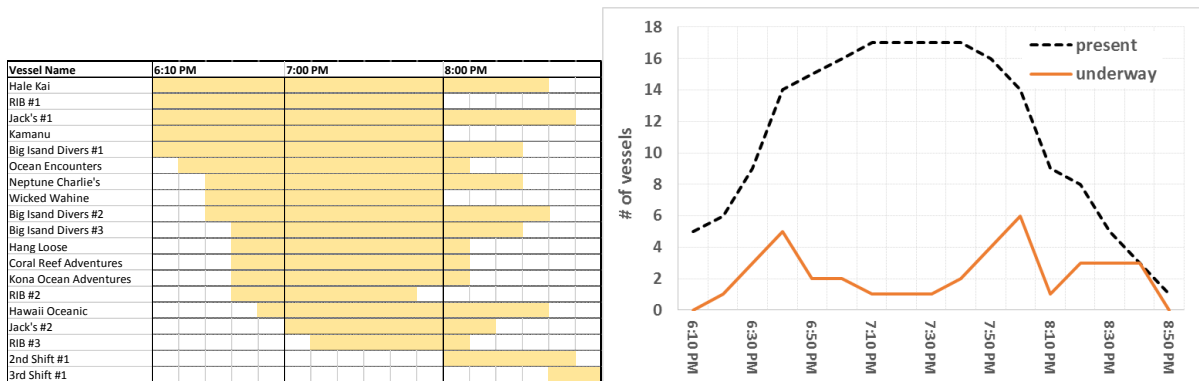
During observations on Aug 10-13, 2015, a total of 16-19 vessels per night were observed with a visual count of 160-190 persons (snorkelers and divers) in the water concurrently. Due to limitations in visibility at night, this count represents a conservative estimate and the actual number was likely higher. Considering that up to 26 concurrent vessels have been recorded at this site (on April 3, 2015), the maximum number of persons in the water concurrently likely exceeds 290 persons on the busiest nights. During the observation period, the arrival and departure of vessels to the manta viewing area was somewhat synchronous with little live boating activity when a majority of persons are in the water (Figure 5). The tour operators who only cater to snorkelers tend to depart early while scuba divers are still underwater. Due to the limited number of moorings, the amount of live boating activity on busy nights is likely higher than observed during this study.

Figure 5. Time-motion statistics at Makako Bay on August 13, 2015 from 6:10-9:00 pm. Yellow bars indicate when each vessel, watercraft, or group was present at the manta viewing site. Each cell represents a 10 minute block of time. The beginning and end of each continuous yellow bar denotes when each vessel/group arrived and departed respectively. A nightly total of 19 vessels were observed with approximately 209 persons. During peak in-water activity 7:00-7:40 pm, most vessels were moored/anchored and relatively few were underway (i.e., actively motoring).

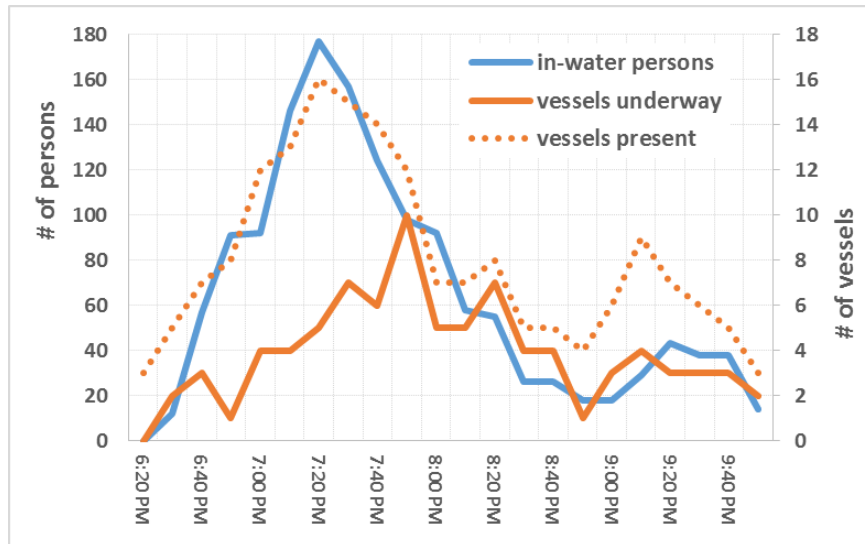
To help illustrate the overlap in boating activity with in-water snorkelers and divers, an intensive time & motion study was conducted on August 21, 2015 from 6:20-10:00 pm from the 2nd floor of the Sheraton Kona Resort. In addition to static totals (21 vessels, 6 kayaks, 1 SUP, and 301 persons), the arrival & departure and the live boating activity for each vessel was tracked across time along with the timing of persons entering and exiting the water from each vessel and from shore. Data was aggregated for each 10 minute block of time, where the number of in-water persons were quantified verses the number of vessels actively motoring at the site. Peak overlap occurred between 7:20-8:00 pm with 98-177 persons in the water while 5-10 vessels were actively motoring in the confined area (Figure 6-7).

Greater overlap between actively motoring vessels and in-water persons would occur on busier days especially given the limited availability of moorings. For example, up to 28 concurrent vessels have been observed at Keauhou (April 3, 2015) which would represent a 38% increase over the maximum of 16 concurrent vessels observed on the date of this time-motion study.

Figure 7. Overlap between in-water persons and live boating activity (i.e., vessels underway) at the Keauhou Bay manta ray viewing site on August 21, 2015. A total of 21 vessels and 301 persons visited the site.

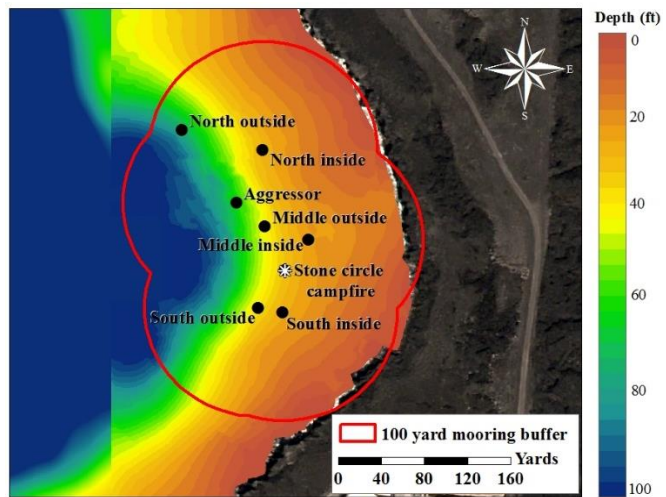
Figure 8. Map of the Makako Bay manta viewing site and the day-use mooring locations – both official and unofficial. The red outline indicates the 100 yard perimeter surrounding the official day-use moorings.

At Makako Bay, at least one or two of the moorings with subsurface floats are not permitted/approved. At Keauhou Bay, three chain based moorings and possible one of the moorings with a subsurface float are not permitted/approved. Of all day-use moorings at both sites, only one at Makako Bay is actually codified in the DLNR DOBOR administrative rules which guide enforcement activities (per Dan Mersburgh, DLNR DOBOR).

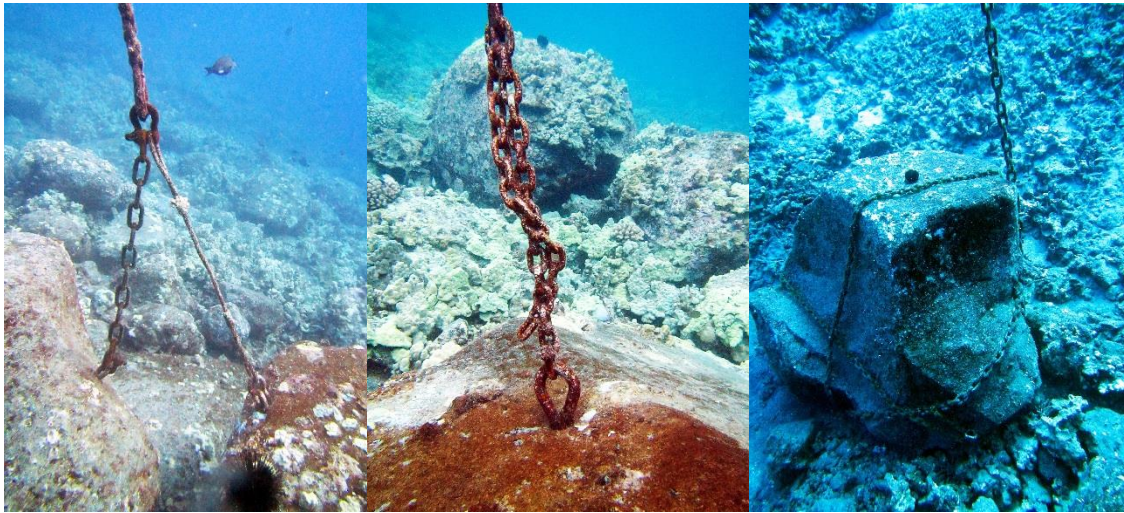
At Makako Bay, seven moorings with subsurface floats are used on a nightly basis (Figure 8, Table 1). Five are anchored using double pins, one (north inside) is anchored with a single pin, and one (north outside) is secured to a large boulder via chains (Figure 9). The north outside mooring is not a U.S. Army Corp of Engineers (USACE) permitted mooring. These moorings are located in close proximity and surround the circle of rocks known as the stone circle “campfire” where scuba divers place lights and sit on the seafloor to view manta rays (Figure 8). The campfire is the primary manta ray viewing site for scuba divers in Makako Bay.

Given the number of vessels compared to available moorings, at least 2-3 vessels simultaneously use each mooring on a nightly basis. The boats are attached end-to-end (“daisy chained”) to each other. Given that the number of vessels observed at Makako Bay during this study was well short of its peak activity, the number of vessels per mooring likely increases on busier days. Due to the limited number of moorings and space constraints, vessels also commonly anchor

Figure 9. Day-use moorings at Makako Bay: (left) middle outside with double pin anchor, (middle) north inside single pin anchor, and (right) north outside with chain anchor.

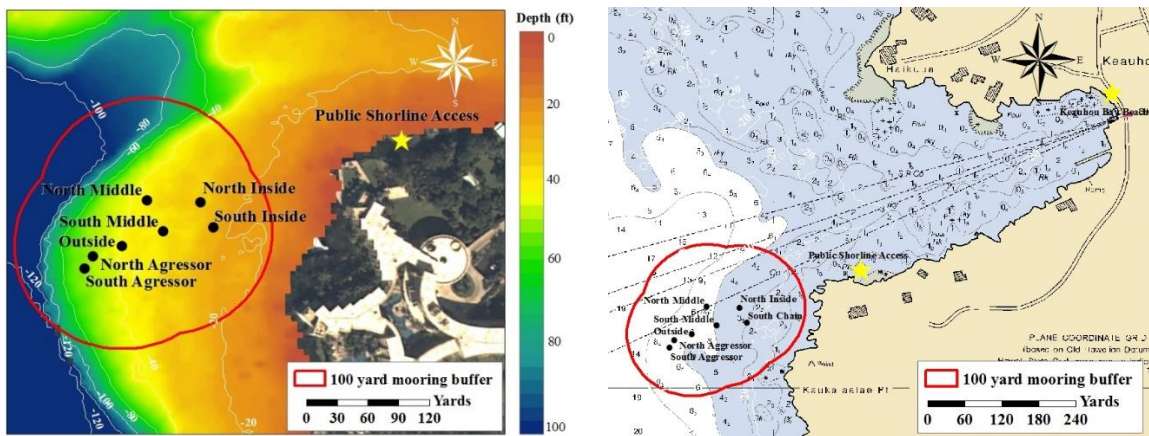
Figure 10. Map of the Keauhou Bay manta viewing site (left) and the day-use mooring locations– both official and unofficial. The red outline indicates the 100 yard perimeter surrounding the official day-use moorings and the yellow star indicates the location of the public shoreline access. The NOAA nautical chart (right) showing the Keauhou harbor boat channel and its proximity to the day-use moorings.

During the night-time observation periods, unrelated vessels exiting and entering the Keauhou harbor at high speed avoided the manta ray viewing area where most moored/anchored vessels were well lit. This behavior contrast to day-time activity when vessels commonly transit over the day-use moorings at high speed when entering & exiting the Keauhou boat harbor. However, on one night multiple groups of swimmers associated with lighted rafts were observed following manta rays well into the boat channel (north of the North Middle mooring) as defined by the NOAA nautical chart (Figure 10).

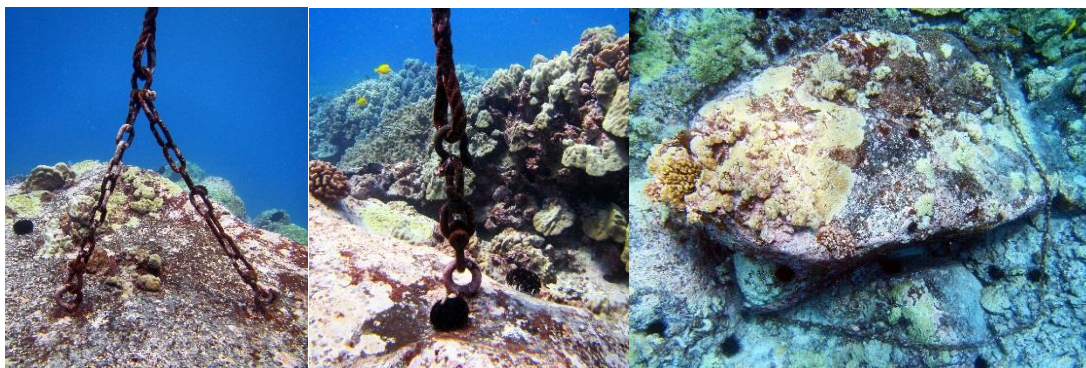
At Keauhou Bay, there are seven moorings but only four have subsurface floats. Three are anchored using double pins, one (inside north) is anchored with a single pin, and three (Aggressor north, Aggressor south, south chain) are anchored to large boulder via chains (Figure 10, Table 1). The three chain moorings do not have subsurface floats and are not USACE permitted moorings. Additionally, the south chain mooring is not secure and consists of a chain loosely looped over a boulder (Figure 11). The Keauhou moorings are located in close proximity to the boat channel which is actively used throughout the day and night by vessels not associated with the manta ray viewing operations.

Based on observations, the four moorings with subsurface floats are regularly used by at least one vessel. Some vessels, arriving after dark, do not moor but instead drop anchors presumably due to their inability to locate available moorings. Boats have also commonly been observed live boating throughout the duration of the night. During busy nights, 3-4 boats were observed using each mooring simultaneously. Compared to the Makako Bay site, the vessels at Keauhou Bay are less centralized and more dispersed along the shoreline and anchoring is much more frequent. While not assessed within the scope of this study, the live coral cover was observed to be quite high throughout the area where anchoring was observed. Damage to live coral colonies is likely unavoidable when anchoring in this area, especially at night.

Figure 11. Day-use moorings at Keauhou Bay: (left) middle south with double pin anchor, (middle) inside north with single pin anchor, and (right) south chain which is only loosely wrapped around a boulder.
