Preliminary Geotechnical Engineering
Evaluation

Waipi'o Valley Road Hāmākua, Hawai'i

Prepared for
County of Hawai'i
Department of Public Works

January 2022
Job No. 3140023002

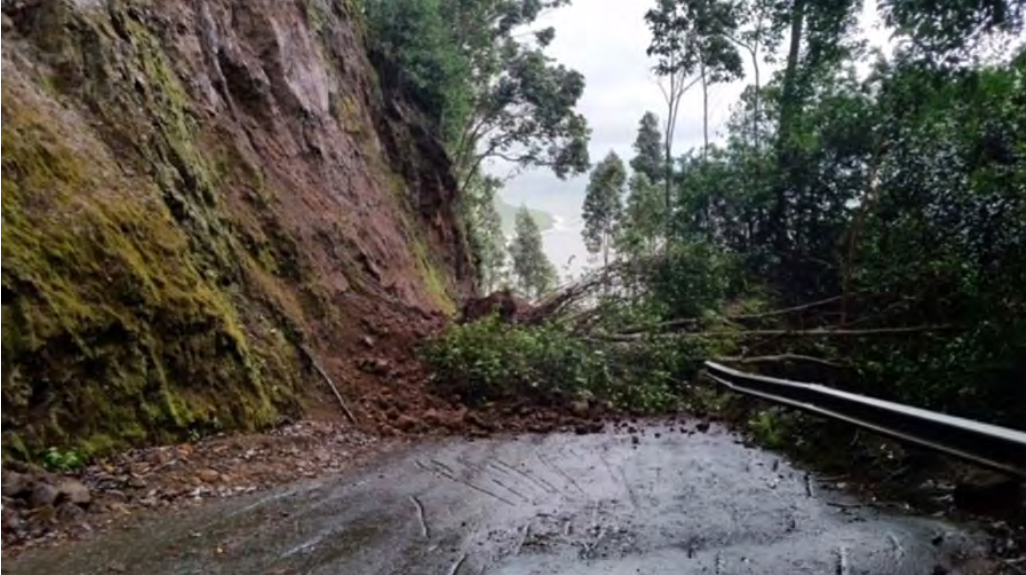
Photograph 1. Soil landslide and uphill tree debris resulting from heavy rains in April 2018. Picture from County of Hawai'i Civil Defense Agency (open source).

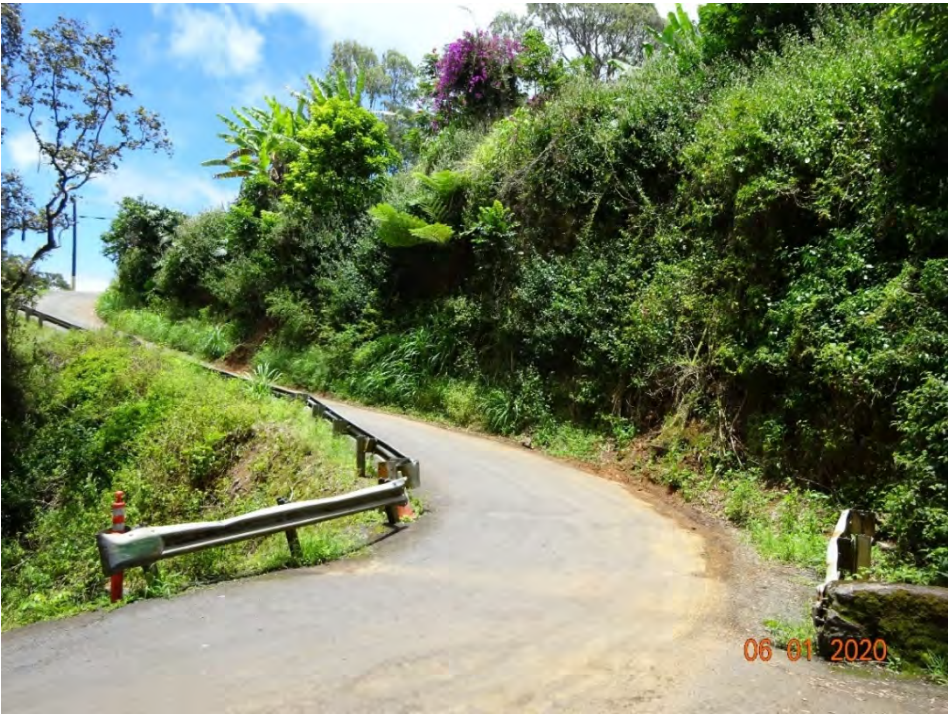
Photograph 2. Transect F-W-01 looking uphill (north). Note the upslope road cut slope with vegetation.

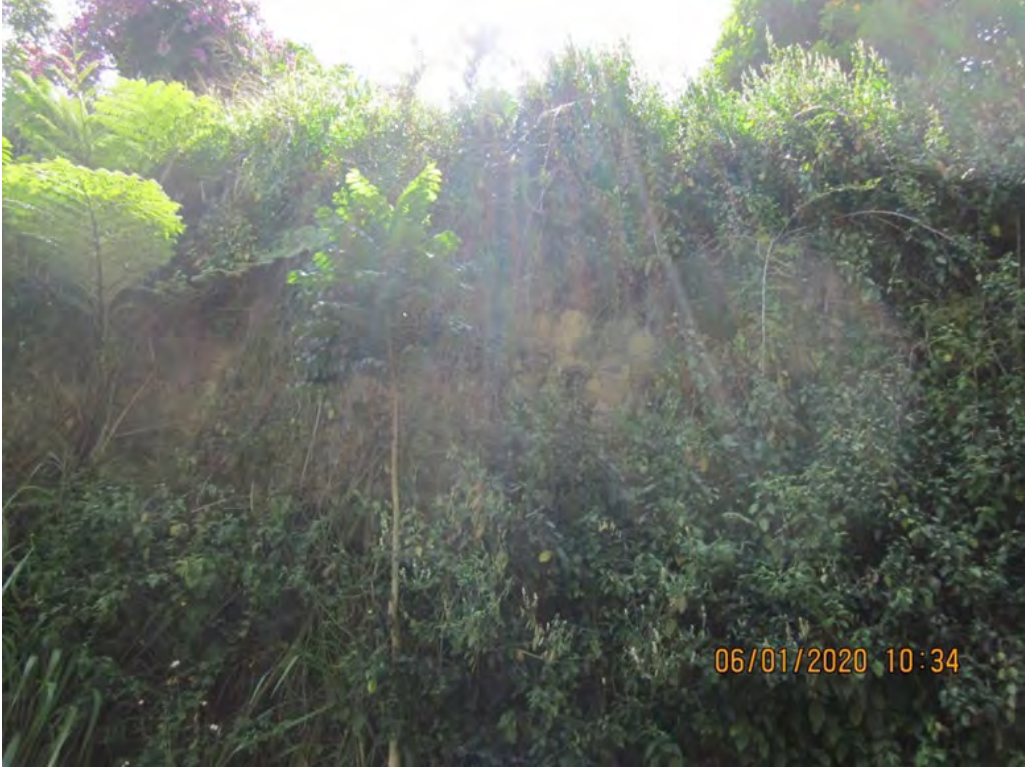
Photograph 3. Partially-vegetated road cut slope with exposed soil in upper slope area.

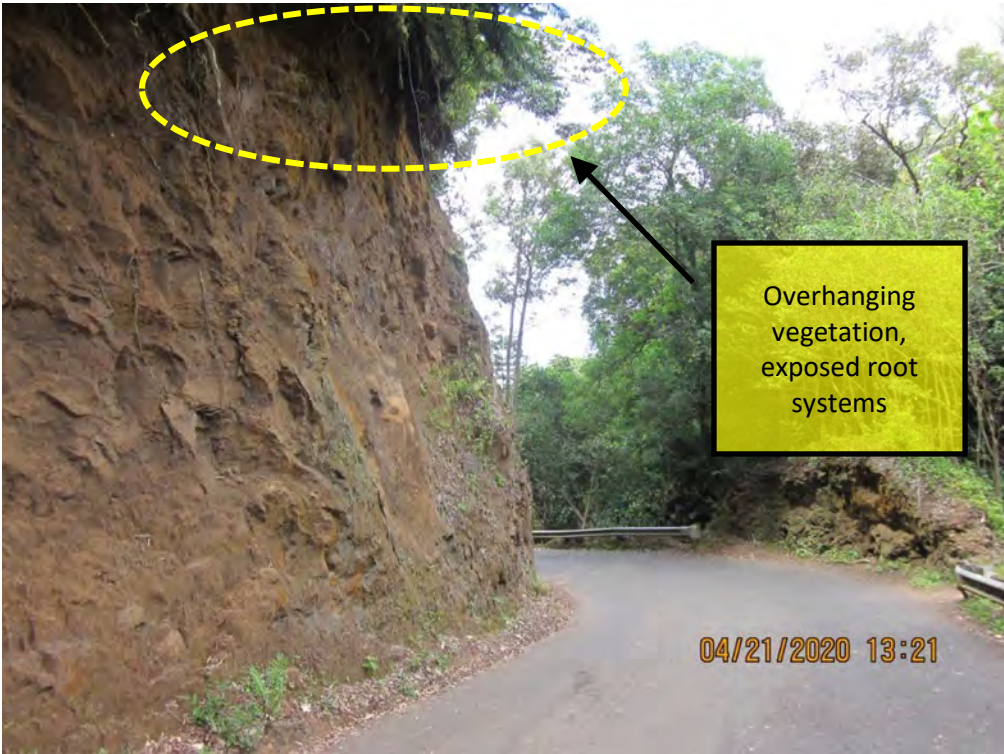
Along transect F-W-02, soil has eroded underneath the vegetation closest to the uphill area edge, thus resulting in overhangs. These overhangs are primarily held together by the root systems of the flora (Photo 4). The road width in this transect is approximately 17 feet and the slope height is approximately 20 feet (observed from the road).

Photograph 4. Exposed soil of upslope road cut slope face. Note overhanging soil and vegetation.

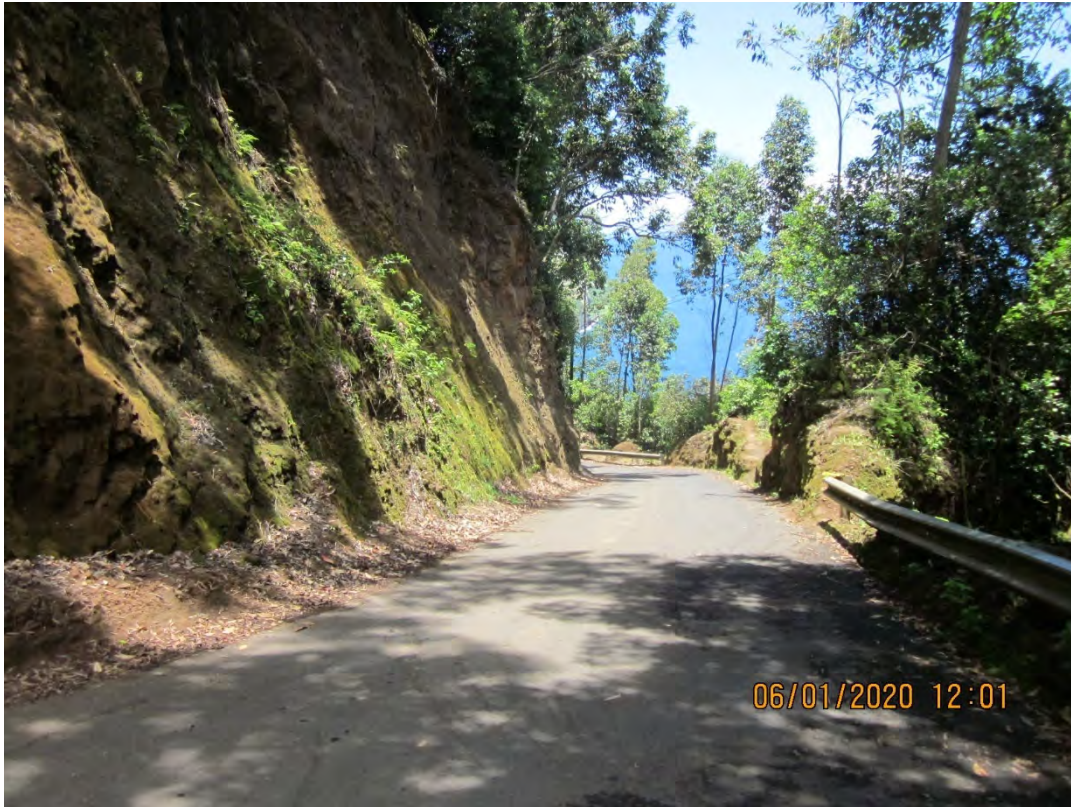
Photo 3. Transect F-W-02, Upper Section. Note the residual overhang upslope of road.

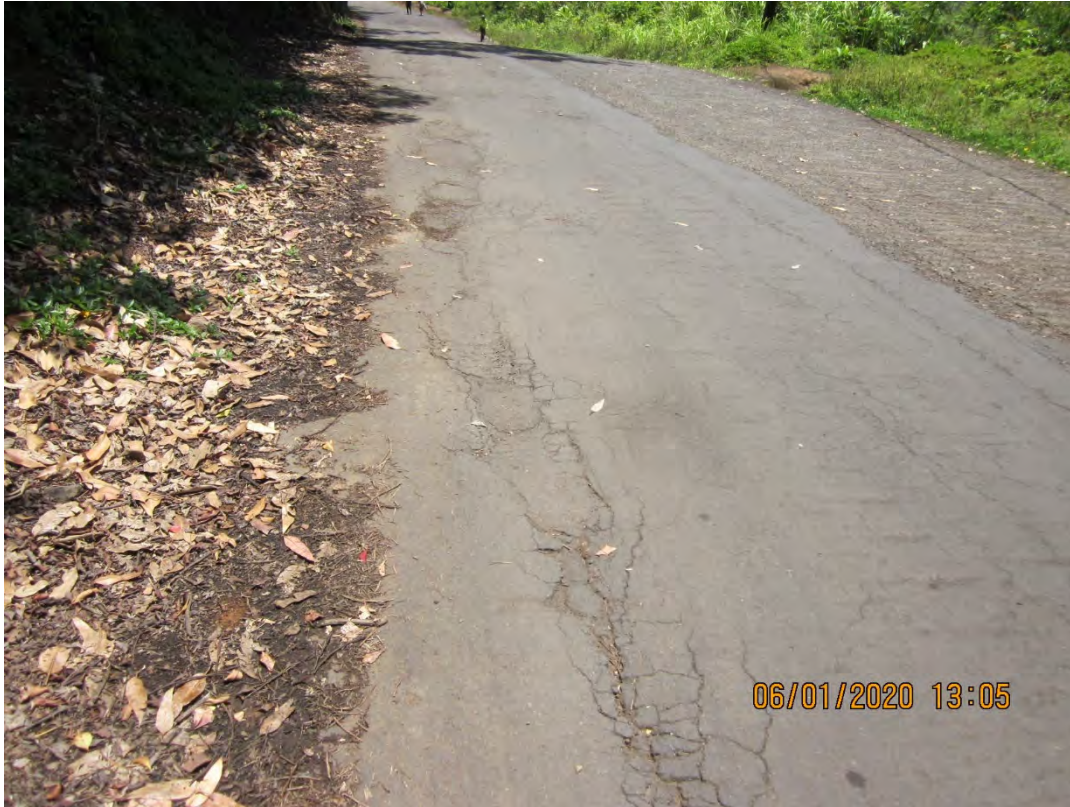
Photo 5. Transect F-W-03, Central Section Area. Note road wear and some potential rock strikes.

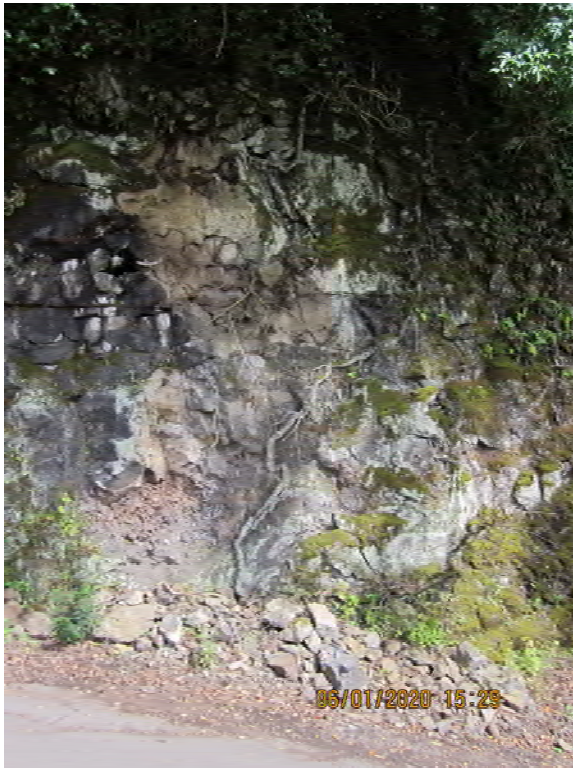
Photo 6. Transect F-W-04, Central Section. Note the rockfall on upslope side of road.

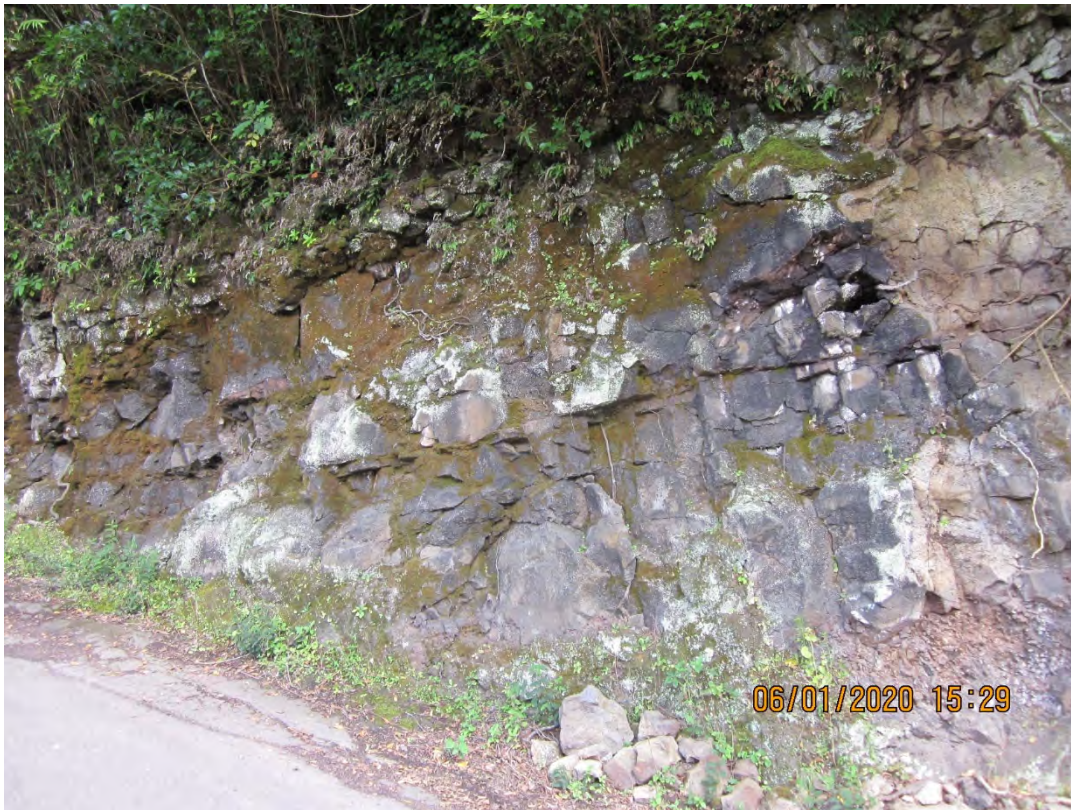
Photo 7. Transect F-W-04, Central Section. Jointed Basalt Outcrop with Residual.

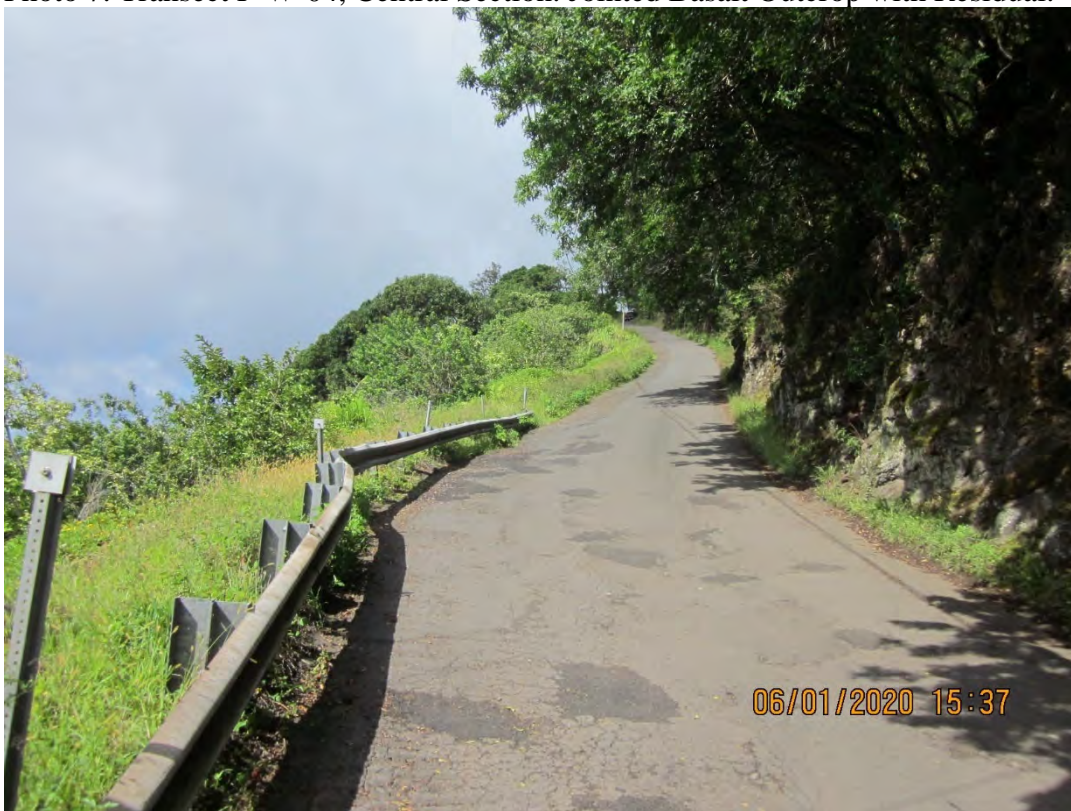
Photo 8. Transect F-W-04, Central Section. Guardrail strike from boulder or vehicle.

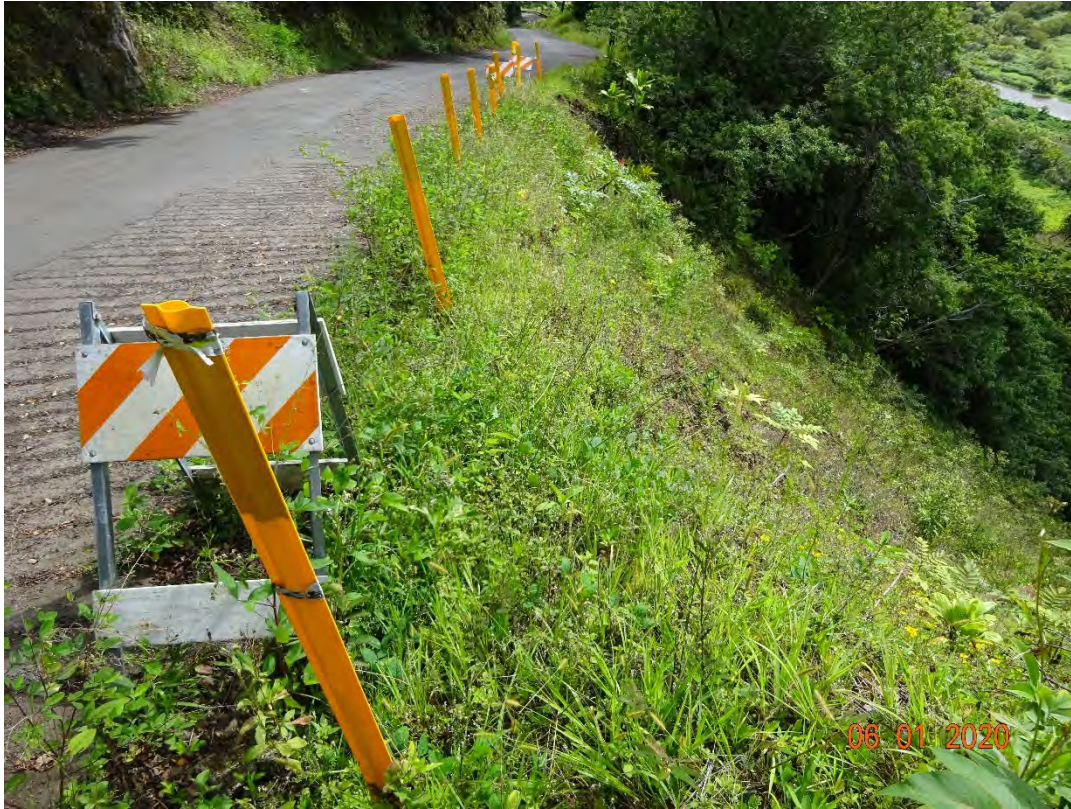
Photo 9. Transect F-W-04, Central Section. March 2018 slide area.

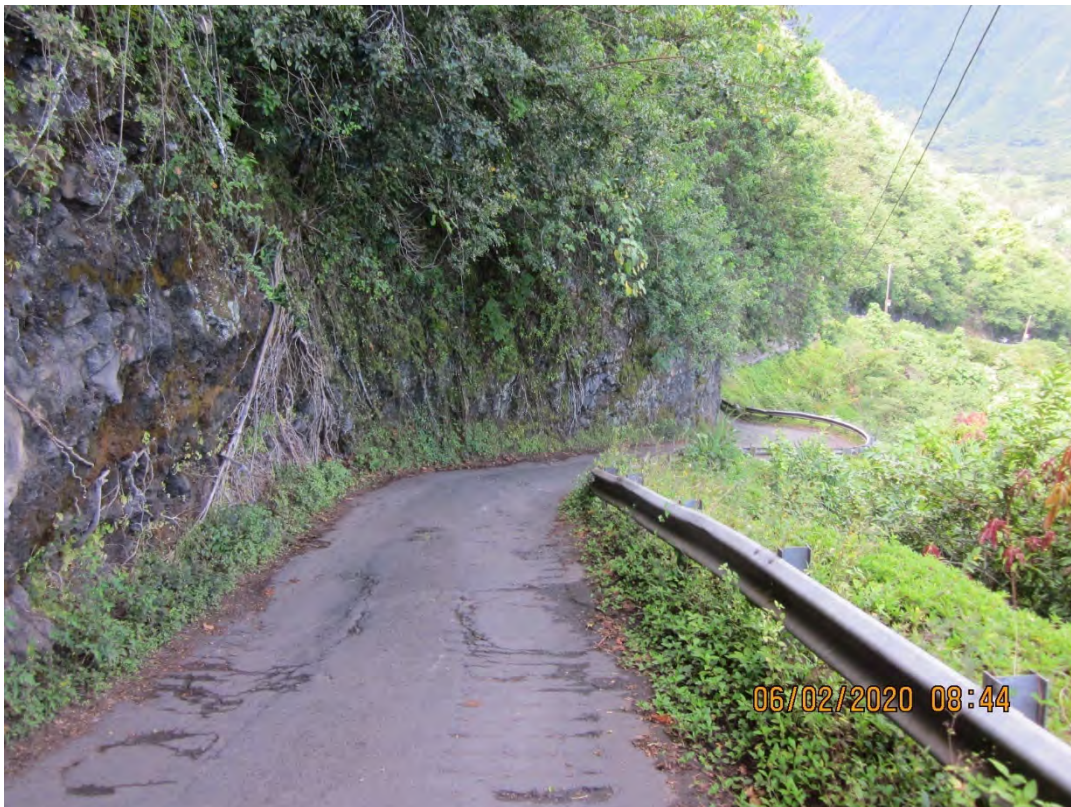
Photo 10. Transect F-W-05, Lower Section. Road narrows and reduced line-of-sight.

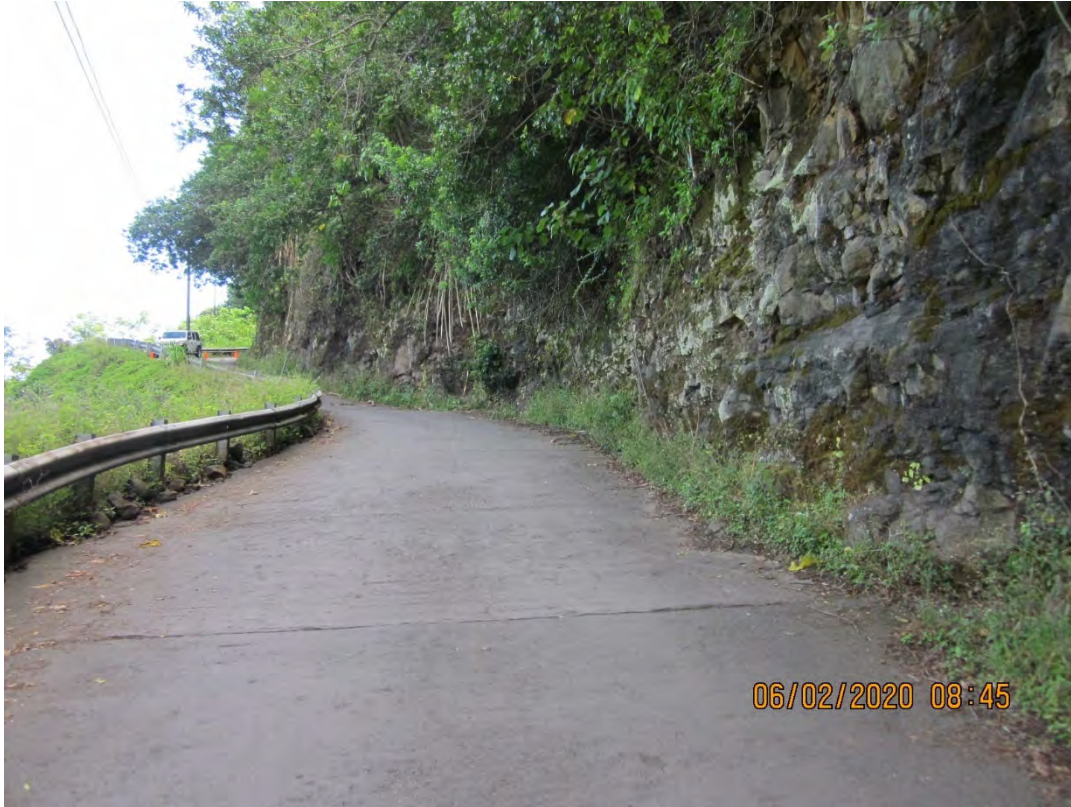
Photo 11. Transect F-W-05, Lower Section. Looking uphill, note steep upslope basalt outcrop.

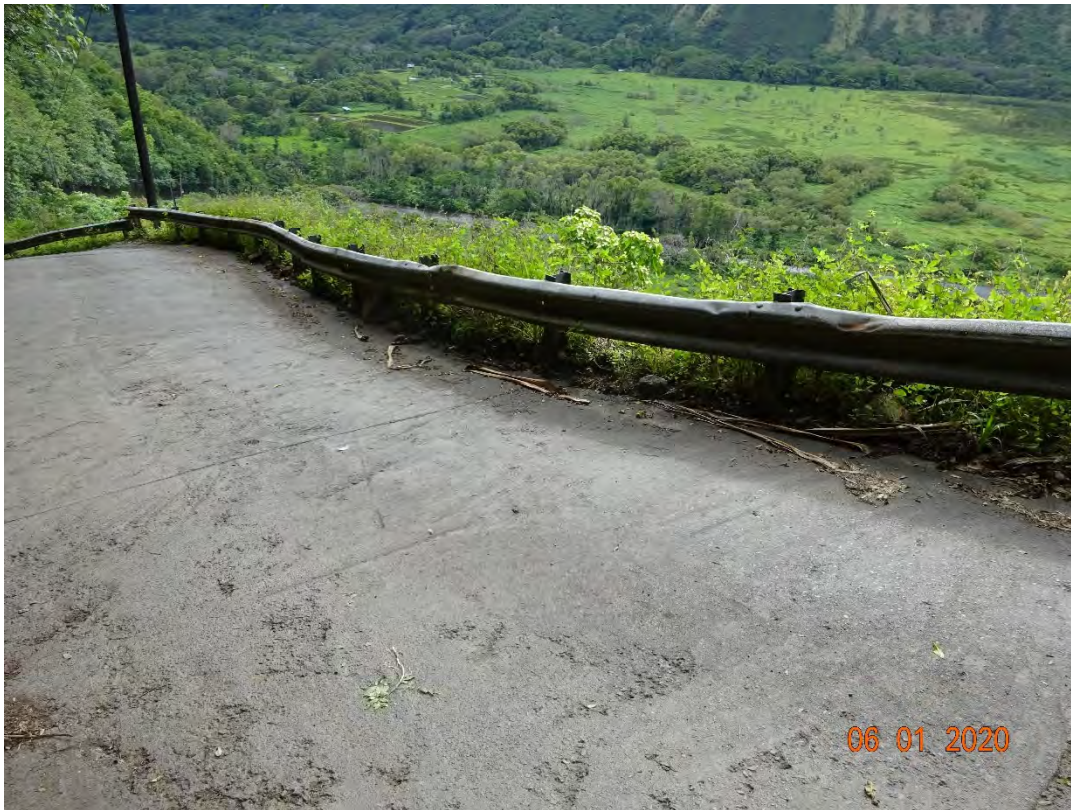
Photo 13. Transect F-W-05, Lower Section. Note guardrail dents from rockfall.

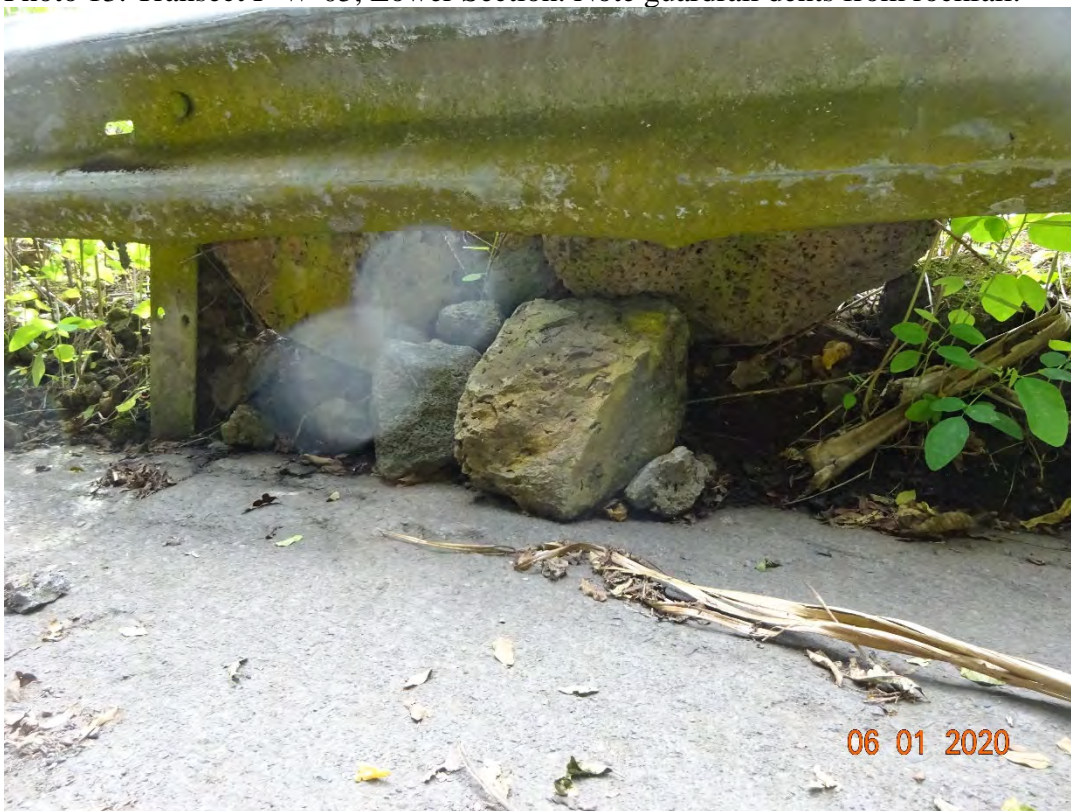
Photo 14. Transect F-W-05, Lower Section. Note previous rockfall makai side of road.

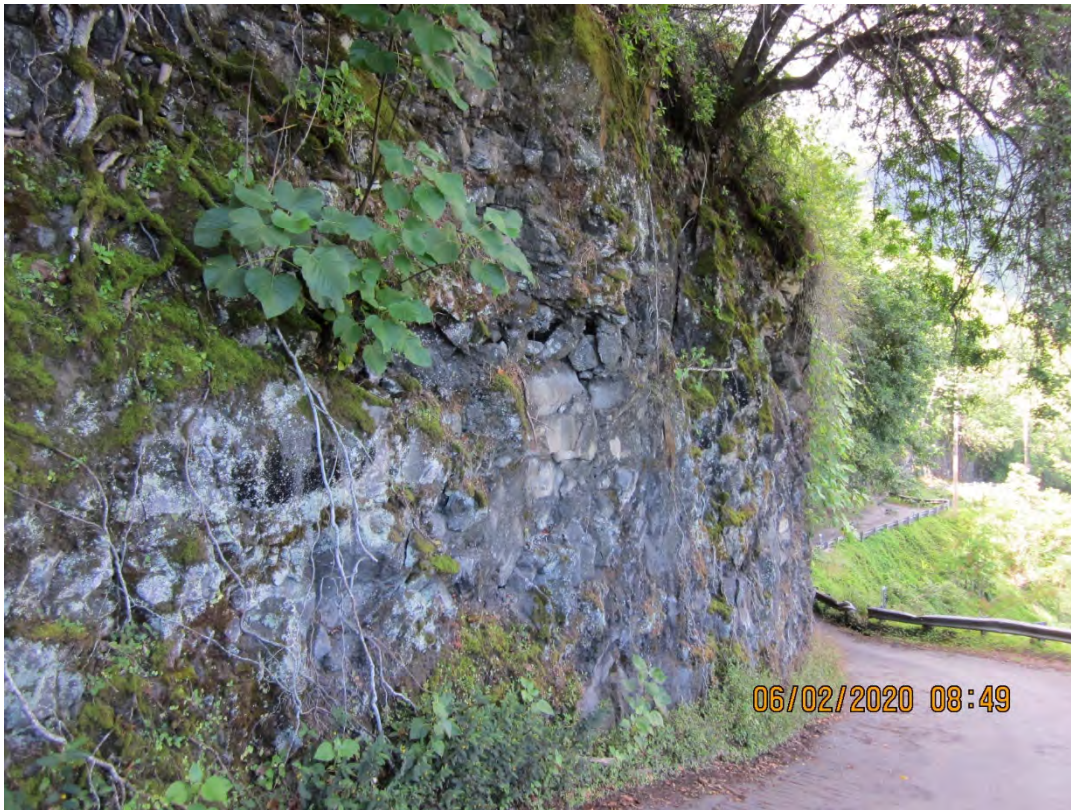
Photo 15. Transect F-W-06, Lower Section. Steep Jointed Basalt outcrop with some residual.

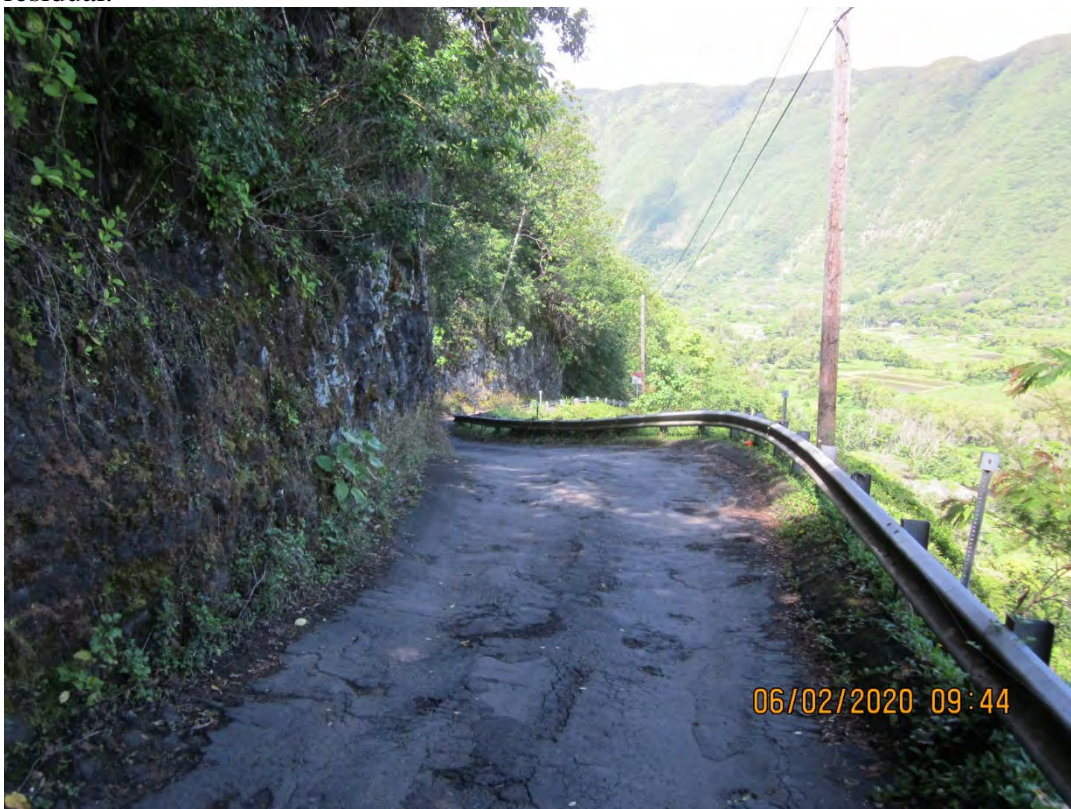
Photo 16. Transect F-W-06, Lower Section. Note the steep upslope and road deformation.

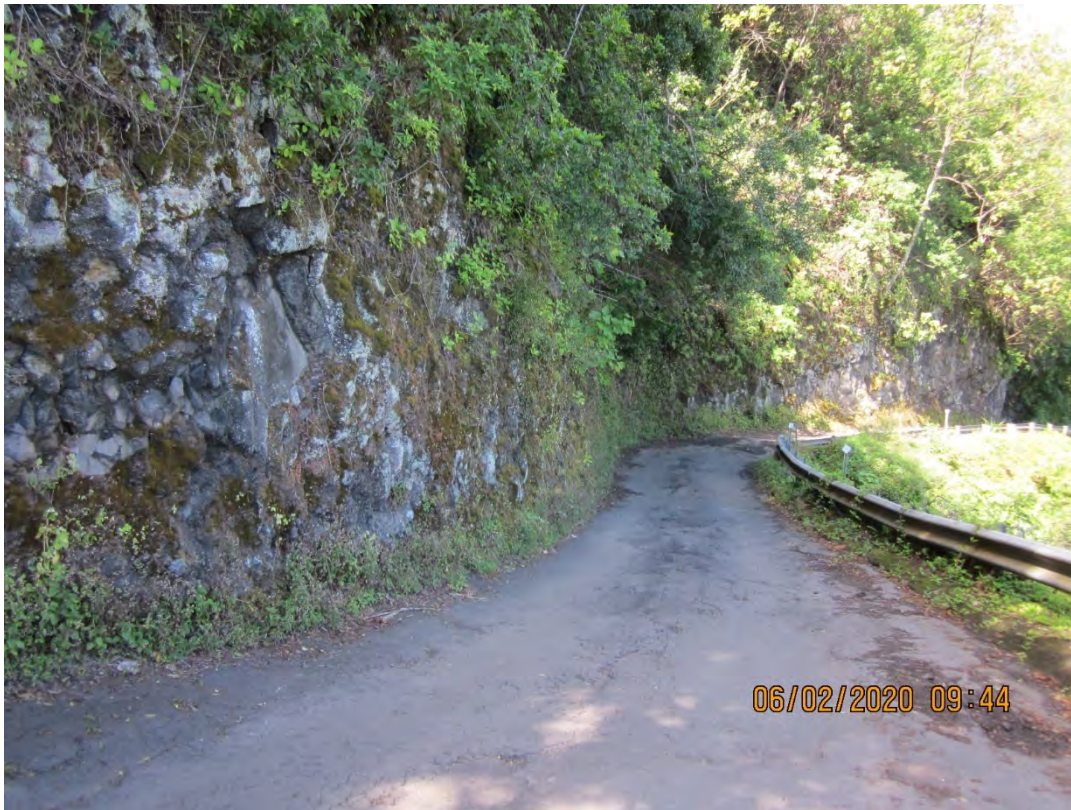
Photo 17. Transect F-W-07, Lower Section. Jointed Basalt outcrop with infilling.

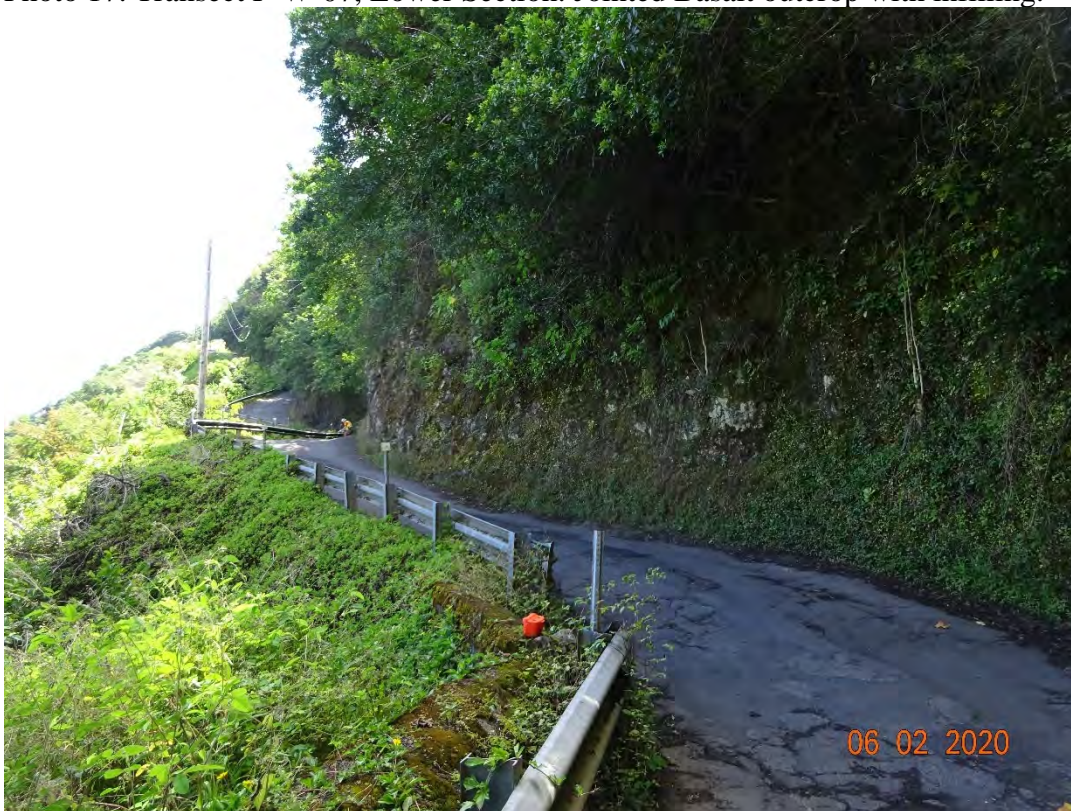
Photo 18. Transect F-W-07, Lower Section. Note small deformed retaining wall makai side of road.

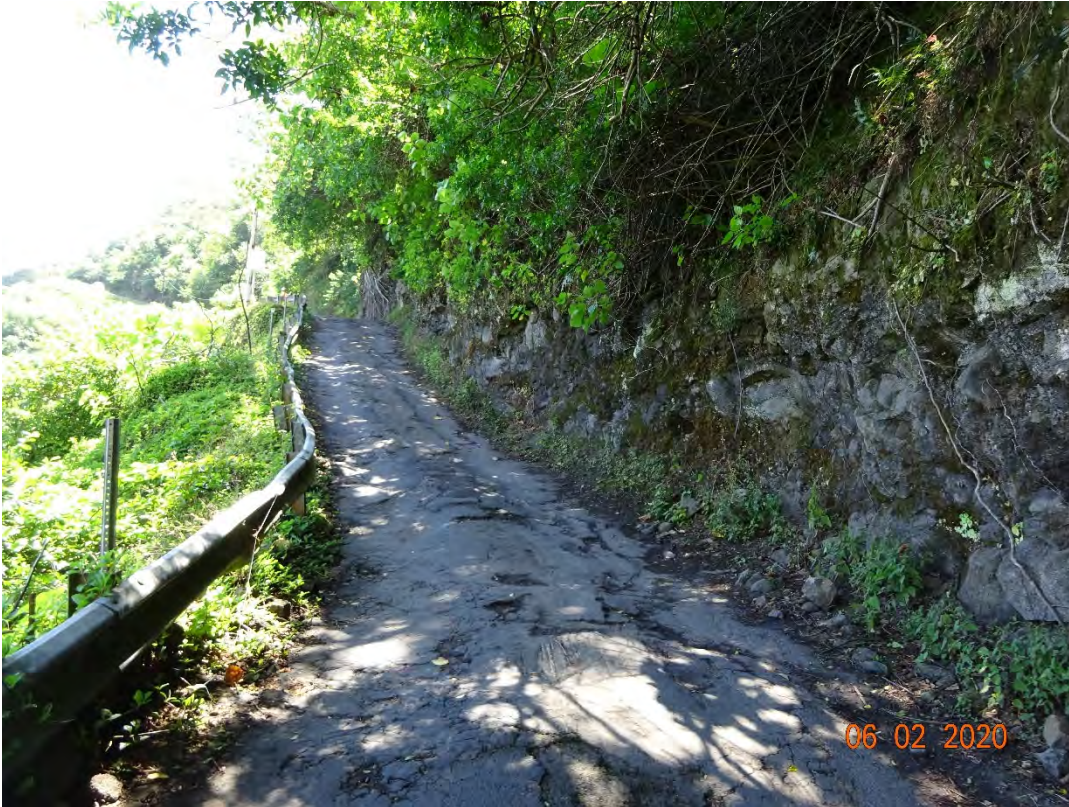
Photo 19. Transect F-W-08, Lower Section. Road narrows, Jointed Basalt with clinker zones observed upslope of road.

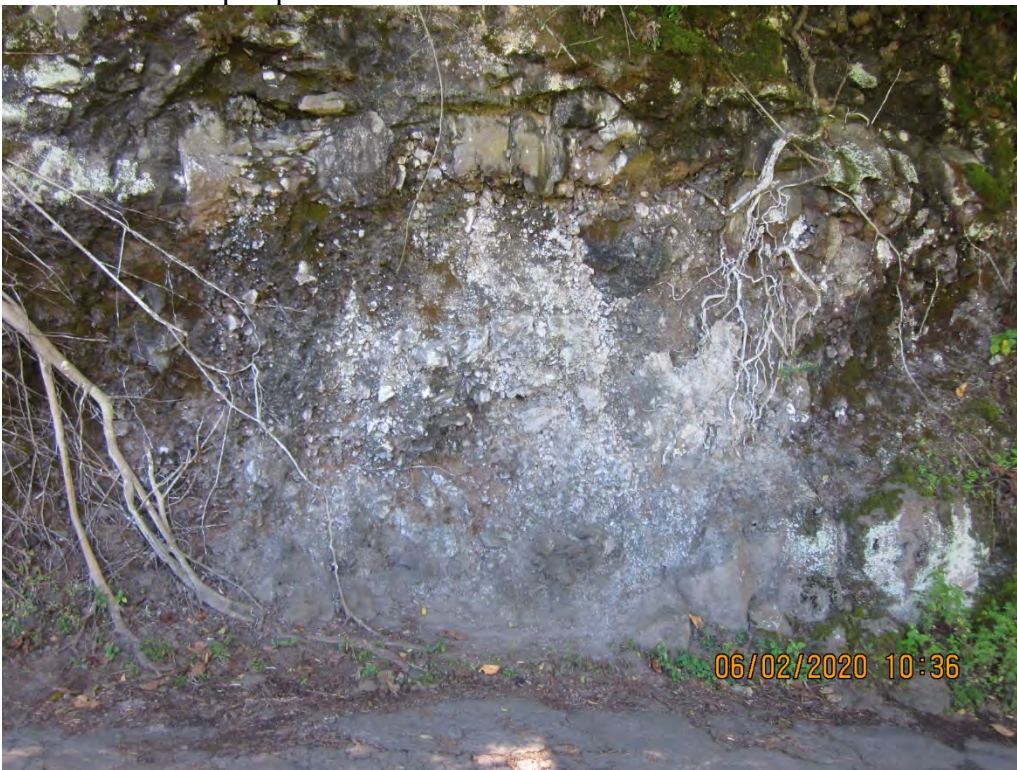
Photo 20. Transect F-W-09, Lower Section. Jointed Basalt with clinker zones and infilling.

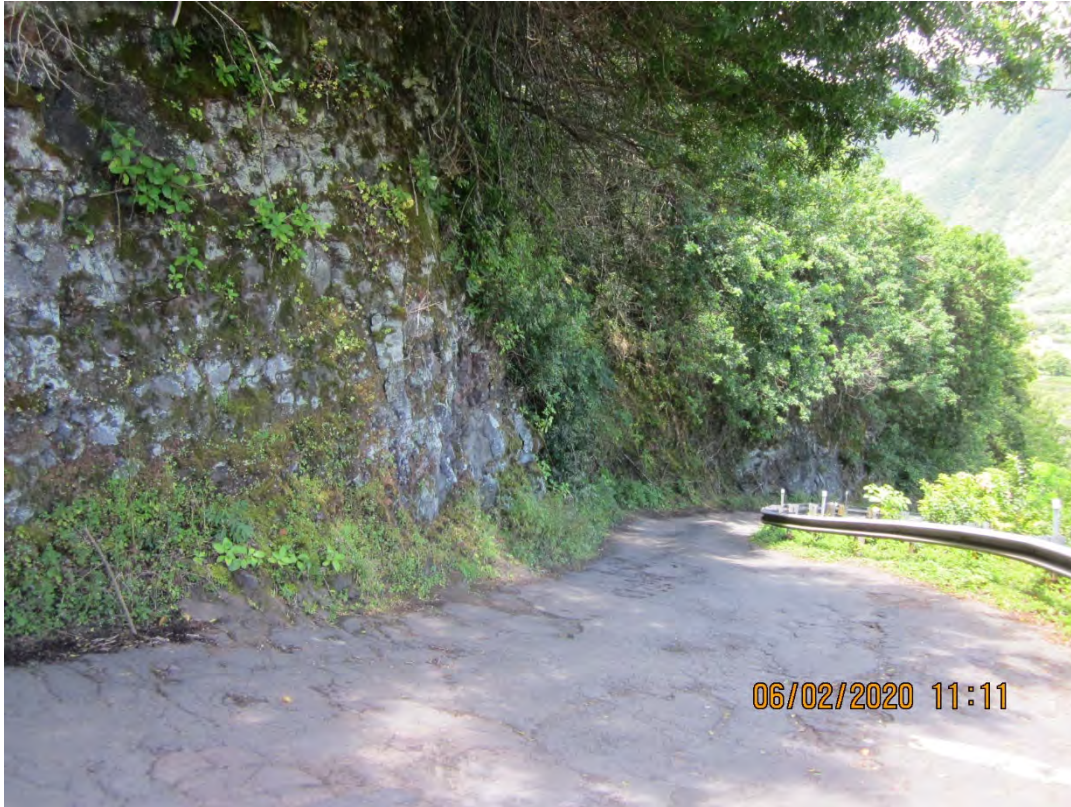
Photo 21. Transect F-W-10, Lower Section. Line-of-sight issues continue downhill.

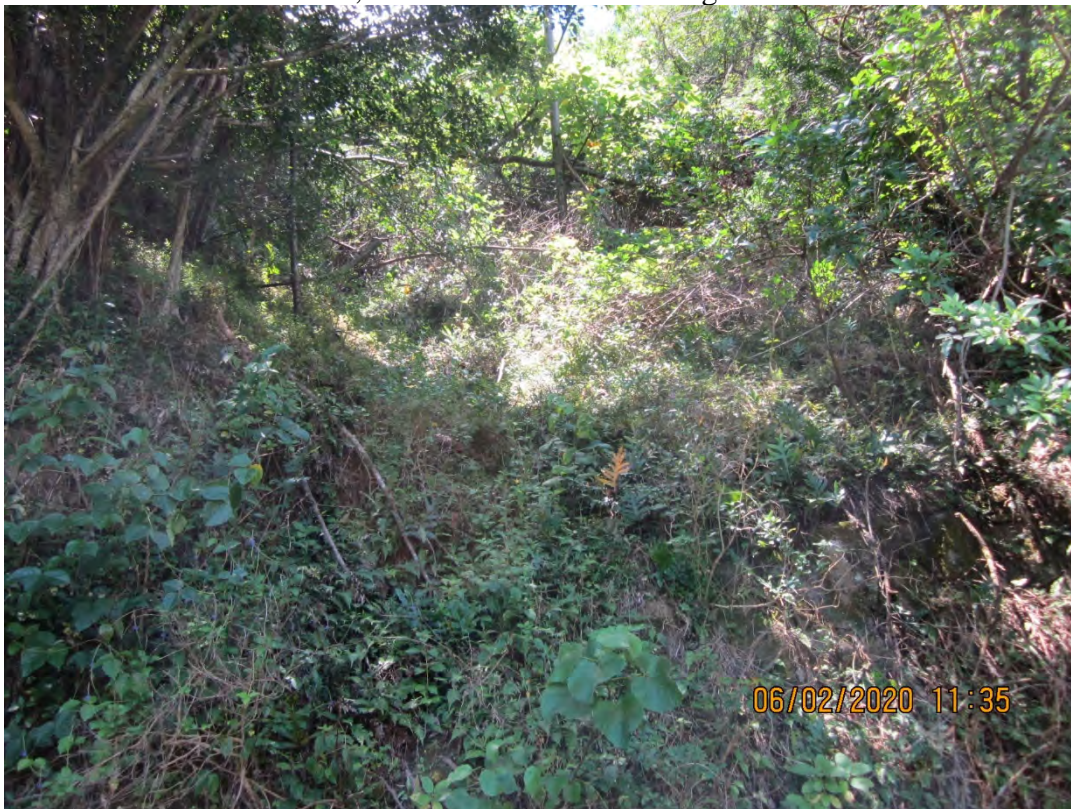
Photo 22. Transect F-W-10, Lower Section. Surface water flow path mauka side of road.

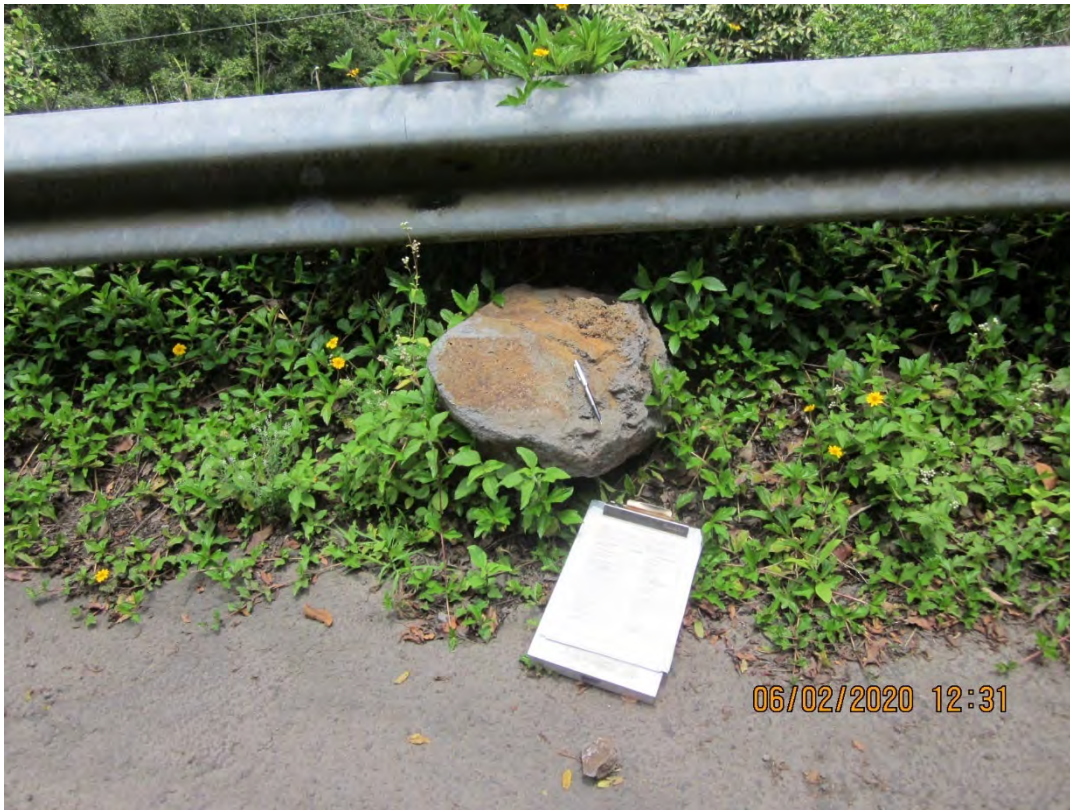
Photo 23. Transect F-W-10, Lower Section. Rockfall makai side of road.

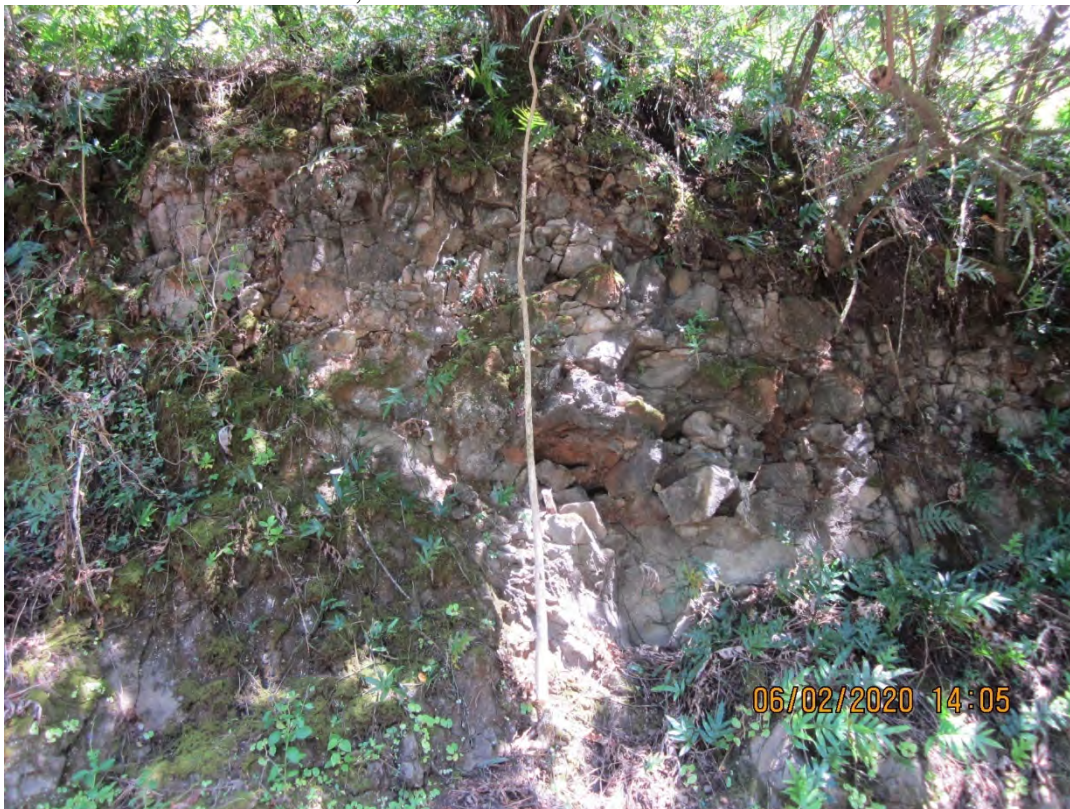
Photo 24. Transect F-W-11, Lower Section. Jointed Basalt with infilling.

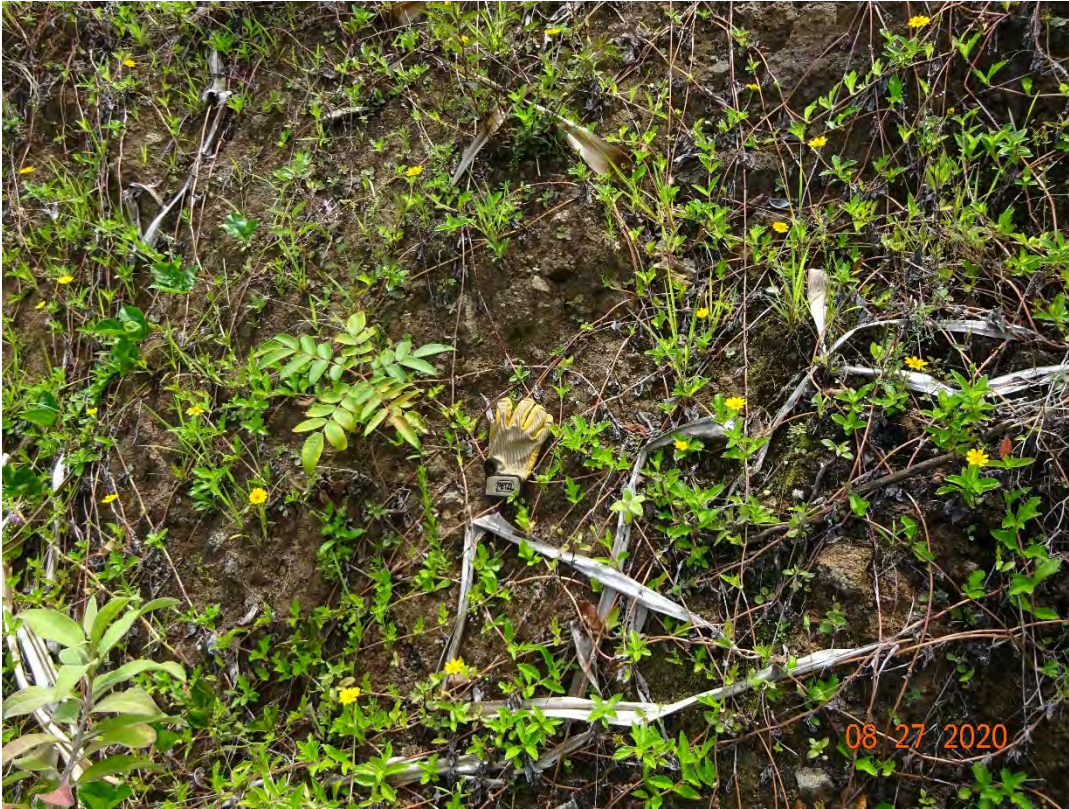
Photo 27. Transect F-W-04, Central Section. Loose soil and rock debris over much of slide area.

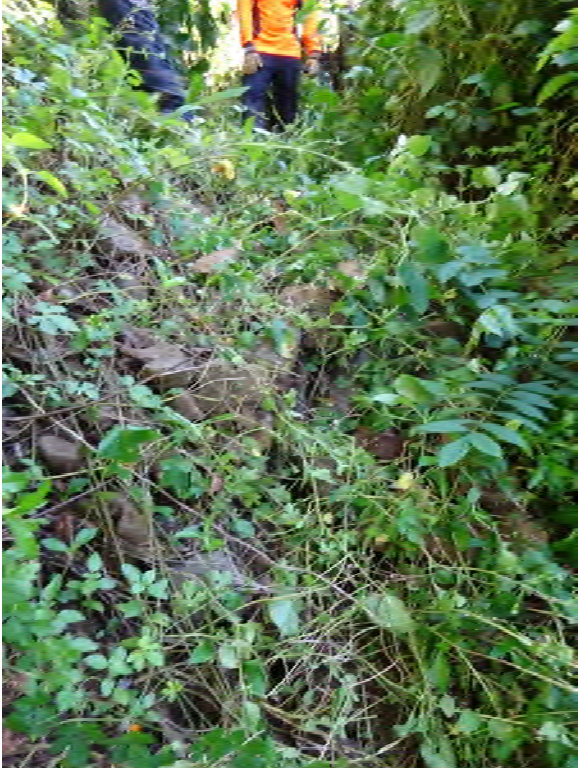
Photo 29. Transect F-W-04, Central Section. Loose and rock debris at base of slide, setback from road to beach.
