January 23, 2017

Subject: Preliminary Geotechnical Consultation Letter
North Abutment Scouring Geotechnical Issues
Hakalau Stream Bridge (No. 29-3)
Hilo, County of Hawaii, Hawaii

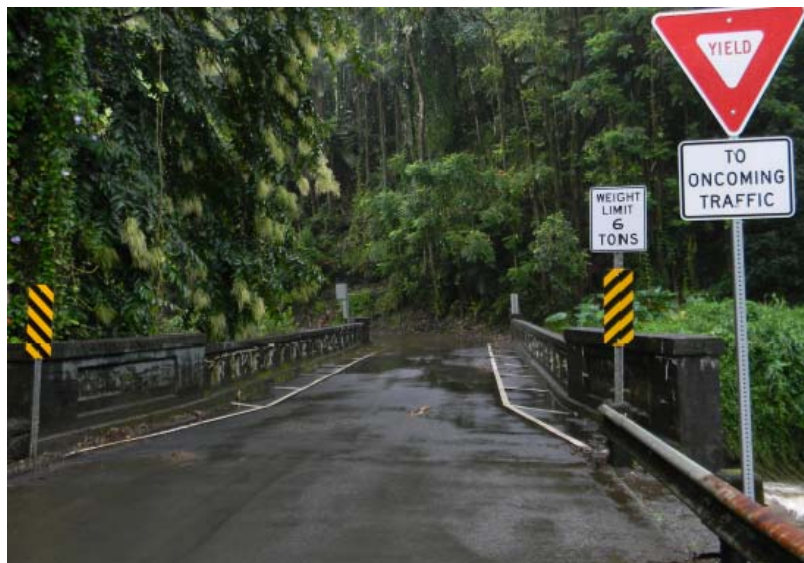
- a. The Old Mamalahoa Highway and Bridge 29-3 provide access to a beach park and maintenance of the steel truss supported Mamalahoa Highway (19) bridge crossing Hakalau Gulch.
- b. Only one lane traffic was allowed to cross the bridge, and weight limit was limited to 6 tons (Insert 2).

Insert 2. Looking south from north abutment.

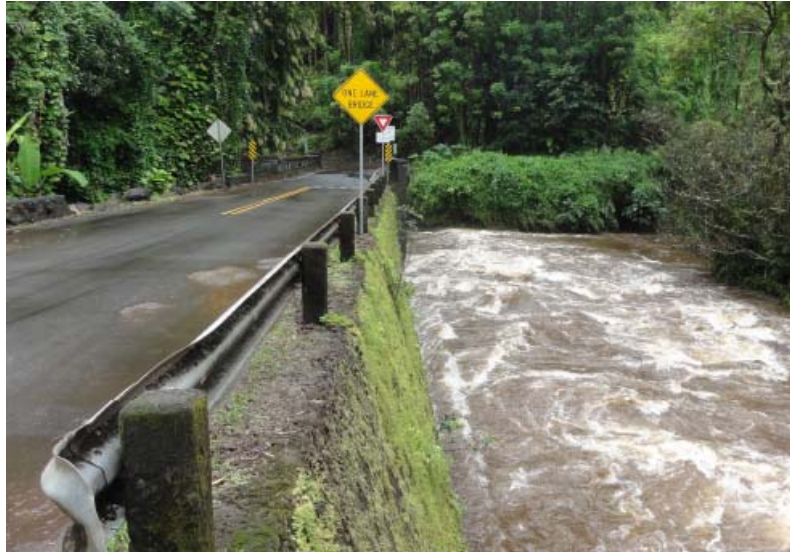
- c. The asphalt concrete road surface appeared recently repaved and cracks on the bridge concrete railings were repaired or patched.
- d. The stream level was above the “rubble masonry slope paving” (Insert 4) fringing the base of the north abutment, and therefore the rubble masonry paving and undermining of the north abutment cannot be observed during the field visit (Insert 3).

Insert 3. View of “Rock Embankment” north of north abutment, looking south.

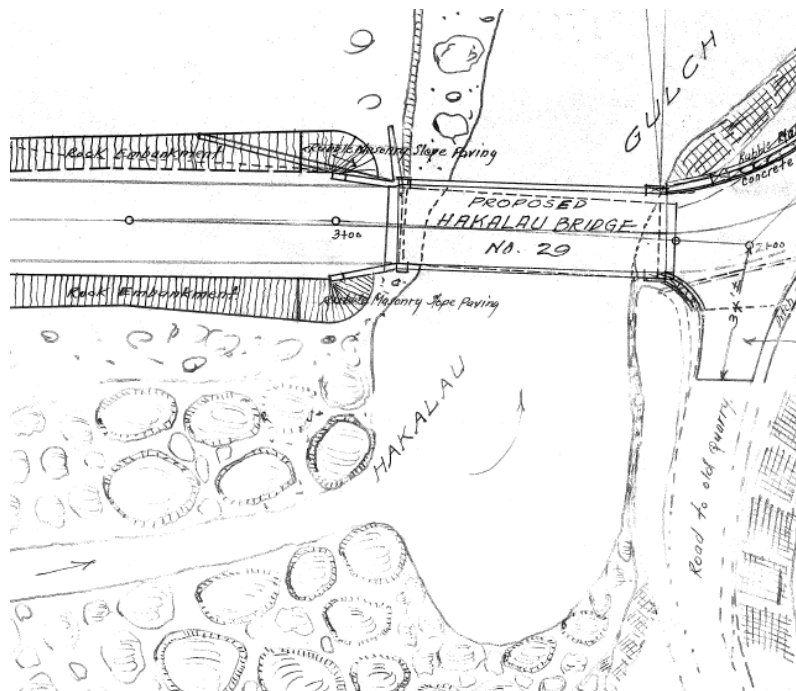
Insert 4. “Rubble Masonry Slope Paving” and “Rock Embankment” call out on 1929 record plans. North abutment is the left abutment on plan shown.

- d. The “rock ledge” described and reported fringing the north abutment in the report should be the “rubble masonry slope paving” according to the 1929 record plan (Figure 1).
