# Remaining Useful Life Determination for the

**Country Club Condominium/Hotel**

**Hilo, Hawaii  
TMK: (3) 2-1-005: 020**

Final Report  
June 2014

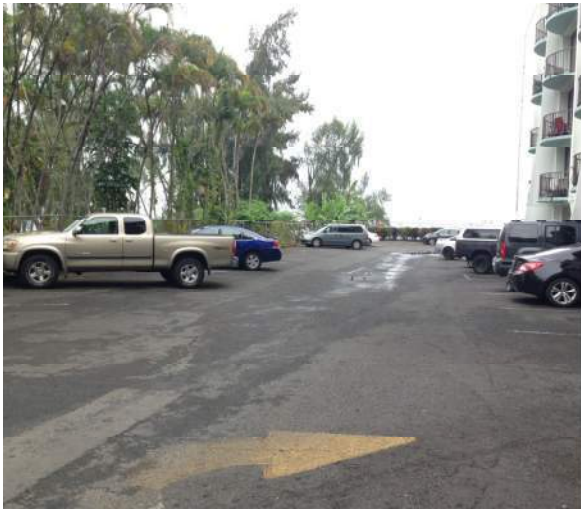
| Element Code | Element | Location of Deficient Elements Noted: | Description of Finding: | RUL Weight:<br>(1 High to 3 Low) | Estimated Age: If<br>Available (Years) | Condition Rating:<br>A to F | Estimated Useful<br>Life (Years) | Remaining Useful<br>Life (Years) | Photos<br>Referenced: | Comments & Major Deficiencies Noted: |
|---|---|---|---|---|---|---|---|---|---|---|
| G2 | Grounds - Drainage & Runoff | a. Parking area in rear of building | a. Minor Ponding noted. | 2 | 45 | C | 25 | 10 | a. IMG_2453 | N/A |

Photo 1: IMG\_2453 – Parking area at rear of building

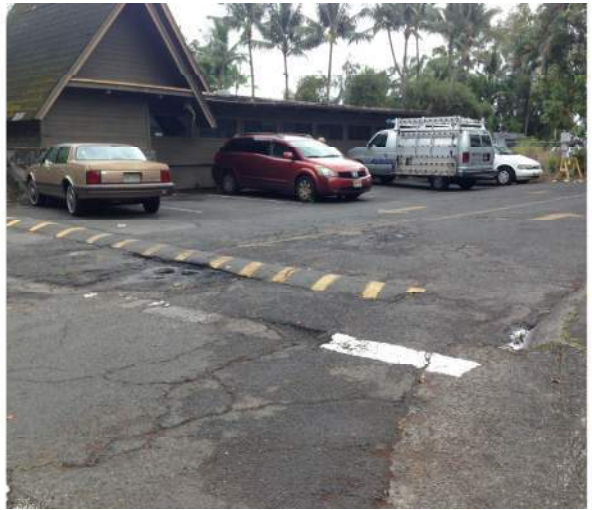
| Element Code | Element | Location of Deficient Elements Noted: | Description of Finding: | RUL Weight:<br>(1 High to 3 Low) | Estimated Age: If<br>Available (Years) | Condition Rating:<br>A to F | Estimated Useful<br>Life (Years) | Remaining Useful<br>Life (Years) | Photos<br>Referenced: | Comments & Major Deficiencies Noted: |
|---|---|---|---|---|---|---|---|---|---|---|
| G3 | Grounds - Parking & Paved Areas | a. Driveway into property is a separate parcel | a. AC Pavement is failing in some locations. Surface is cracked and worn. | 2 | 45 | D | 25 | 5 | a. IMG_2445 | a. Resurfacing is recommended with continued use, however, since this is a separate parcel, there is no control over its condition. |

Photo 2: IMG\_2445 – Deteriorated pavement at entry parcel

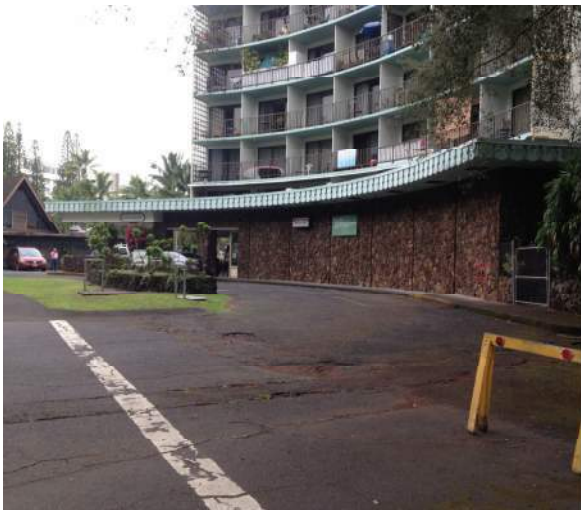
| Element Code | Element | Location of Deficient Elements Noted: | Description of Finding: | RUL Weight:<br>(1 High to 3 Low) | Estimated Age: If<br>Available (Years) | Condition Rating:<br>A to F | Estimated Useful<br>Life (Years) | Remaining Useful<br>Life (Years) | Photos<br>Referenced: | Comments & Major Deficiencies Noted: |
|---|---|---|---|---|---|---|---|---|---|---|
| | | c. Parking area behind/beneath building | c. AC Pavement exhibits minor cracking and wear. However, pavement failure was not observed. | 2 | | D | | 5 | c. IMG_2447 | |

Photo 3: IMG\_2447– Deteriorated pavement at drop off area

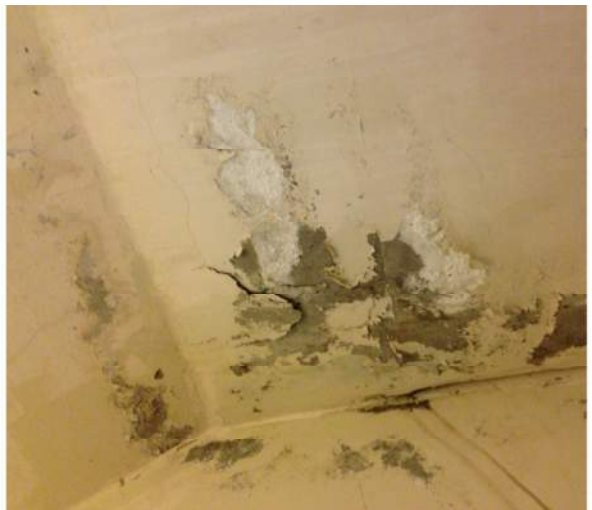
| Element Code | Element | Location of Deficient Elements Noted: | Description of Finding: | RUL Weight:<br>(1 High to 3 Low) | Estimated Age: If<br>Available (Years) | Condition Rating:<br>A to F | Estimated Useful<br>Life (Years) | Remaining Useful<br>Life (Years) | Photos<br>Referenced: | Comments & Major Deficiencies Noted: |
|---|---|---|---|---|---|---|---|---|---|---|
| S2 | Structural - Floor Slabs | a. Various locations<br>b. Ledger at Elevator Shaft | a. Spalling at various locations noted.<br>b. Rusting and loose/missing bolts observed at ledgers. | 1 | 45 | C | 25 | 15 | a. IMG_2494<br>b. IMG_2507 | a,b. Recommend repairs with continued use. |

Photo 4: IMG\_2494– Concrete slab spalling and efflorescence in stairwell

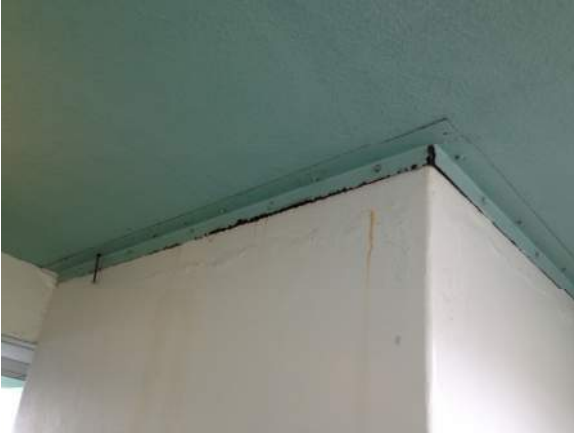
Photo 5: IMG\_2507 – Rusting and loose bolt at slab ledger

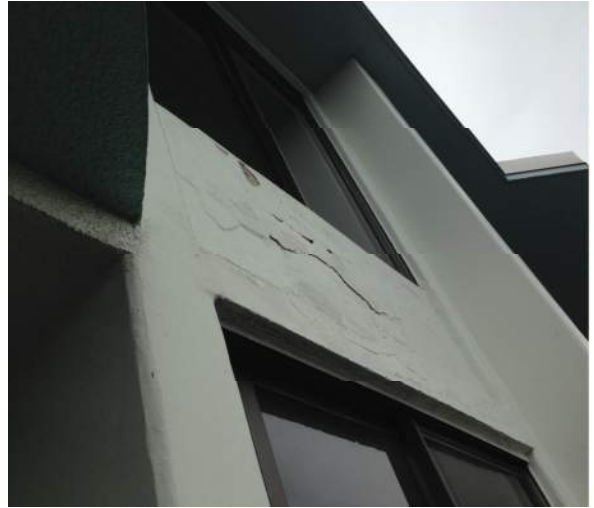
| Element Code | Element | Location of Deficient Elements Noted: | Description of Finding: | RUL Weight:<br>(1 High to 3 Low) | Estimated Age: If<br>Available (Years) | Condition Rating:<br>A to F | Estimated Useful<br>Life (Years) | Remaining Useful<br>Life (Years) | Photos<br>Referenced: | Comments & Major Deficiencies Noted: |
|---|---|---|---|---|---|---|---|---|---|---|
| S3 | Structural - Walls | a. Various locations including exterior walls (especially near windows), Interior and Exterior Elevator Room Walls and Stairwell Walls | a. Cracking and Spalling at various locations noted | 1 | 45 | C | 25 | 15 | a. IMG_2523,<br>IMG_2491 | a. Recommend repairs with continued use. |

Photo 6: IMG\_2523– Spalling at Exterior Wall

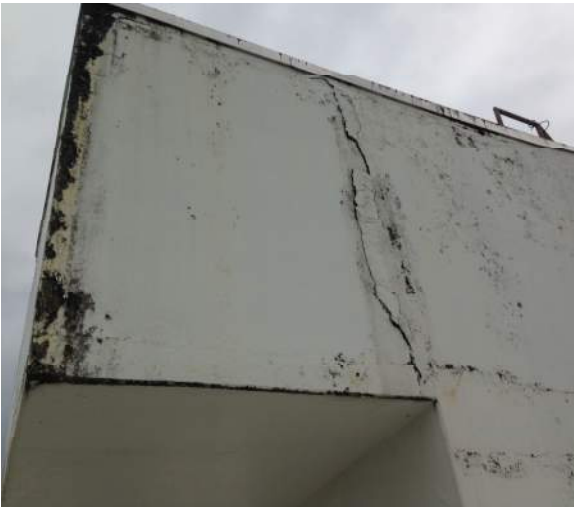
Photo 7: IMG\_2491 – Spalling and cracking at Elevator Room

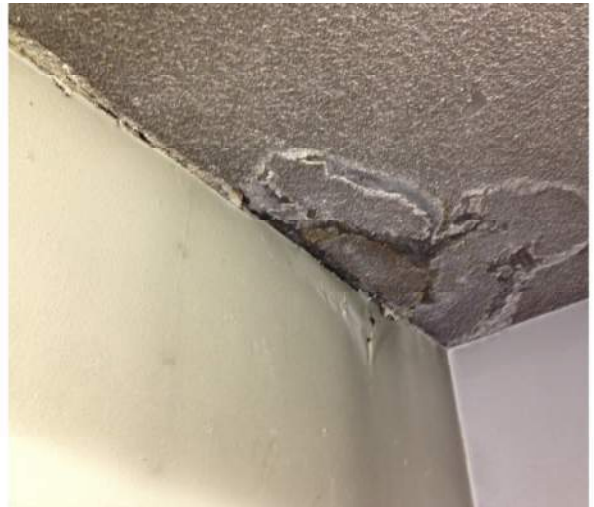
| Element Code | Element | Location of Deficient Elements Noted: | Description of Finding: | RUL Weight:<br>(1 High to 3 Low) | Estimated Age: If<br>Available (Years) | Condition Rating:<br>A to F | Estimated Useful<br>Life (Years) | Remaining Useful<br>Life (Years) | Photos<br>Referenced: | Comments & Major Deficiencies Noted: |
|---|---|---|---|---|---|---|---|---|---|---|
| S5 | Structural - Roof Framing | a. Reinforced Cast in Place Concrete Roof | a. Cracking and effloresence due to water infiltration observed. | 1 | 45 | D | 25 | 10 | a. IMG_2519 | a. Recommend repairs with continued use. |

Photo 8: IMG\_2519 – Water Damage, cracking and efflorescence at ceiling

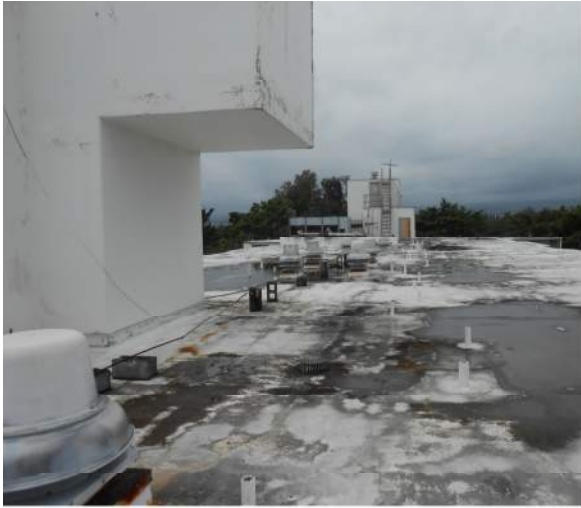
- The roof is cast in place concrete and there is evidence of leaking and is in need of re-application of roofing. Roofing is under warranty but the building maintenance supervisor is having trouble getting them to perform the corrective work.

| Element Code | Element | Location of Deficient Elements Noted: | Description of Finding: | RUL Weight:<br>(1 High to 3 Low) | Estimated Age: If<br>Available (Years) | Condition Rating:<br>A to F | Estimated Useful<br>Life (Years) | Remaining Useful<br>Life (Years) | Photos<br>Referenced: | Comments & Major Deficiencies Noted: |
|---|---|---|---|---|---|---|---|---|---|---|
| | | b. Roofing Treatment | b. Evidence of leakage and water damage observed in some locations. Roofing treatment is torn in places and ponding of water was observed. | | Unknown | | | | b. DSCN0465 | b. In need of re-application of roofing. |

Photo 9: DSCN0465 – Roof treatment failure and ponding water

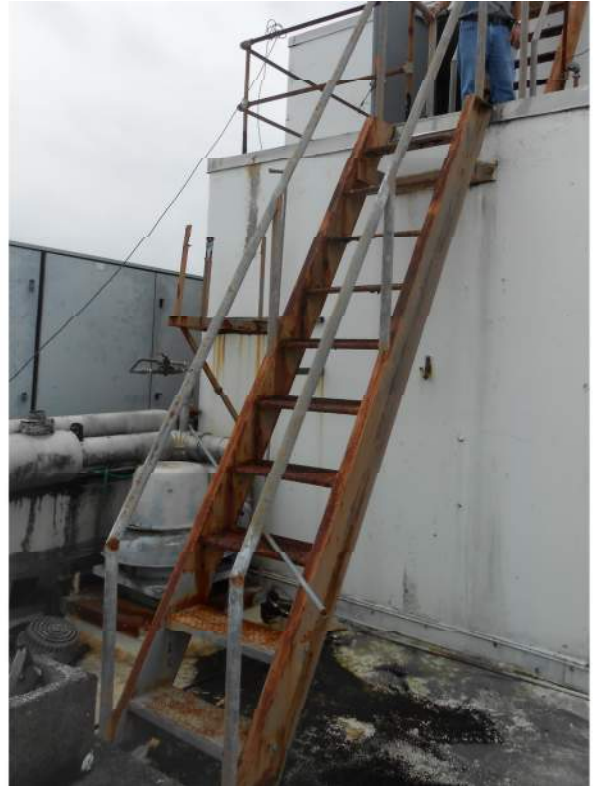
| Element Code | Element | Location of Deficient Elements Noted: | Description of Finding: | RUL Weight:<br>(1 High to 3 Low) | Estimated Age: If<br>Available (Years) | Condition Rating:<br>A to F | Estimated Useful<br>Life (Years) | Remaining Useful<br>Life (Years) | Photos<br>Referenced: | Comments & Major Deficiencies Noted: |
|---|---|---|---|---|---|---|---|---|---|---|
| S6 | Structural - Stairs | a. Steel Stairways | a. Widespread Rusting observed. | 2 | 45 | F | 20 | 8 | a. DSCN0471,<br>DSCN0481 | a. Replacement or Repair necessary. |

Photo 10: DSCN0471 – Roof stair rusting

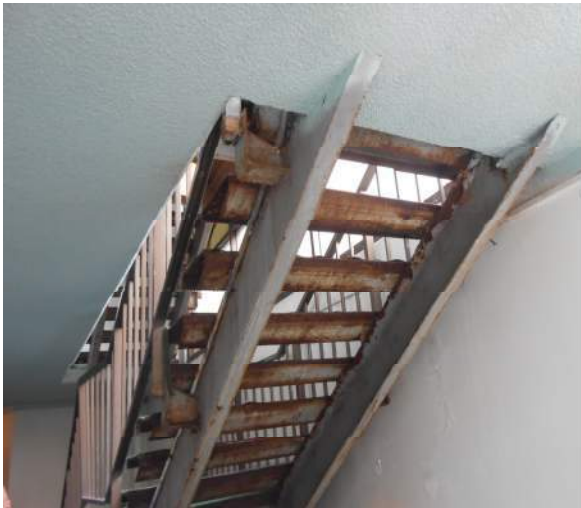
Photo 11: DSCN0481– Typical steel stair rusting

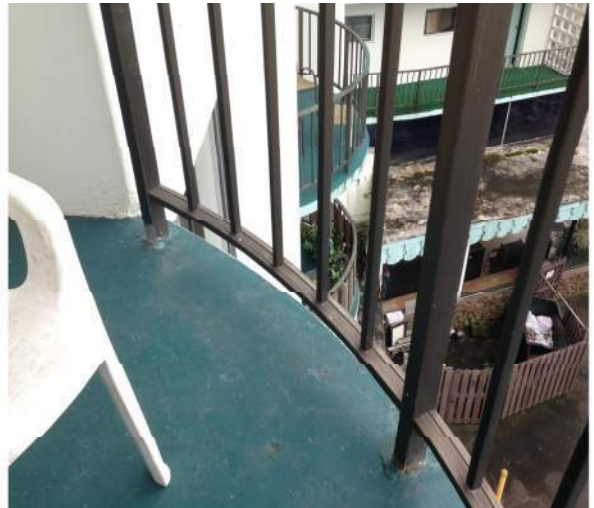
| Element Code | Element | Location of Deficient Elements Noted: | Description of Finding: | RUL Weight:<br>(1 High to 3 Low) | Estimated Age: If<br>Available (Years) | Condition Rating:<br>A to F | Estimated Useful<br>Life (Years) | Remaining Useful<br>Life (Years) | Photos<br>Referenced: | Comments & Major Deficiencies Noted: |
|---|---|---|---|---|---|---|---|---|---|---|
| S7 | Structural - Balconies | a. Typical Balcony - All Rooms | No significant issues noted. | 2 | 45 | C | 20 | 10 | a. IMG-2522 | N/A |

Photo 12: IMG\_2522 – Typical Balcony

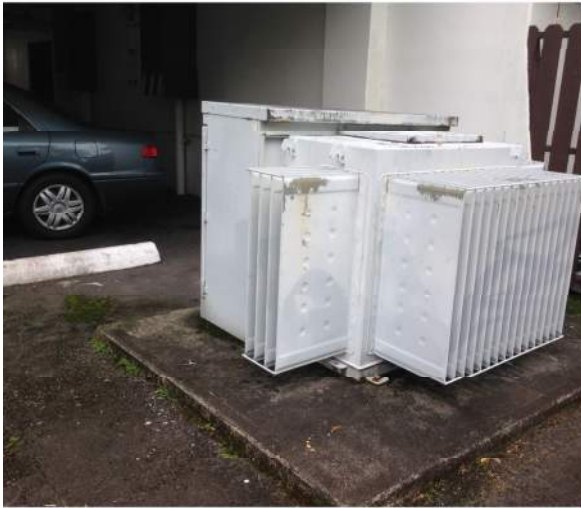
| Element Code | Element | Location of Deficient Elements Noted: | Description of Finding: | RUL Weight:<br>(1 High to 3 Low) | Estimated Age: If<br>Available (Years) | Condition Rating:<br>A to F | Estimated Useful<br>Life (Years) | Remaining Useful<br>Life (Years) | Photos<br>Referenced: | Comments & Major Deficiencies Noted: |
|---|---|---|---|---|---|---|---|---|---|---|
| E1 | Electrical - Wiring & Distribution | a. Panel on each floor<br>b. Transformer | a. Operational within Limits.<br>b. Was replaced; original still in place due to difficulty in removal. | 2 | 45 | D | 15 | 5 | b. IMG_2451,<br>DSCN0451 | a. In need of upgrade with continued use. Current system unable to accommodate surge loads. |

Photo 13: IMG\_2451 – Electrical transformer

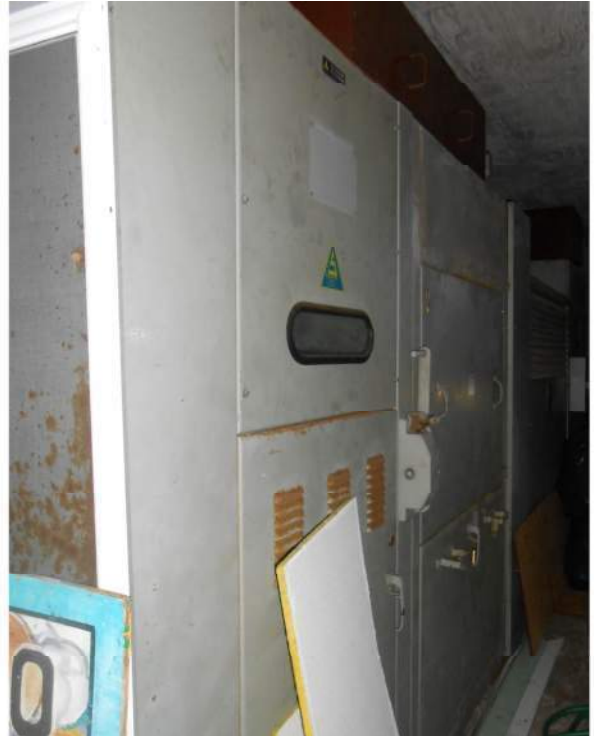
Photo 14: DSCN0451- Old electrical transformer, no longer in use

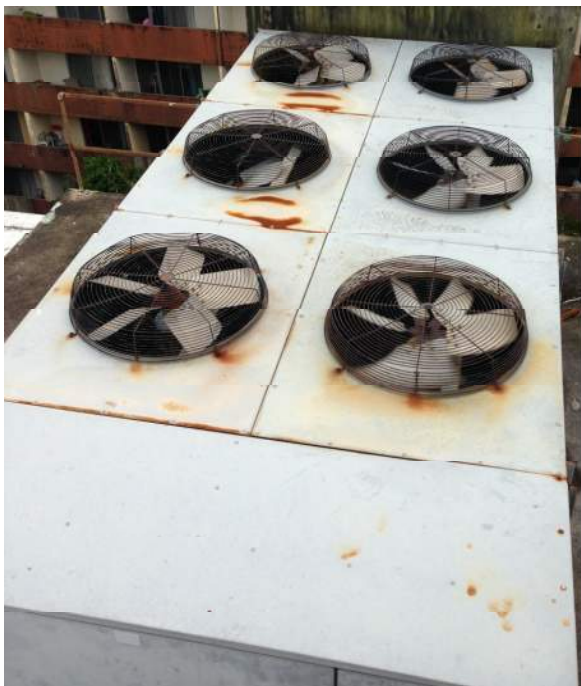
| Element Code | Element | Location of Deficient Elements Noted: | Description of Finding: | RUL Weight:<br>(1 High to 3 Low) | Estimated Age: If<br>Available (Years) | Condition Rating:<br>A to F | Estimated Useful<br>Life (Years) | Remaining Useful<br>Life (Years) | Photos<br>Referenced: | Comments & Major Deficiencies Noted: |
|---|---|---|---|---|---|---|---|---|---|---|
| M1 | Mechanical - Air Conditioning Plant | a. Water Chiller on Roof<br>b. Former Restaurant | a. Replaced in the 1990's Condition is fair and in need of replacement. Not fully operational.<br>b. Air Condition System not in use and unserviceable. | 2 | 40 | F | 15 | 0 | a. IMG_2489<br>b. DSCN0457,<br>DSCN0479,<br>DSCN0480 | a. Serious Condition and in need of Repairs or Replacement. |

Photo 15: IMG\_2489 – Air cooled chiller unit

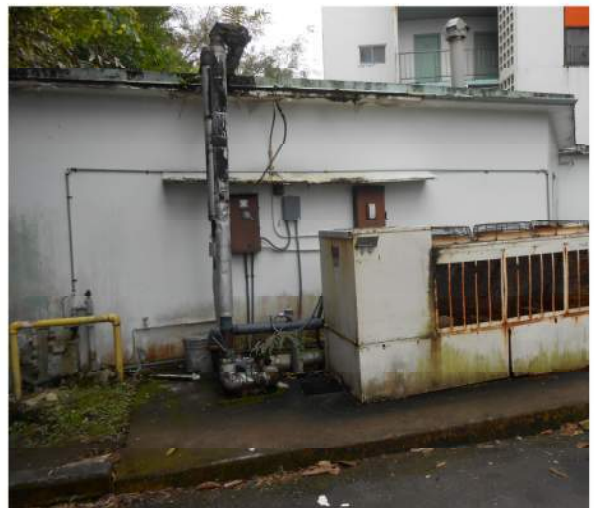
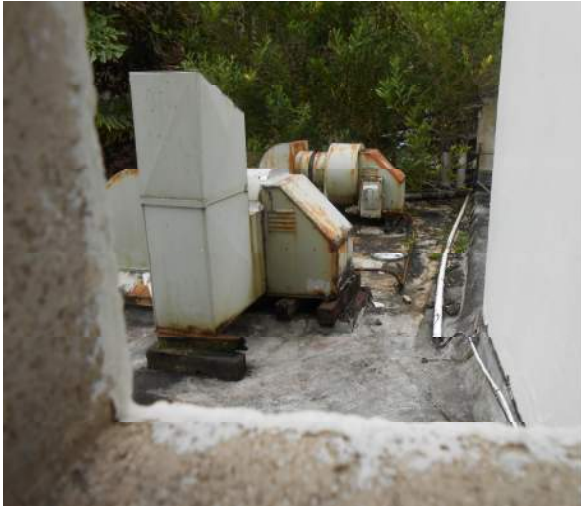
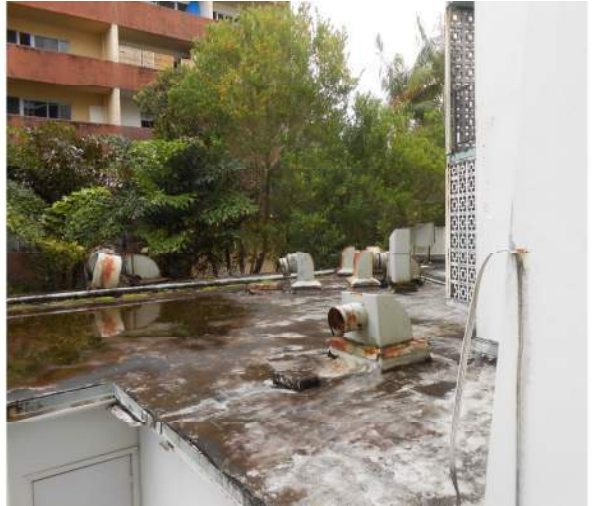
Photo 16: DSCN0457 – Defunct restaurant chiller unit

Photo 17: DSCN0479 – Defunct restaurant equipment

Photo 18: DSCN0480 – Defunct restaurant equipment

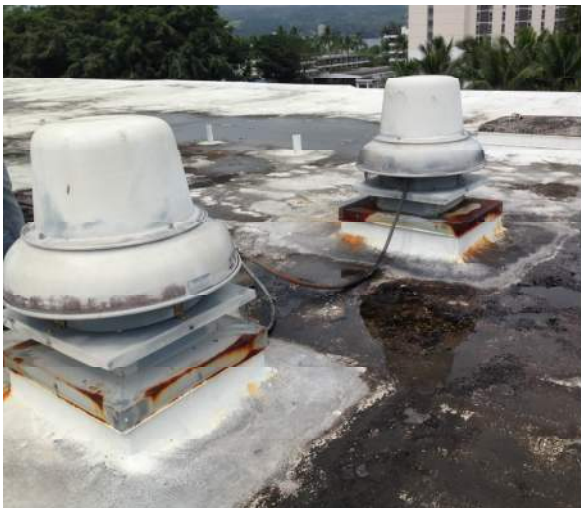
| Element Code | Element | Location of Deficient Elements Noted: | Description of Finding: | RUL Weight:<br>(1 High to 3 Low) | Estimated Age: If<br>Available (Years) | Condition Rating:<br>A to F | Estimated Useful<br>Life (Years) | Remaining Useful<br>Life (Years) | Photos<br>Referenced: | Comments & Major Deficiencies Noted: |
|---|---|---|---|---|---|---|---|---|---|---|
| M2 | Mechanical - Air Conditioning Ducts | a. Exhaust Fans | a. In poor condition | 2 | 45 | D | 20 | 2 | a. IMG_2469 | a. Replacement needed with continued use. |

Photo 19: IMG\_2569 – Exhaust Fans

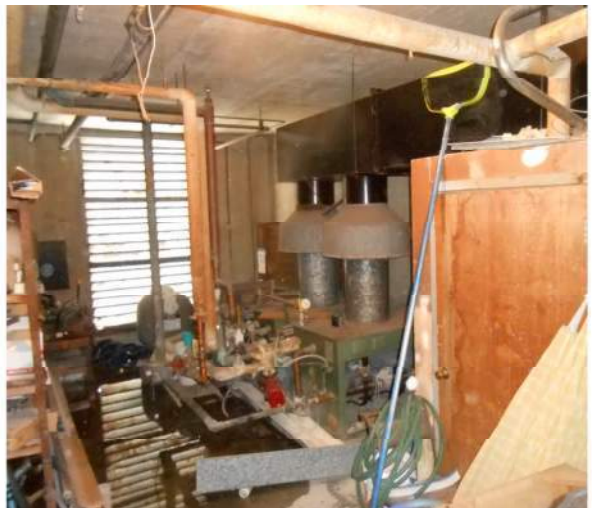
| Element Code | Element | Location of Deficient Elements Noted: | Description of Finding: | RUL Weight:<br>(1 High to 3 Low) | Estimated Age: If<br>Available (Years) | Condition Rating:<br>A to F | Estimated Useful<br>Life (Years) | Remaining Useful<br>Life (Years) | Photos<br>Referenced: | Comments & Major Deficiencies Noted: |
|---|---|---|---|---|---|---|---|---|---|---|
| U2 | Utility - Heater & Flue, Commercial Size | a. Boiler/Water Heater | a. Old & Obsolete | 2 | N/A | D | 15 | 2 | a. DSCN0461 | a. Boiler needs replacement. |

Photo 20: DSCN0461 – Heater/Boiler Room

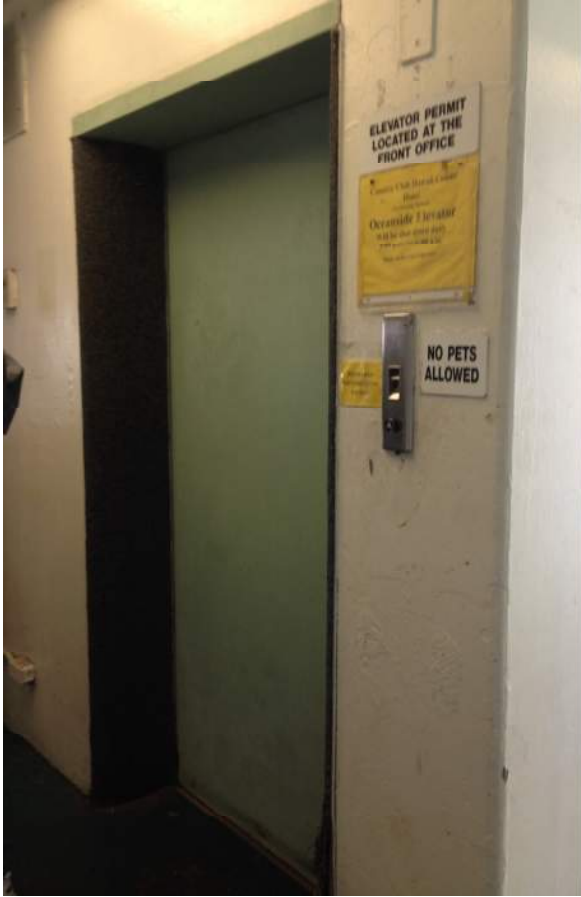
| Element Code | Element | Location of Deficient Elements Noted: | Description of Finding: | RUL Weight:<br>(1 High to 3 Low) | Estimated Age: If<br>Available (Years) | Condition Rating:<br>A to F | Estimated Useful<br>Life (Years) | Remaining Useful<br>Life (Years) | Photos<br>Referenced: | Comments & Major Deficiencies Noted: |
|---|---|---|---|---|---|---|---|---|---|---|
| O2 | ELEVATOR SYSTEM | 2 Elevators one front; other rear | Both in good condition as maintained by OTIS. | 3 | 45 | B | 15 | 15 | IMG_2461 | N/A |

Photo 21: IMG\_2461- Elevator in Lobby

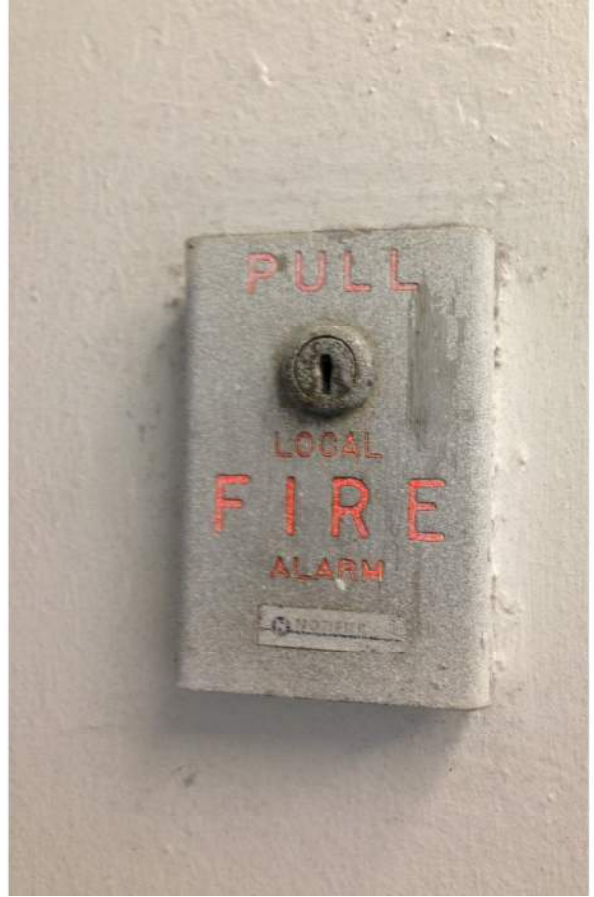
Photo 22: IMG\_2463 – Fire alarm pull box

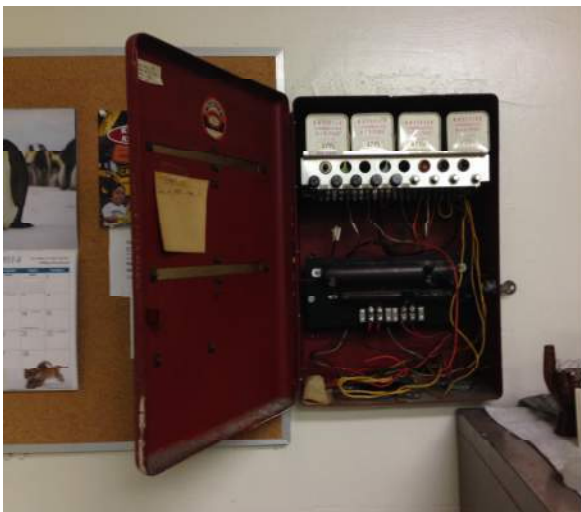
Photo 23: IMG\_2450- Fire alarm control box

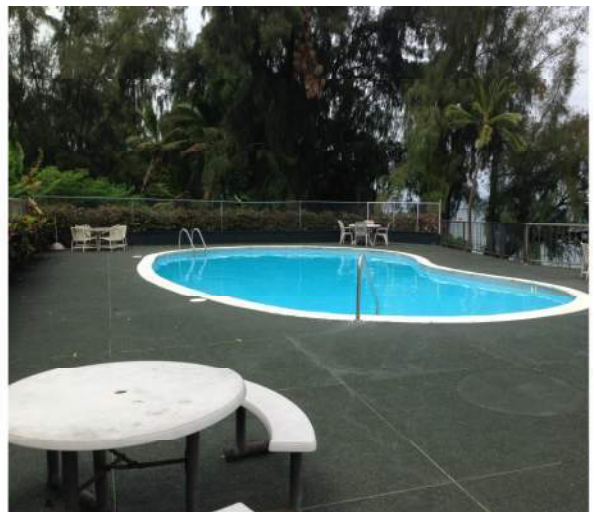
| Element Code | Element | Location of Deficient Elements Noted: | Description of Finding: | RUL Weight:<br>(1 High to 3 Low) | Estimated Age: If<br>Available (Years) | Condition Rating:<br>A to F | Estimated Useful<br>Life (Years) | Remaining Useful<br>Life (Years) | Photos<br>Referenced: | Comments & Major Deficiencies Noted: |
|---|---|---|---|---|---|---|---|---|---|---|
| O4 | Swimming Pool | a. Makai of Building next to Ocean | a. In use and no significant problems. | 3 | 45 | C | 15 | 15 | a. IMG_2524 | N/A |

Photo 24: IMG\_2524 – Swimming Pool
