# Remaining Useful Life Determination for the

Reed's Bay Hotel

Hilo, Hawaii  
TMK: (3) 2-1-005: 022

Final Report  
June 2014

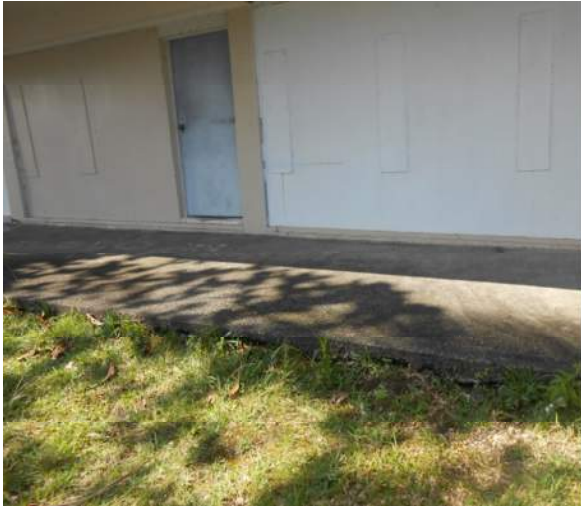
| Element Code | Element | Location of Elements Noted: | Description of Finding: | RUL Weight:<br>(1 High to 3 Low) | Estimated Age: If Available (Years) | Condition Rating:<br>A to F | Estimated Useful Life (Years) | Remaining Useful Life (Years) | Photos Referenced: | Comments & Major Deficiencies Noted: |
|---|---|---|---|---|---|---|---|---|---|---|
| G1 | Grounds - Settlement & Erosion | a. Walkway Slab @ South Building Makai Ground Level<br>b. Cracking in Concrete Walkways between Hotel and Restaurant Wings | a. Undermining of Walkway Slab beginning<br>b. Various cracking in slab leading to pool, as well as along walkway. May pose tripping hazard. | 3<br>3 | 42 - 45 Years | C<br>C | 25 | 15 | a. DSCN0429<br>b. DSCN0438<br>(also shown in photo for M1, IMG_2266) | Slab not yet showing signs of distress. |

Photo 1: DSCN0429 – Undermining at Makai South Building Sidewalk

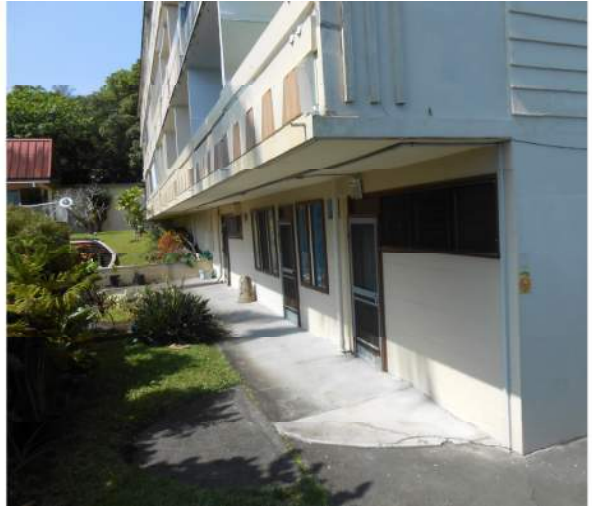
Photo 2: DSCN0438 – Cracking in Walkway

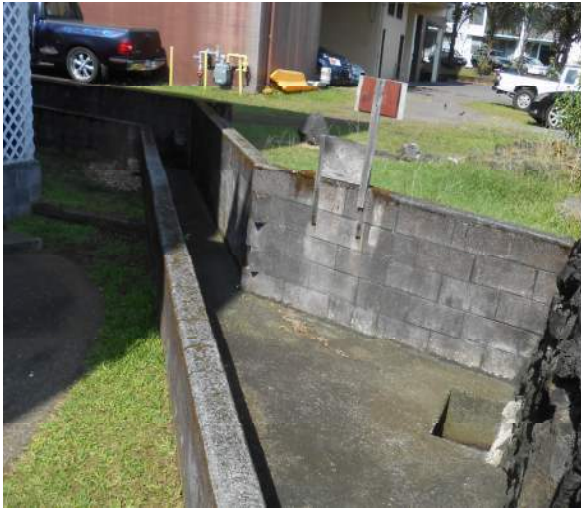
| Element Code | Element | Location of Elements Noted: | Description of Finding: | RUL Weight:<br>(1 High to 3 Low) | Estimated Age: If Available (Years) | Condition Rating:<br>A to F | Estimated Useful Life (Years) | Remaining Useful Life (Years) | Photos Referenced: | Comments & Major Deficiencies Noted: |
|---|---|---|---|---|---|---|---|---|---|---|
| G2 | Grounds - Drainage & Runoff | a. Along North Property Line; Concrete Lined Drainage Channel | a. Clean and in good condition; is maintained regularly | 3 | 42 - 45 Years | B | 25 | 20 | DSCN0443 | N/A |

Photo 3: DSCN0443– Concrete Drainage Ditch

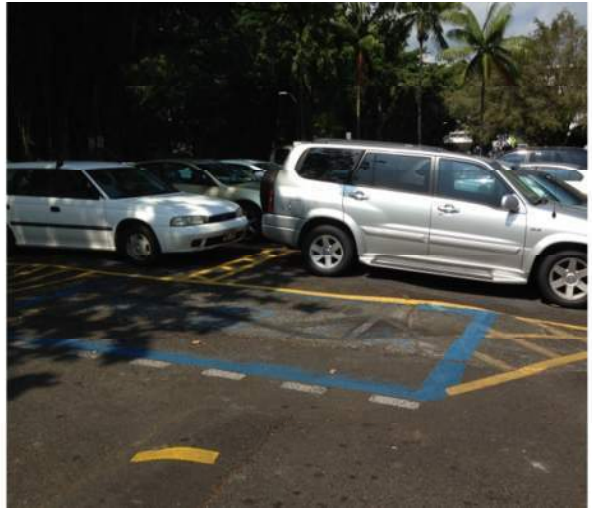
| Element Code | Element | Location of Elements Noted: | Description of Finding: | RUL Weight:<br>(1 High to 3 Low) | Estimated Age: If Available (Years) | Condition Rating:<br>A to F | Estimated Useful Life (Years) | Remaining Useful Life (Years) | Photos Referenced: | Comments & Major Deficiencies Noted: |
|---|---|---|---|---|---|---|---|---|---|---|
| G3 | Grounds - Parking & Paved Areas | General Areas include Front Parking , Driveways, Interior & Perimeter Grounds. | a. Parking lot is in decent condition but has some cracking, patching and uneven areas | 3 | 42 - 45 Years | C | 25 | 25 | IMG_2037 | a. Expected wear observed. Resurfacing/reconstruction will be required for long term use |

Photo 4: IMG\_2037 – Paved Parking Lot

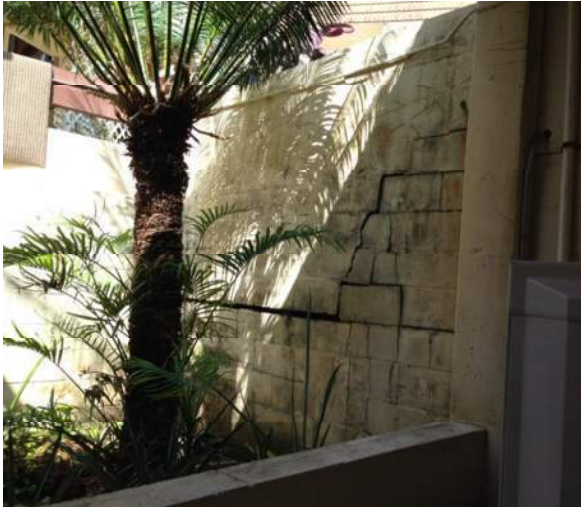
| Element Code | Element | Location of Elements Noted: | Description of Finding: | RUL Weight:<br>(1 High to 3 Low) | Estimated Age: If Available (Years) | Condition Rating:<br>A to F | Estimated Useful Life (Years) | Remaining Useful Life (Years) | Photos Referenced: | Comments & Major Deficiencies Noted: |
|---|---|---|---|---|---|---|---|---|---|---|
| S1 | Structural - Foundation | a. Retaining Wall - Between Open Area & Stairs to Basement | a. CMU is cracked and failing. | 2 | 42 - 45 Years | F | 25 | 4 | IMG_2278 | a. CMU Hollow Tile Retaining Wall is cracking and failing at the planter in the Open Area. Corrective action is necessary. |

Photo 5: IMG\_2278 – CMU Wall Failure

- Site Retaining Wall – The repair of retaining wall in the restaurant wing is failing and will need to be re-constructed.
- Restaurant Wing Structural Repairs – There are several beams supporting the second floor that are badly deteriorated and need to be replaced. To fully utilize this wing, extensive repairs would be necessary, including but not limited to, reconstruction of the second floor roof and walls, cleaning and patching of isolated concrete spalling and all existing steel beams would need to be cleaned, repaired where required and painted.

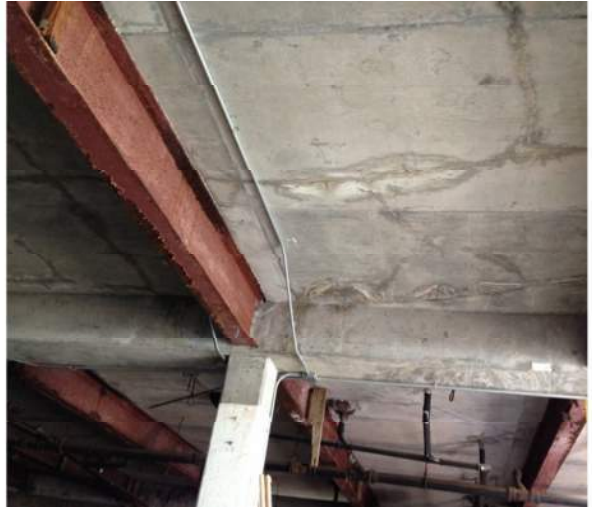
| Element Code | Element | Location of Elements Noted: | Description of Finding: | RUL Weight:<br>(1 High to 3 Low) | Estimated Age: If Available (Years) | Condition Rating:<br>A to F | Estimated Useful Life (Years) | Remaining Useful Life (Years) | Photos Referenced: | Comments & Major Deficiencies Noted: |
|---|---|---|---|---|---|---|---|---|---|---|
| S2 | Structural - Floor Slabs | a. Old Restaurant Floor/basement ceiling<br>b. Main building floors were covered with carpet and textured ceiling finish. | a. Cracking with leakage, rust staining and effloresence noted from underside of slab.<br>b. No obvious cracking noted through finishes | 1<br>1 | 42 - 45 Years | B<br>B | 30 | 20 | IMG_2276 | Rust staining indicates corrosion of reinforcing is occurring. |

Photo 6: IMG\_2276 – Cracking, Staining and Efflorescence at Restaurant Basement

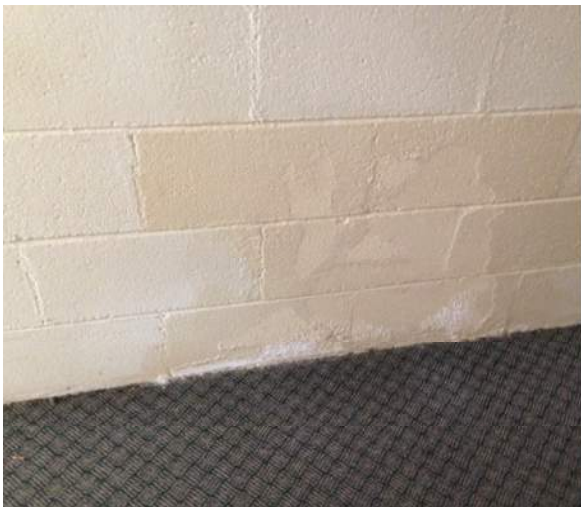
Photo 7: IMG\_2297 - Efflorescence and Cracking/Patching in Hallways

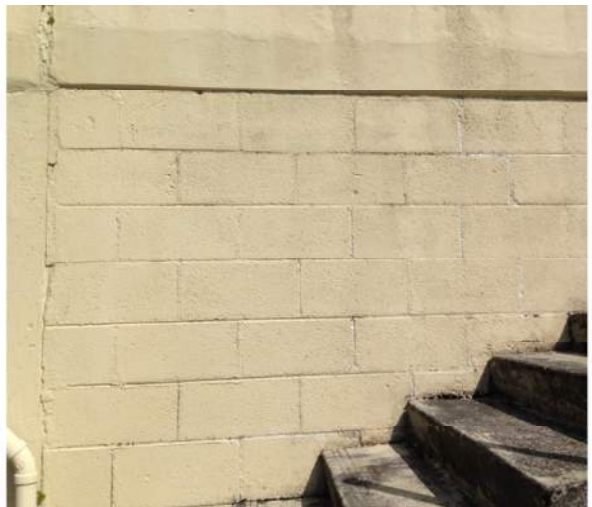
| Element Code | Element | Location of Elements Noted: | Description of Finding: | RUL Weight:<br>(1 High to 3 Low) | Estimated Age: If Available (Years) | Condition Rating:<br>A to F | Estimated Useful Life (Years) | Remaining Useful Life (Years) | Photos Referenced: | Comments & Major Deficiencies Noted: |
|---|---|---|---|---|---|---|---|---|---|---|
| S3 | Structural - Walls | a. CMU hallways on ground level (North side)<br>b. Exterior Wall in Basement, South East Corner | a. Cracking and/or patching with effloresence noted in 2 locations<br>b. Horizontal and stepped cracks in CMU Wall with effloresence | 1<br>2 | 42 - 45 Years | C<br>D | 25 | 20 | a. IMG_2297<br>b. IMG_2283 | Effloresence indicates water interaction. No displacement at cracking noted. |

Photo 8: IMG\_2283 – Cracking at Exterior Basement Wall.

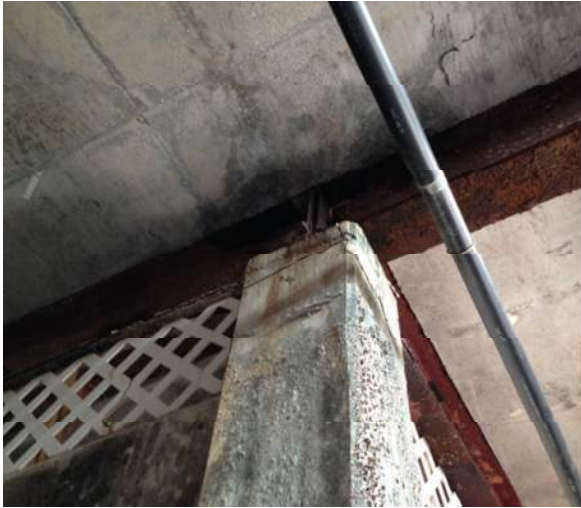
Photo 9: IMG\_2269 – Cracking at Top of Column

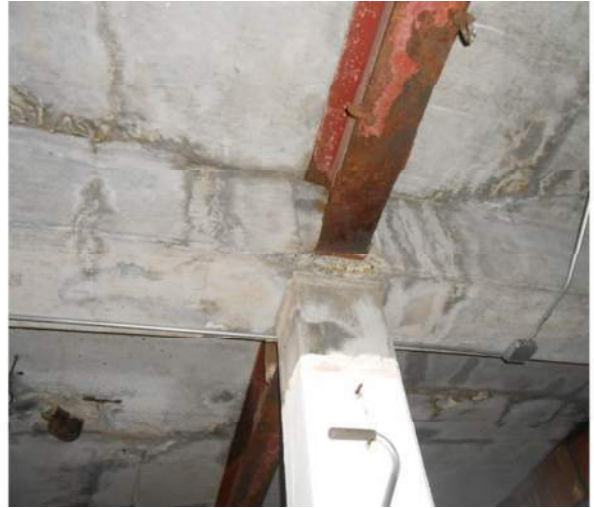
Photo 10: DSCN0420 – Spalling in Concrete Beam

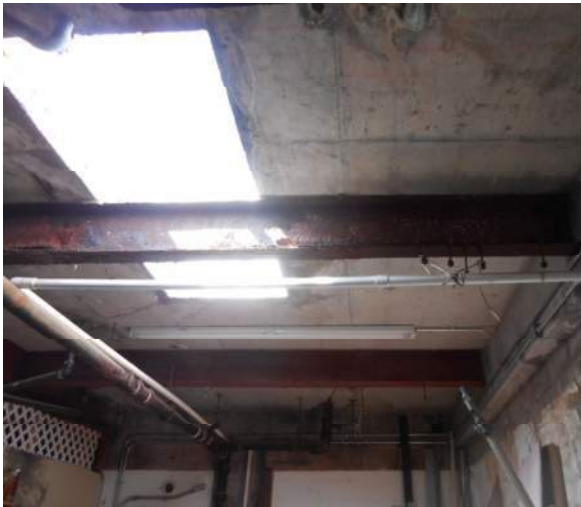
| Element Code | Element | Location of Elements Noted: | Description of Finding: | RUL Weight:<br>(1 High to 3 Low) | Estimated Age: If Available (Years) | Condition Rating:<br>A to F | Estimated Useful Life (Years) | Remaining Useful Life (Years) | Photos Referenced: | Comments & Major Deficiencies Noted: |
|---|---|---|---|---|---|---|---|---|---|---|
| S4 | Structural - Columns & Beams | a. Basement Area, Concrete Columns<br>b. Basement Area, Concrete Beams<br>c. Basement Area, Steel I Beams<br>d. Restaurant Area, Roof & Wall Framing | a. Cracking noted at the top of 1 column<br>b. Spalling noted at the top of 1 beam (3 locations)<br>c. 2-4 of 16 Section Lengths with Sections severely reduced by rust. Mild to moderate surface rusting with some section loss on remainder of steel beams.<br>d. Majority of roof and wall framing was destroyed by fire in 1983 and subsequent exposure. Remaining roof beams are severely corroded. | 2<br>2<br>1<br>3 | 42 - 45 Years | D<br>D<br>D<br>F | 25 | 8<br>8<br>12<br>0 | a. IMG_2269<br>b. DSCN0420<br>c. DSCN0415<br>d. DSCN0434 | a. Repair is suggested but not critical for continued use of the space.<br>b. Repair is suggested but not critical for coninued use of the space.<br>c. Repair of the beams with severe corrosion is necessary for continued use of the space.<br>d. Not rated heavily since area has not been used for 30 years. Reconstruction of the roof and wall framing is required should this area be returned to use. |

Photo 11: DSCN0415 – Section Loss at Steel Beam due to Corrosion

- Element No. S 1.a – Retaining wall is in need of repair & re-construction.
- Element No. S 4.b - Structural steel beams, a few of which have section loss due to corrosion. These members will need cleaning and reinforcement and/or replacement in certain locations if the use of this location continues.
- Element No. E 1.a – Electrical wiring & breakers are unsatisfactory. Continued use will require the upgrade of this system to meet current codes.
- Element No. U 2.a – Commercial gas water heater & flue has limited life. Although not a critical element to RUL, replacement of this element within the next 2-5 years is recommended.

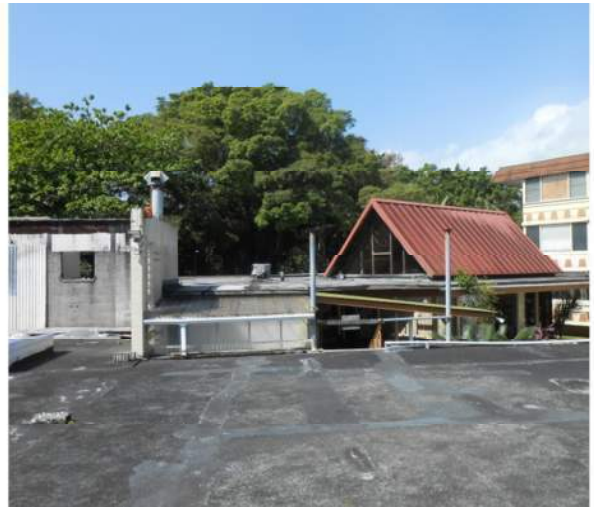
Photo 12: DSCN0434 – Wall and Roof Framing and Restaurant Level

- The floor level above the basement was once a restaurant which was destroyed by fire in 1983. This area has been barricaded and is no longer in use, but is considered structurally satisfactory aside from a few steel beams needing replacement and/or reinforcement. The walls and roof framing for the former restaurant area will need to be reconstructed if this area is to be put back into use.

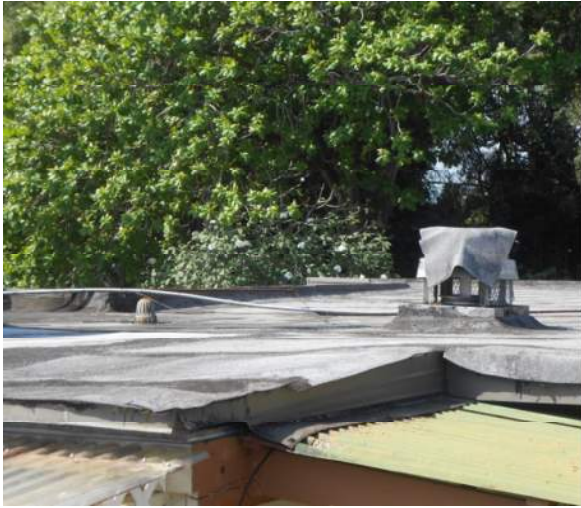
Photo 13: DSCN0431 Roof at Lobby Area

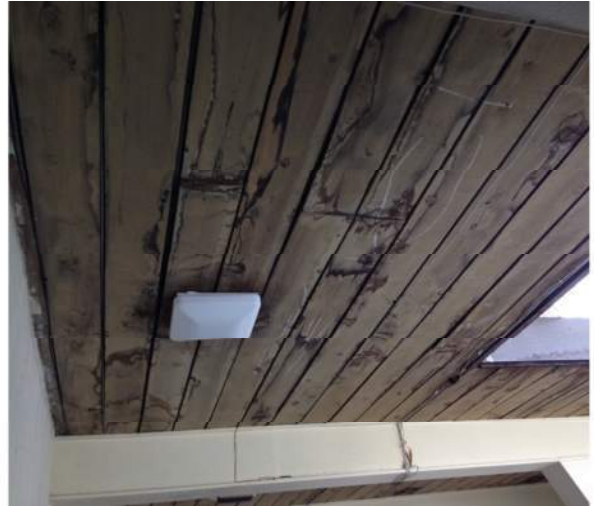
| Element Code | Element | Location of Elements Noted: | Description of Finding: | RUL Weight:<br>(1 High to 3 Low) | Estimated Age: If Available (Years) | Condition Rating:<br>A to F | Estimated Useful Life (Years) | Remaining Useful Life (Years) | Photos Referenced: | Comments & Major Deficiencies Noted: |
|---|---|---|---|---|---|---|---|---|---|---|
| S5 | Structural - Roof Framing | a. Lobby Area Roof was inaccessible but was able to be viewed from the restaurant area.<br>b. Main Buidling Roof was inacessible. | a. Lobby area roof structure was not able to be observed from above due to roof covering, but roofing appears to have low spots. No ponding water was observed. Water staining is visible on the wood paneling below.<br>b. NOT APPLICABLE | 2<br>2 | 42 - 45 Years | C<br>N/A | 25<br>N/A | 10<br>N/A | a. DSCN0431<br>IMG_2306<br><br>N/A | N/A |

Photo 14: IMG\_2306 Water Staining at Underside of Lobby Area Roof

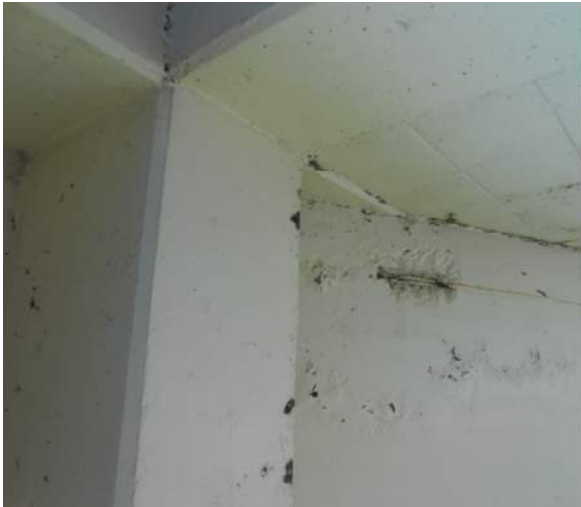
Photo 15: DSCN0428 – Spalling at Exterior Stair Soffit

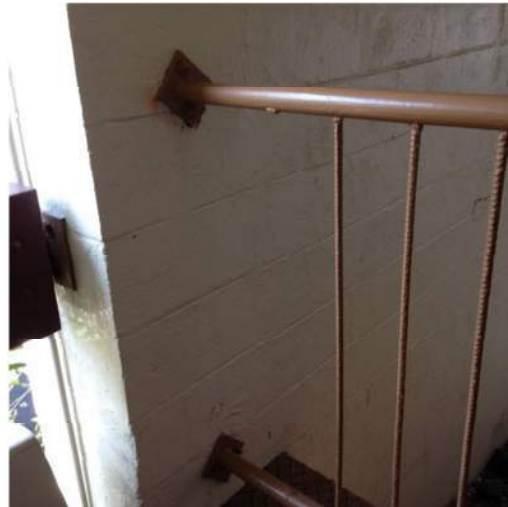
Photo 16: IMG\_2296 - Railing Missing Bolt and Vertical

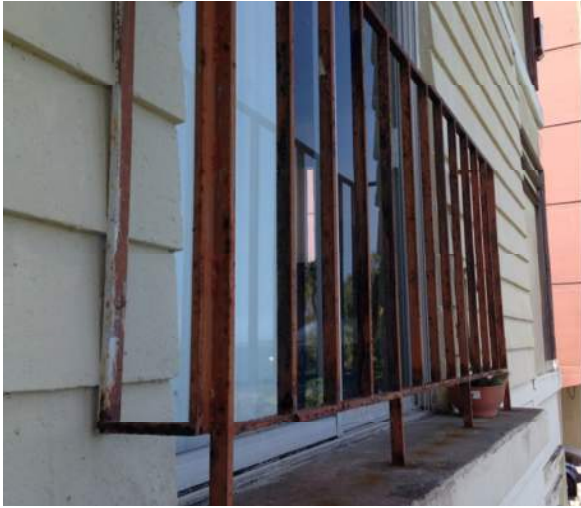
Photo 17: IMG\_2300 – Rusting Railings at East End

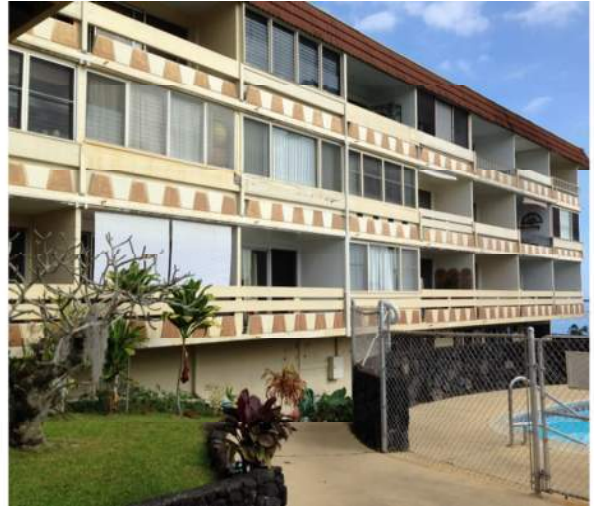
| Element Code | Element | Location of Elements Noted: | Description of Finding: | RUL Weight:<br>(1 High to 3 Low) | Estimated Age: If Available (Years) | Condition Rating:<br>A to F | Estimated Useful Life (Years) | Remaining Useful Life (Years) | Photos Referenced: | Comments & Major Deficiencies Noted: |
|---|---|---|---|---|---|---|---|---|---|---|
| S7 | Structural - Balconies | a. Railings on East End<br>b. Balcony Railings | a. Typically rusting<br>b. Many have been replaced, some need replacing, damage to CMU wall at anchorage at South East Corner | 2<br>2 | 42 - 45 Years | C<br>D | 25 | 20 | a. IMG_2300<br>b. IMG_2264 | a. Suggest cleaning and painting.<br>B. Continued replacement should be anticipated. |

Photo 18: IMG\_2264 – Typical Railing Condition

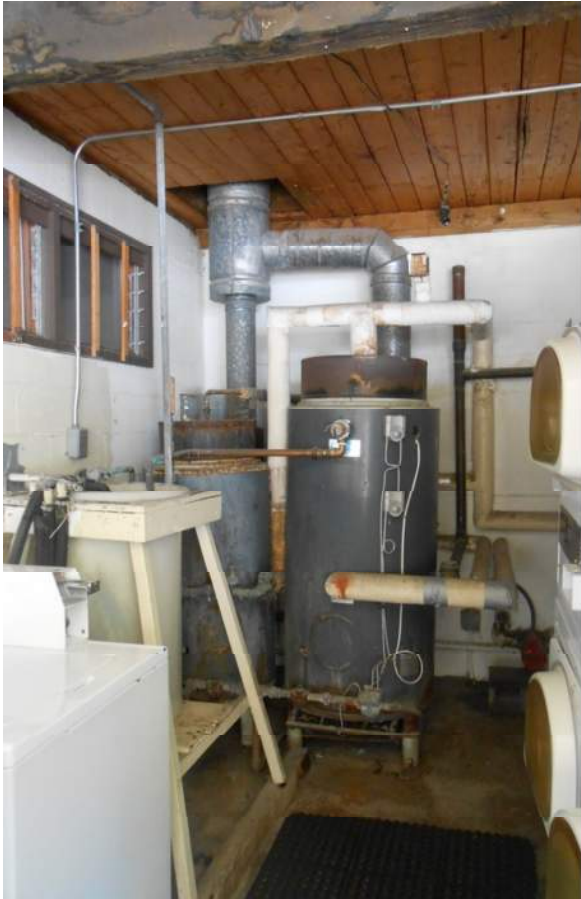
| Element Code | Element | Location of Elements Noted: | Description of Finding: | RUL Weight:<br>(1 High to 3 Low) | Estimated Age: If Available (Years) | Condition Rating:<br>A to F | Estimated Useful Life (Years) | Remaining Useful Life (Years) | Photos Referenced: | Comments & Major Deficiencies Noted: |
|---|---|---|---|---|---|---|---|---|---|---|
| U2 | Utility - Heater & Flue, Commercial Size | a. In Laundromat Area to the South of Receptions Office | a. Reaching Age Limit | 1 | Not Known | D | 15+ | 2-3 Years | DSCN0423 | a. Gas Hot Water Heater and Flue will need to be replaced with continued use. |

Photo 21: DSCN0423 – Hot Water Heater

- Water Heater System – continued use of this building facility will require replacement of this Water Heater and Flue System. Again, this is important to continued use, but not a major RUL factor.
