# Remaining Useful Life Determination for

**Uncle Billy's Hilo Bay Hotel**

**Hilo, Hawaii**

Final Report  
June 2014

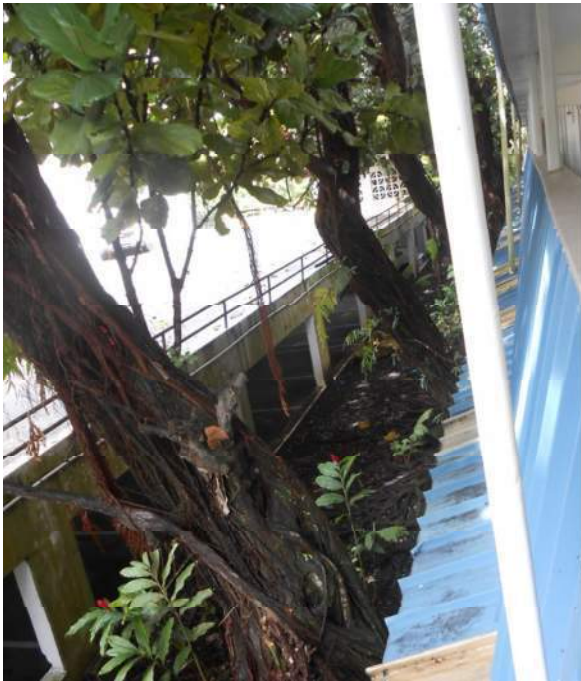
| Element Code | Element | Location of Deficient Elements Noted: | Description of Finding: | RUL Weight: (1 High to 3 Low) | Estimated Age: If Available (Years) | Condition Rating: A to F | Estimated Useful Life (Years) | Remaining Useful Life (Years) | Photos Referenced: | Comments & Major Deficiencies Noted: |
|---|---|---|---|---|---|---|---|---|---|---|
| G1 | Grounds - Settlement & Erosion | a. Kitchen Wing<br>b. Lobby near Restrooms | a. Tree roots along West side lifting concrete walkway.<br>b. Cracking through ceiling finishes in Lobby near restrooms. | 2 | 43 -48 | D<br>B | 15 | 4<br>15 | a. DSCN0529<br>b. IMG_2528 | a. In need of tree or tree root removal and reconstruction of Walkway.<br>b. Cause of cracking cannot be determined due to inaccessibility of area. |

Photo 1: DSCN0529 – Trees causing displacement of the ground floor of the Kitchen Wing

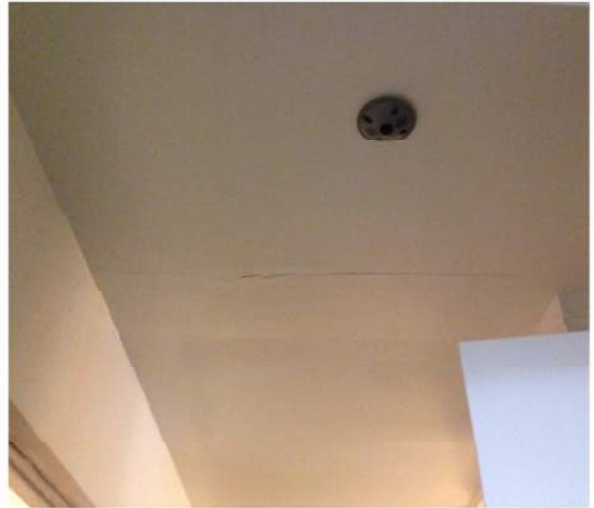
Photo 2: IMG\_2528 – Cracking of ceiling finishes near the restrooms in the Lobby

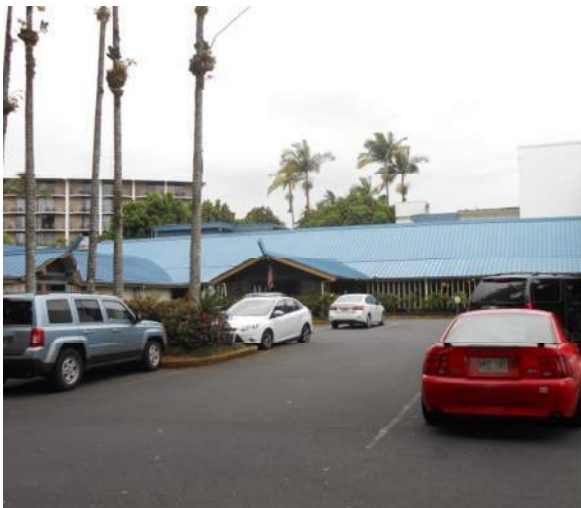
| Element Code | Element | Location of Deficient Elements Noted: | Description of Finding: | RUL Weight: (1 High to 3 Low) | Estimated Age: If Available (Years) | Condition Rating: A to F | Estimated Useful Life (Years) | Remaining Useful Life (Years) | Photos Referenced: | Comments & Major Deficiencies Noted: |
|---|---|---|---|---|---|---|---|---|---|---|
| G3 | Grounds - Parking & Paved Areas | a. Parking Area | a. Parking with 50 or so stalls is inadequate for usage. | 2 | Unknown | C | 15 | 10 | a. DSCN0508,<br>DSCN0519 | N/A |

Photo 3: DSCN0508– Parking Lot

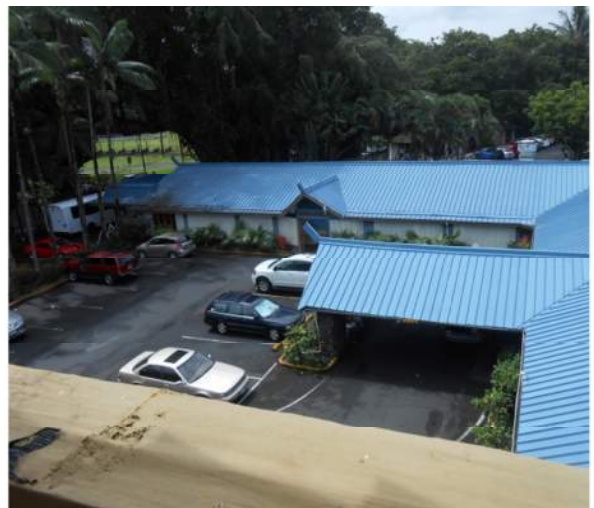
Photo 4: DSCN0519– Aerial view of Parking Lot

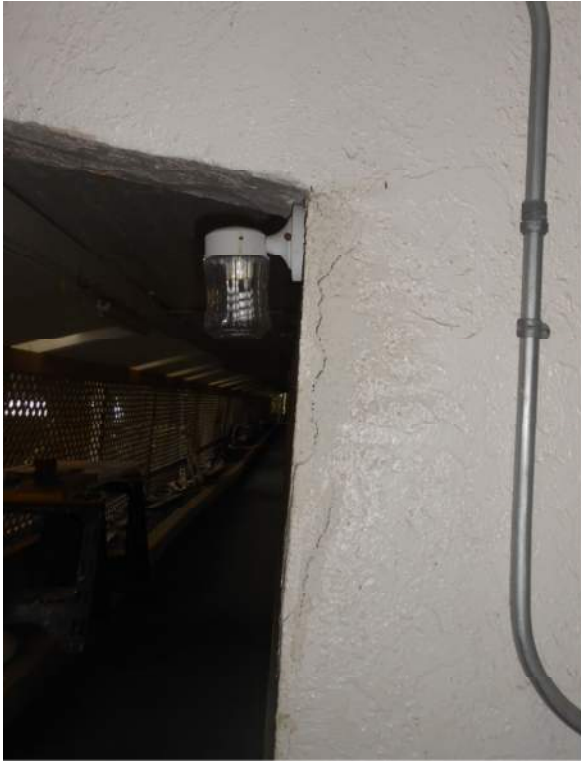
| Element Code | Element | Location of Deficient Elements Noted: | Description of Finding: | RUL Weight: (1 High to 3 Low) | Estimated Age: If Available (Years) | Condition Rating: A to F | Estimated Useful Life (Years) | Remaining Useful Life (Years) | Photos Referenced: | Comments & Major Deficiencies Noted: |
|---|---|---|---|---|---|---|---|---|---|---|
| S3 | Structural - Walls | a. Various locations at Kitchen and Main Wings | a. Spalling, delamination and cracks noted in various walls. | 2 | 43 -48 | D | 25 | 15 | a. DSCN0488,<br>DSCN0490,<br>DSCN0496,<br>DSCN0501 | a. Spall repair or rehab needed with continued use. Textured finish covers many of the concrete surfaces and is cracking and delaminating, making it difficult to assess the condition of the structural elements beneath it. |

Photo 5: DSCN04888 – Crack with delamination at wall in Kitchen Wing

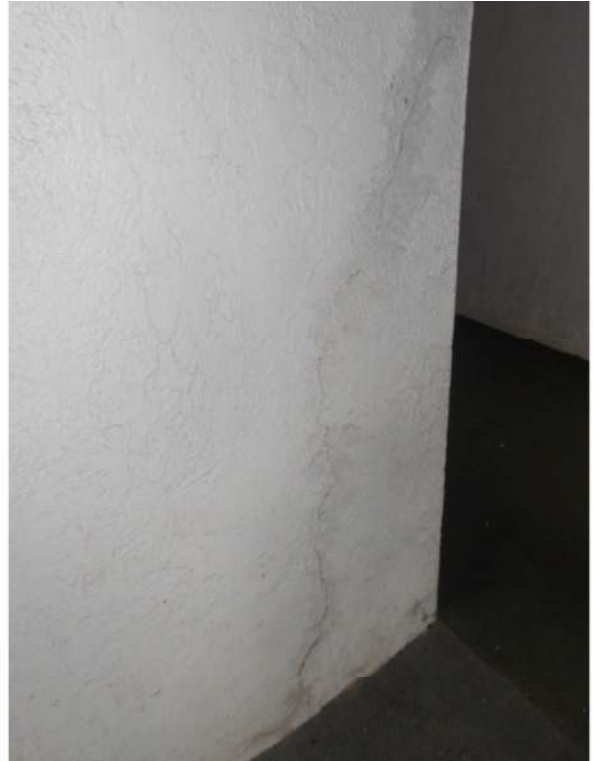
Photo 6: DSCN0490 – Crack with delamination at wall in Kitchen Wing

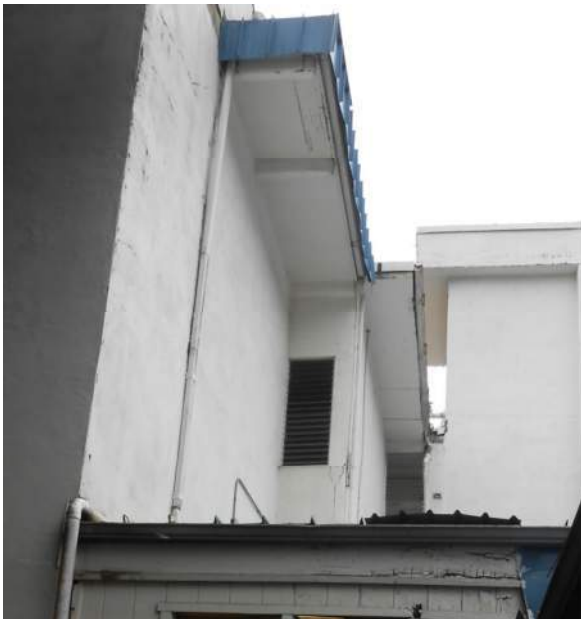
Photo 7: DSCN0496 – Cracking and spalling near elevator room

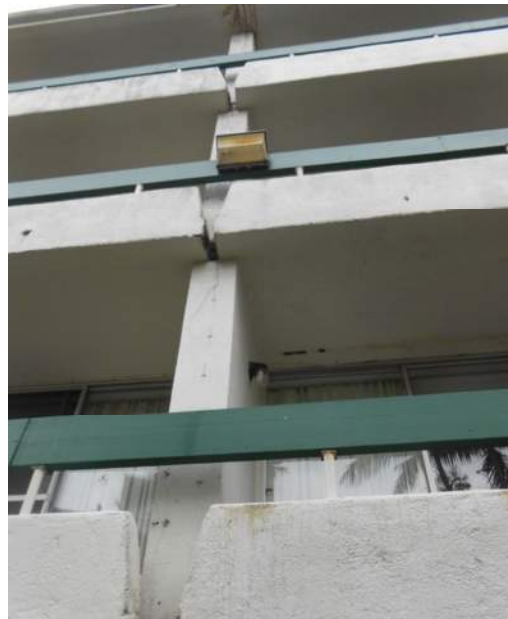
Photo 8: DSCN0501 – Cracking at Exterior Balcony Wall

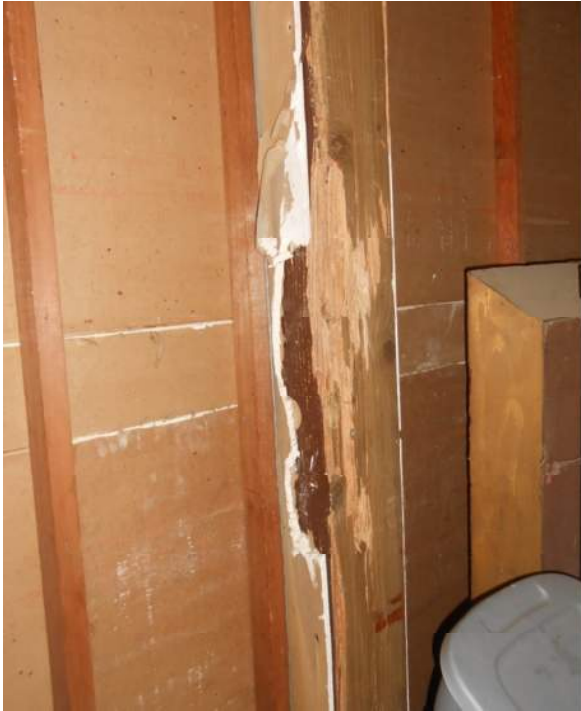
| Element Code | Element | Location of Deficient Elements Noted: | Description of Finding: | RUL Weight: (1 High to 3 Low) | Estimated Age: If Available (Years) | Condition Rating: A to F | Estimated Useful Life (Years) | Remaining Useful Life (Years) | Photos Referenced: | Comments & Major Deficiencies Noted: |
|---|---|---|---|---|---|---|---|---|---|---|
| S4 | Structural - Columns & Beams | a. Electrical Room<br>b. Lobby<br>c. Kitchen Wing and Main Wing | a. Termite Damage noted on 1 column; Cracking noted in beam at top of concrete column.<br>b. Widespread evidence of termited damage noted. Does not appear significant, however, a closeup inspection was not possible due to location.<br>c. Various cracking and spalling observed. | 2<br>1<br>2 | 43 -48 | C<br>C<br>C | 20 | 15 | a. DSCN0487,<br>DSCN0486<br>b. IMG_2561 | a. Further investigation into extent of cracking and repair is recommended for continued use. a, b. Detailed survey of termite damage is recommended with continued use.<br><br>c. Repair and refinish. Textured finish covers many of the concrete surfaces and is cracking and delaminating, making it difficult to assess the condition of the structural elements beneath it. |

Photo 9: DSCN0487 – Termite damage in wood column in Electrical Room

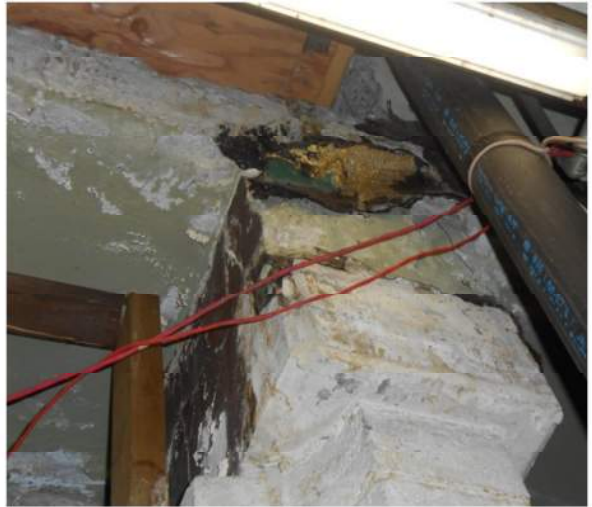
Photo 10: DSCN0486 – Cracking in beam at top of column in Electrical Room

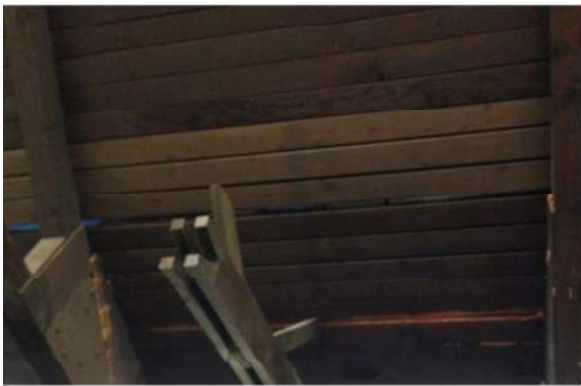
Photo 11: IMG\_2561 – Termite damage in Lobby

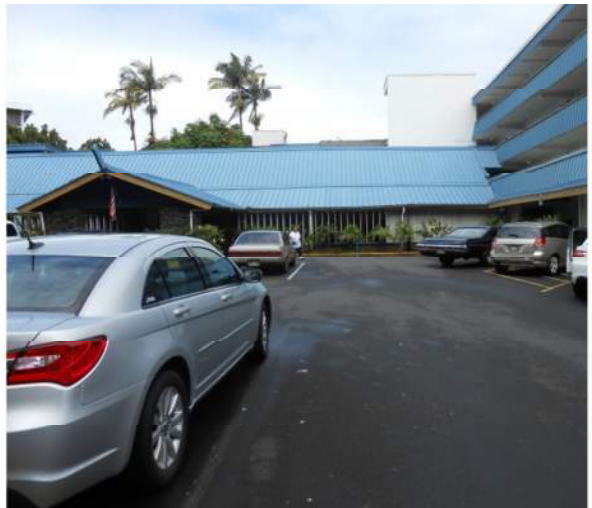
| Element Code | Element | Location of Deficient Elements Noted: | Description of Finding: | RUL Weight: (1 High to 3 Low) | Estimated Age: If Available (Years) | Condition Rating: A to F | Estimated Useful Life (Years) | Remaining Useful Life (Years) | Photos Referenced: | Comments & Major Deficiencies Noted: |
|---|---|---|---|---|---|---|---|---|---|---|
| S5 | Structural - Roof Framing | a. Lobby, Restaurant & Shop Wood Frame<br>b. Kitchen, Main, Shop Buildings | a. Sagging noted with some termite damage. Collision damage at porte cochere roof.<br>b. Cast in Place Concrete - Inaccessible. | 2<br>N/A | 43 | D<br>N/A | 10<br>25 | 7<br>N/A | a. DSCN0511,<br>DSCN0512 | a,b. Repair & Rehab recommended with continued use. |

Photo 12: DSCN0511 – Sagging at roof areas

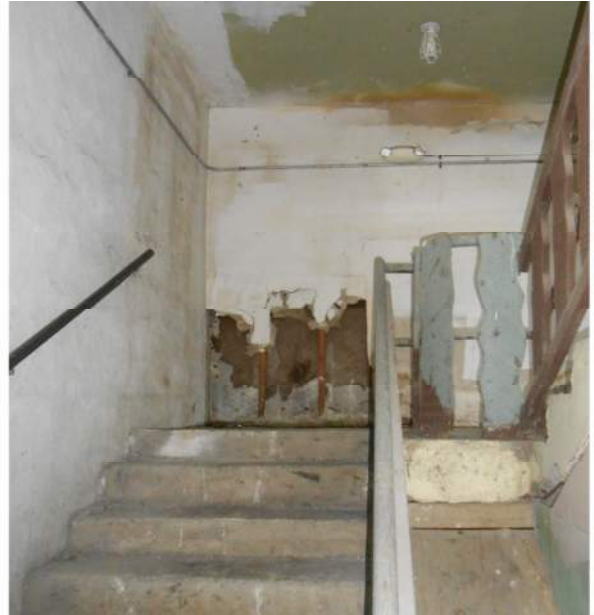
| Element Code | Element | Location of Deficient Elements Noted: | Description of Finding: | RUL Weight: (1 High to 3 Low) | Estimated Age: If Available (Years) | Condition Rating: A to F | Estimated Useful Life (Years) | Remaining Useful Life (Years) | Photos Referenced: | Comments & Major Deficiencies Noted: |
|---|---|---|---|---|---|---|---|---|---|---|
| S6 | Structural - Stairs | a. Fire Escape Stairway | a. In need of maintenance and rehab. | 1 | 43 -48 | F | 15 | 3 | a. DSCN0491 | a. Repair or Replacement needed. |

Photo 14: DSCN0491- Emergency Exit stairwell

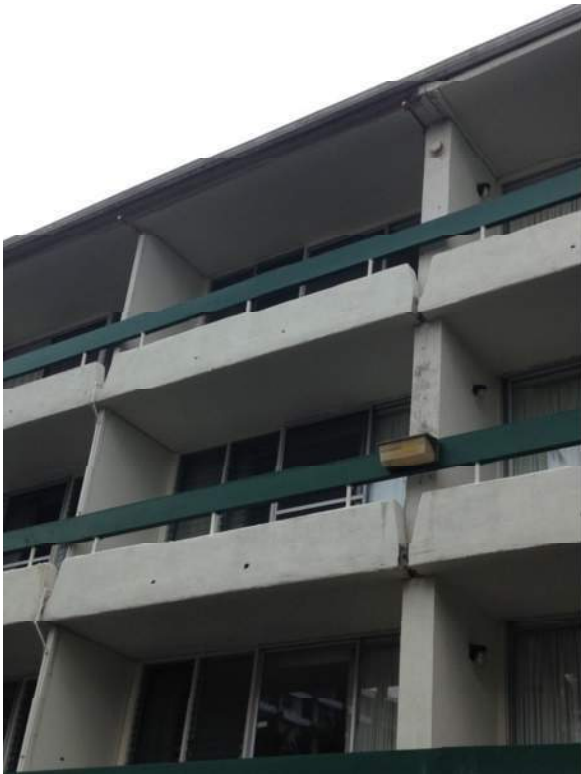
| Element Code | Element | Location of Deficient Elements Noted: | Description of Finding: | RUL Weight: (1 High to 3 Low) | Estimated Age: If Available (Years) | Condition Rating: A to F | Estimated Useful Life (Years) | Remaining Useful Life (Years) | Photos Referenced: | Comments & Major Deficiencies Noted: |
|---|---|---|---|---|---|---|---|---|---|---|
| S7 | Structural - Balconies | a, b. Various locations throughout property | a. Ends of hollow core planks are exposed in a few locations and minor cracking and spalling of the concrete parapets and balcony slabs was observed.<br>b. Minor deterioration of some wooden balcony rails. | 2 | 43-48 | C | 25 | 15 | a. IMG_2552<br>b. IMG_2555 | a. Recommend repairing of cracks and spalls and patching the exposed ends of the hollow core planks with continued use.<br>b. Routine repair and replacement of wooden railing components should be expected with continued use. |

Photo 15: IMG\_2552 – Area with exposed hollow core plank edges

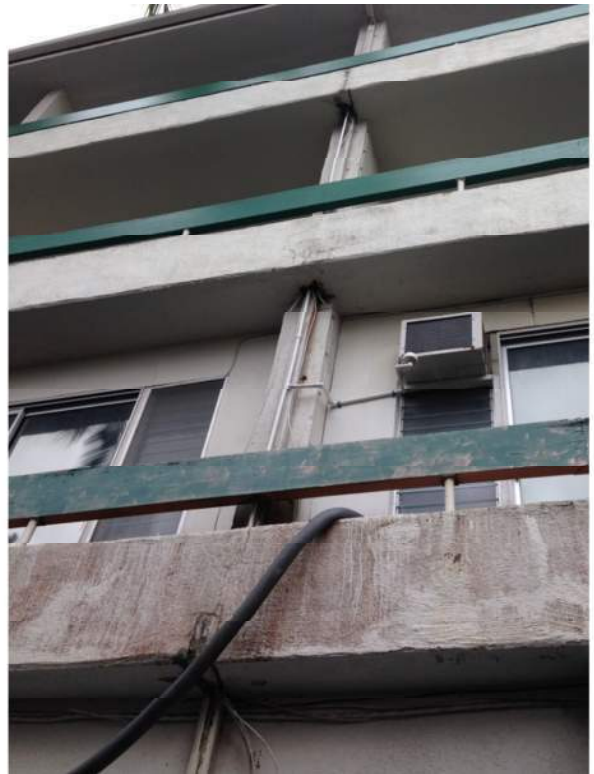
Photo 16: IMG\_2555 – Deteriorating timber railing and balcony cracking

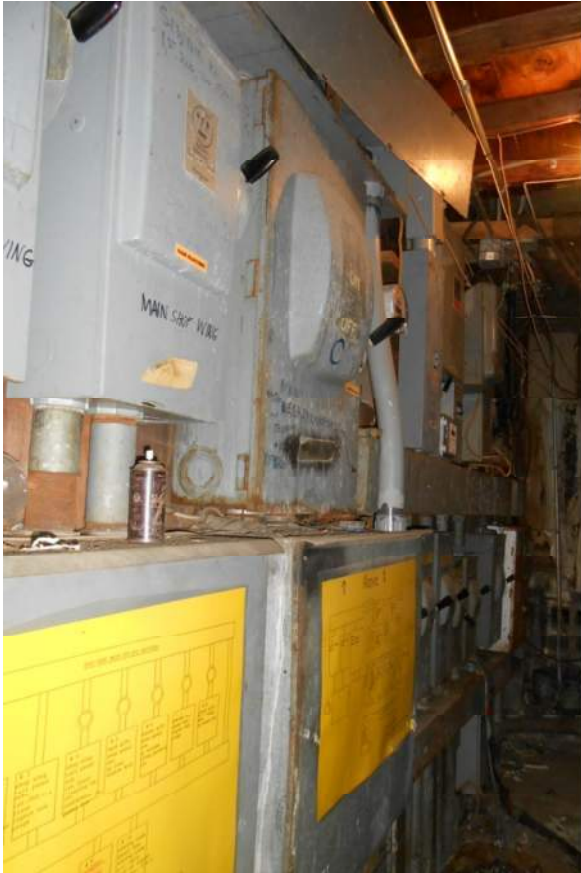
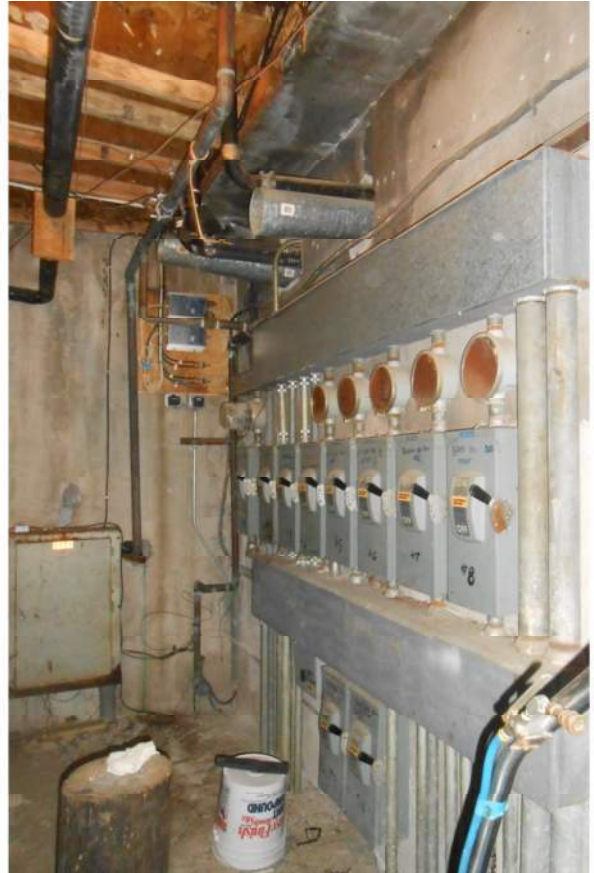
| Element Code | Element | Location of Deficient Elements Noted: | Description of Finding: | RUL Weight: (1 High to 3 Low) | Estimated Age: If Available (Years) | Condition Rating: A to F | Estimated Useful Life (Years) | Remaining Useful Life (Years) | Photos Referenced: | Comments & Major Deficiencies Noted: |
|---|---|---|---|---|---|---|---|---|---|---|
| U1 | Utility - Electrical Power Supply | a. Main Power Supply w/ Transformer in Lobby Area | a. Operational and in satisfactory condition. | 1 | N/A | C | 15 | 12 | a. DSCN0483,<br>DSCN0484 | |

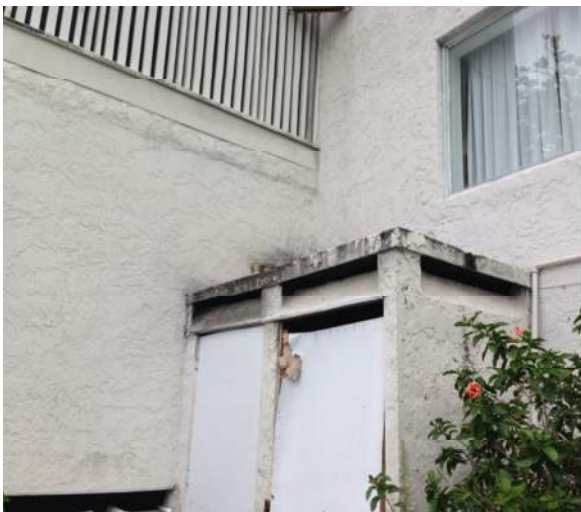
| Element Code | Element | Location of Deficient Elements Noted: | Description of Finding: | RUL Weight: (1 High to 3 Low) | Estimated Age: If Available (Years) | Condition Rating: A to F | Estimated Useful Life (Years) | Remaining Useful Life (Years) | Photos Referenced: | Comments & Major Deficiencies Noted: |
|---|---|---|---|---|---|---|---|---|---|---|
| U2 | Utility - Heater & Flue, Commercial Size | a. Seven (7) Gas Water Heaters in various locations throughout the Hotel | a. Operational | 2 | 3-10 | D | 10 | 5 | a. IMG_2547 | a. Necessary to assess condition of heaters and appropriate repair or replacement. |

Photo 19: IMG\_2547 – Gas Heater Enclosure

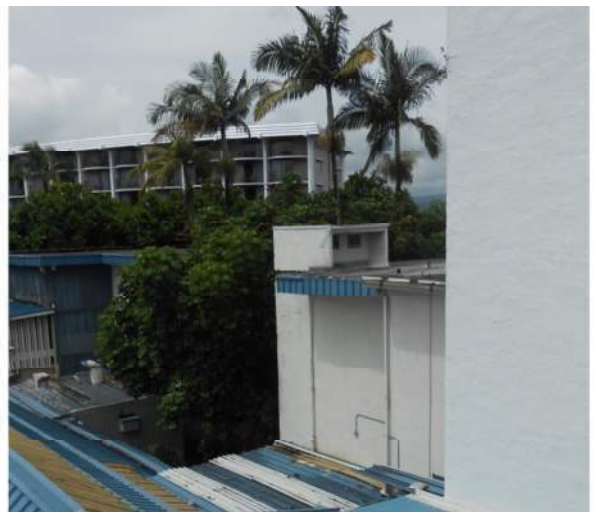
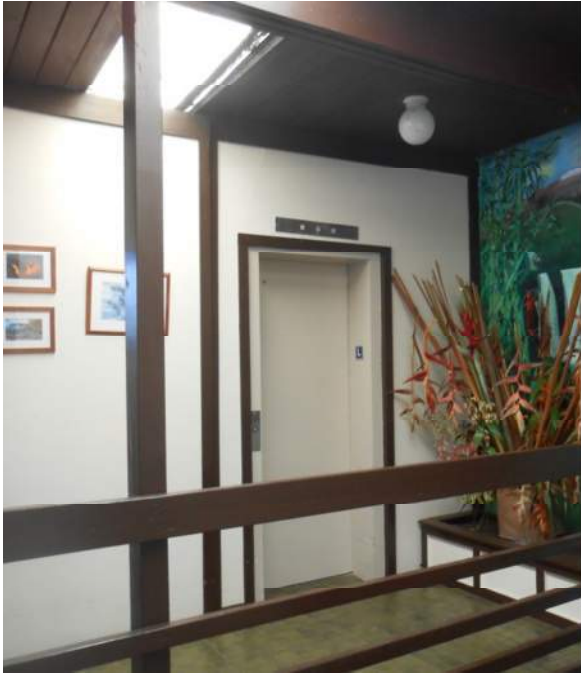
| Element Code | Element | Location of Deficient Elements Noted: | Description of Finding: | RUL Weight: (1 High to 3 Low) | Estimated Age: If Available (Years) | Condition Rating: A to F | Estimated Useful Life (Years) | Remaining Useful Life (Years) | Photos Referenced: | Comments & Major Deficiencies Noted: |
|---|---|---|---|---|---|---|---|---|---|---|
| O2 | Elevator System | a. One (1) located in the Main Wing off of the Lobby Area | a. Operational | 2 | 40+ | C | 15 | 15 | a. DSCN0522,<br>DSCN0524 | N/A |

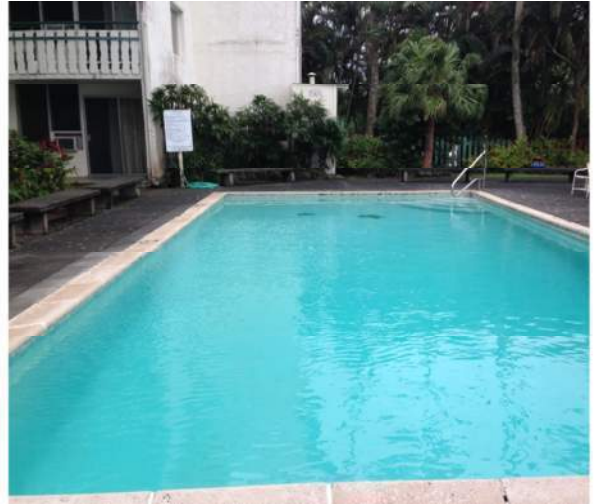
| Element Code | Element | Location of Deficient Elements Noted: | Description of Finding: | RUL Weight: (1 High to 3 Low) | Estimated Age: If Available (Years) | Condition Rating: A to F | Estimated Useful Life (Years) | Remaining Useful Life (Years) | Photos Referenced: | Comments & Major Deficiencies Noted: |
|---|---|---|---|---|---|---|---|---|---|---|
| O4 | Swimming Pool | a. Makai between the Kitchen Wing and the Main Wing | a. Good condition including pumps & filters. | 2 | 40+ | C | 20 | 15 | a. IMG_2546 | N/A |
