Underwater Bridge Inspection
for
Hakalau Stream Bridge
(Bridge No. 001290001100003)

Prepared for
County of Hawaii
Department of Public Works

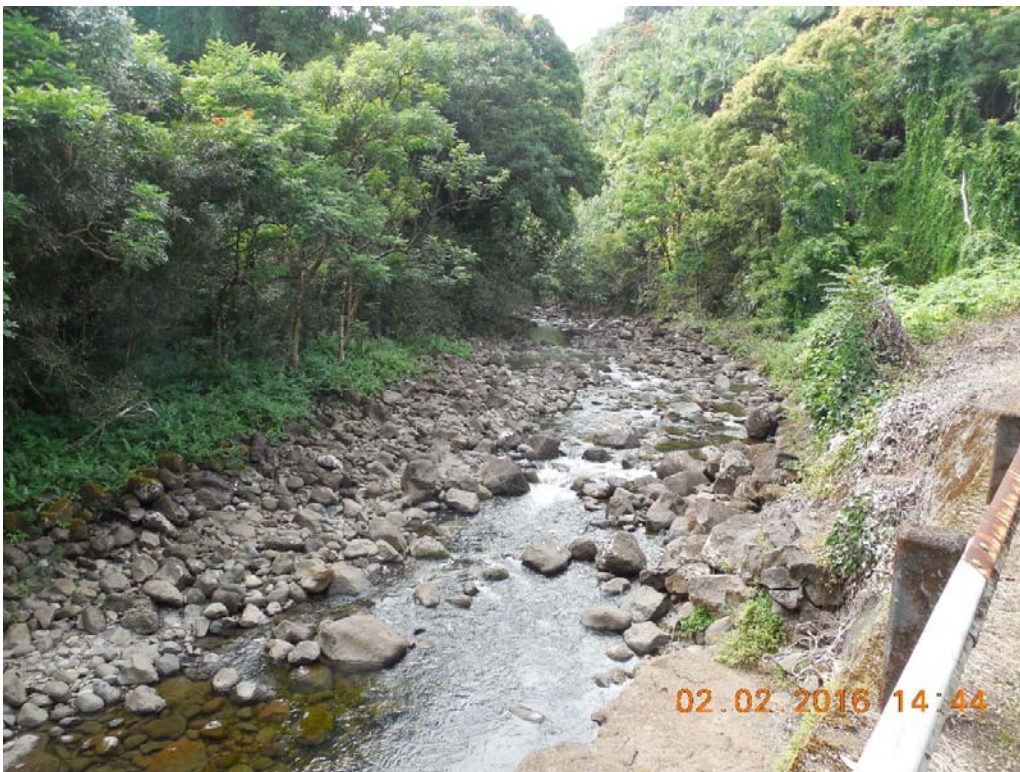
B4: Upstream flow condition.

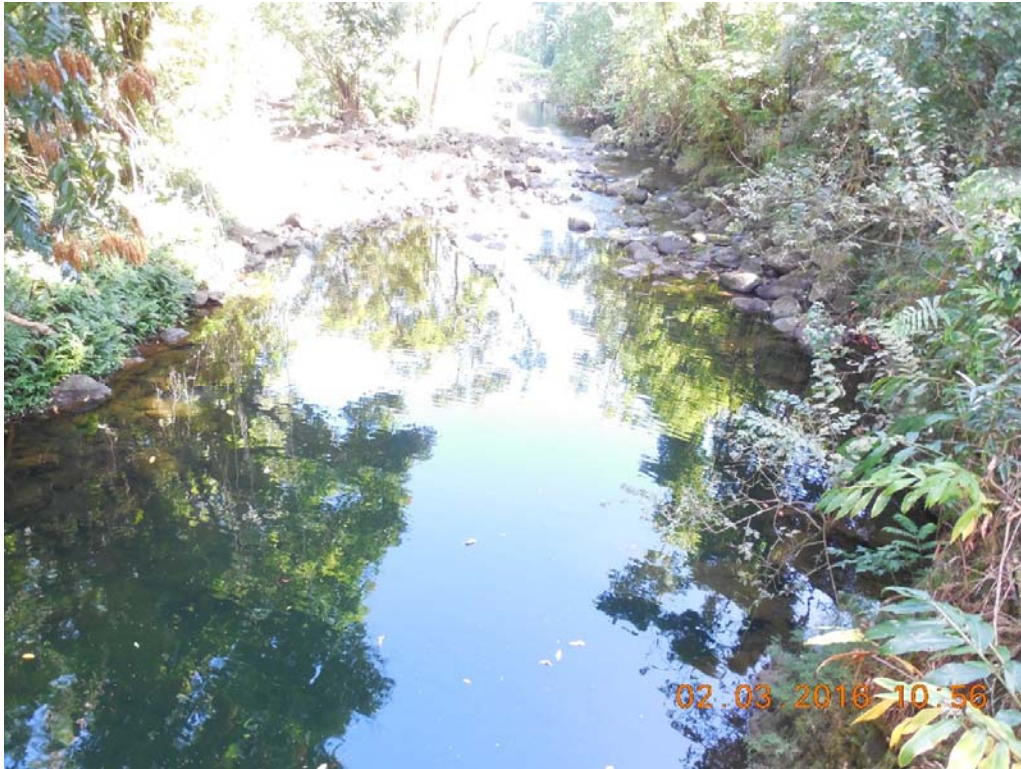
B5: Downstream flow condition.

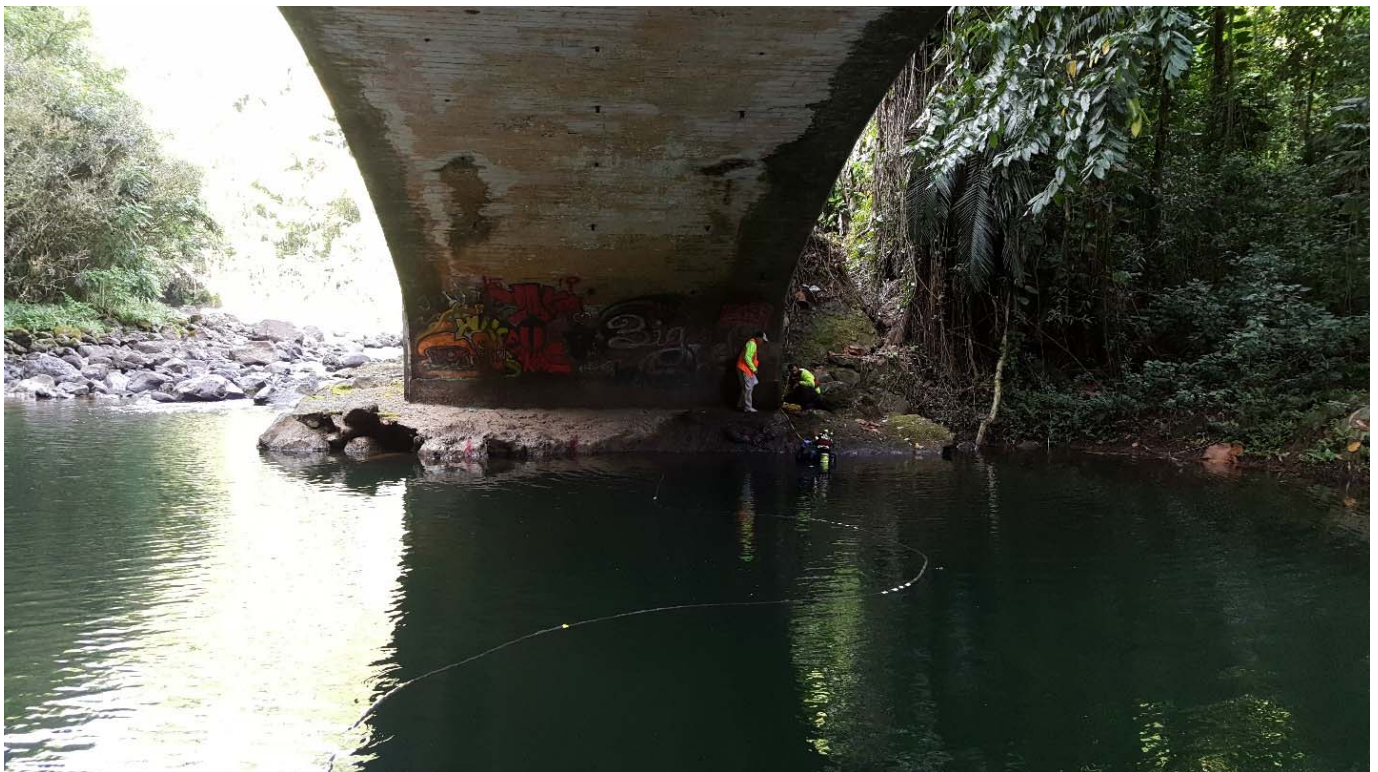
B6: North end abutment & rock ledger.

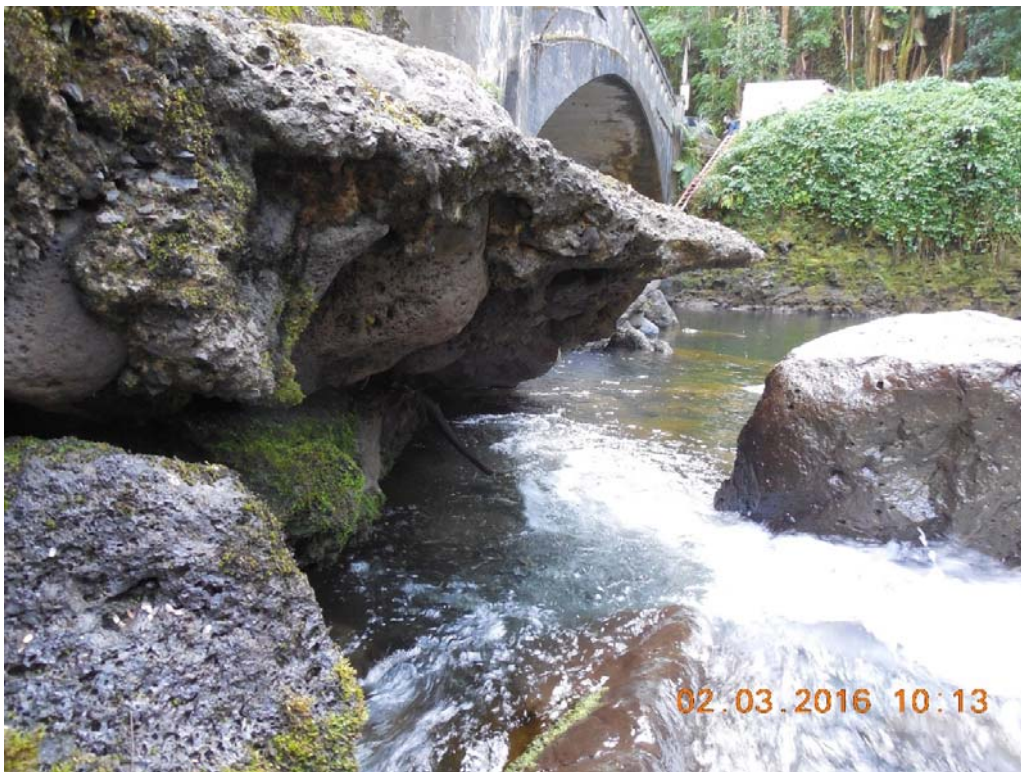
B10: Scour/undermined condition below the rock ledge inlet side at north end of bridge.

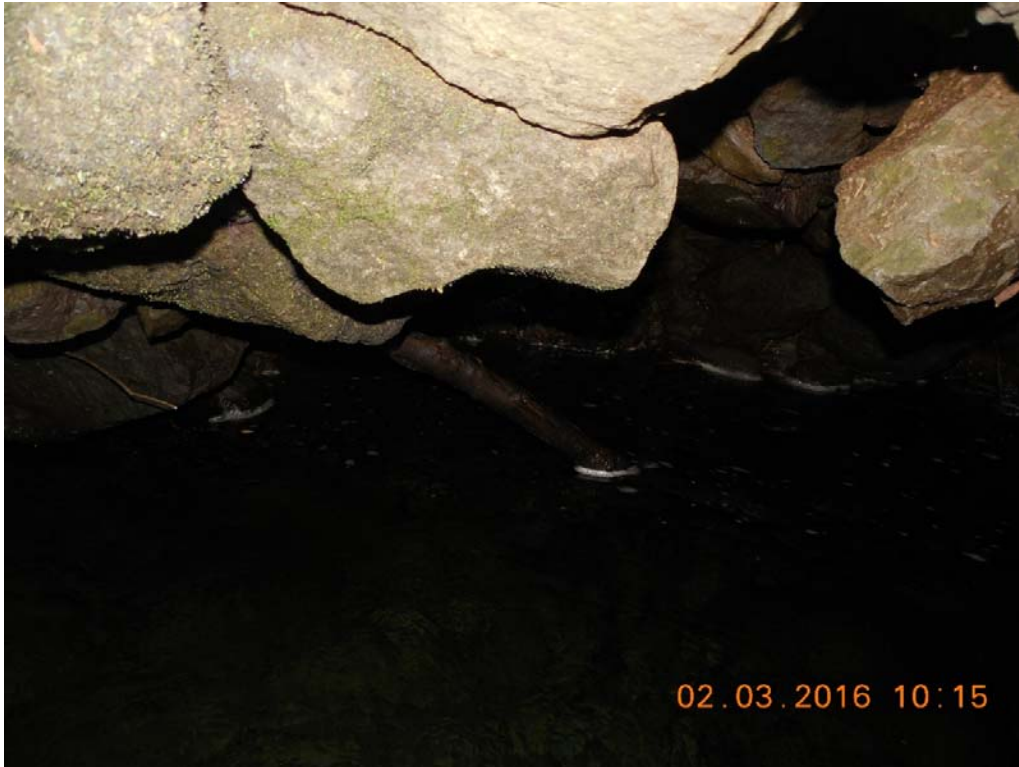
B11: Close up of the scour/undermined condition inlet side at north abutment upstream.

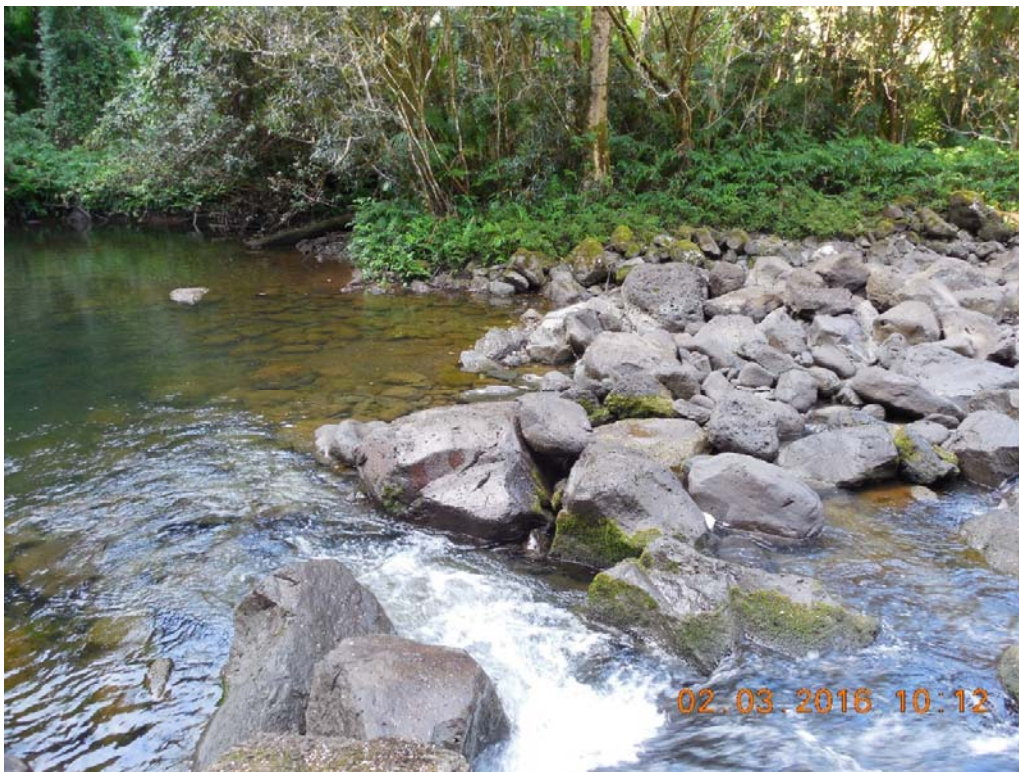
B12: Boulders and smaller rock debris cause restriction on water flow upstream.

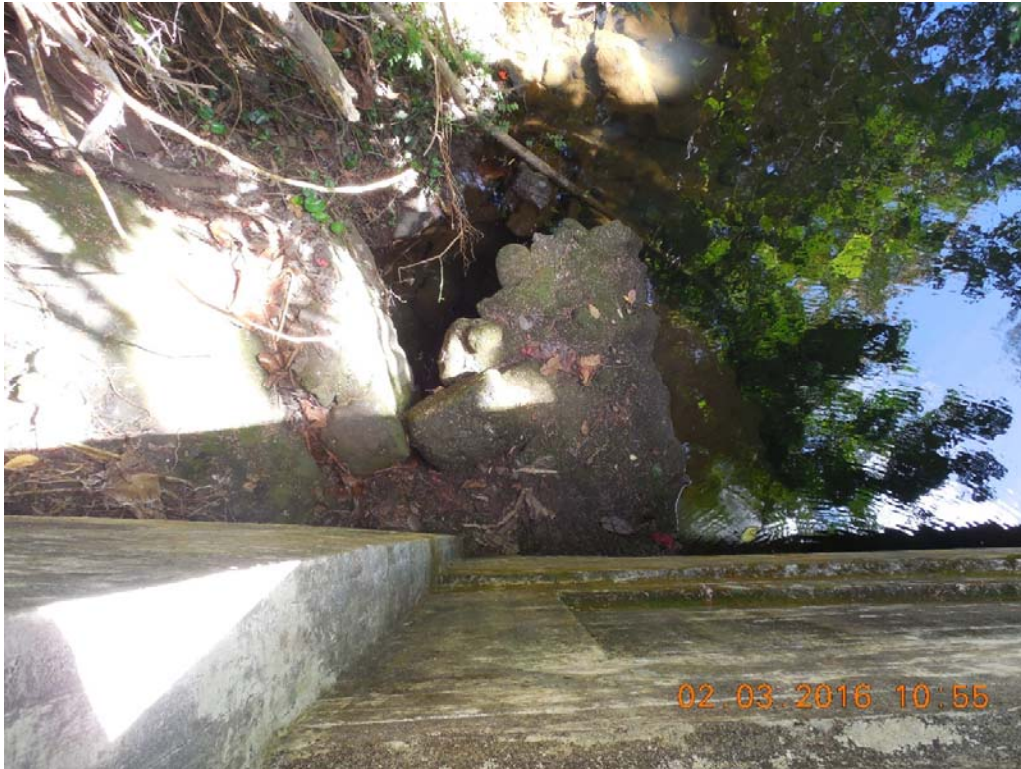
B13: Scour/undermined condition on the outlet side downstream end at the north abutment.

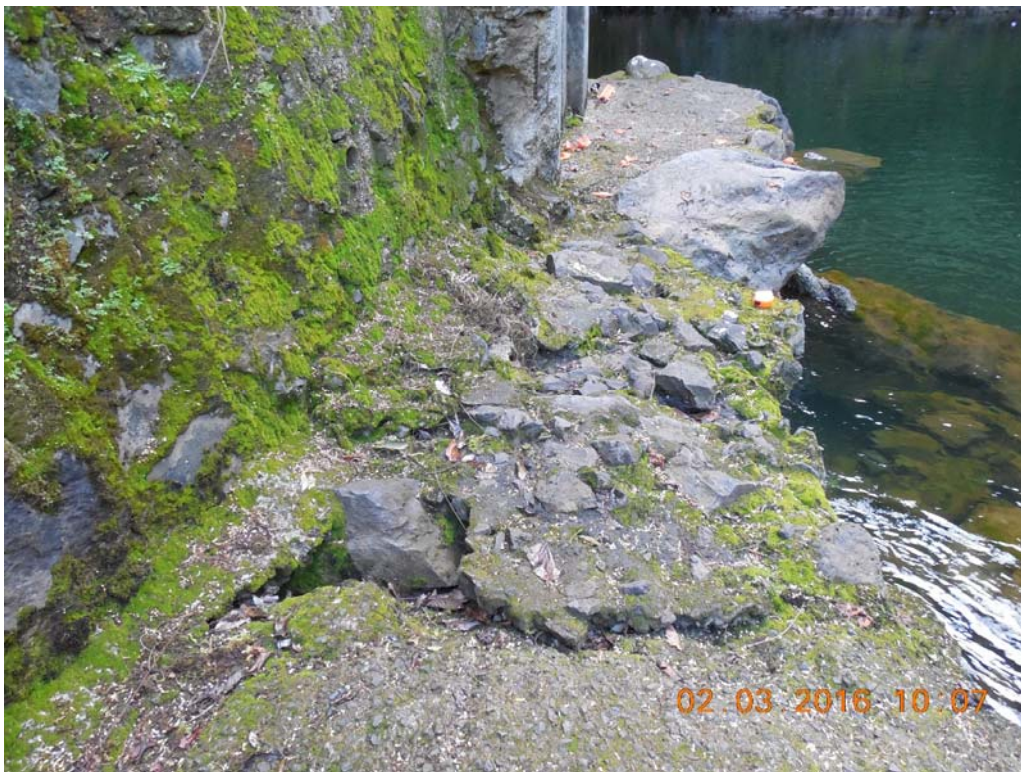
B14: Fractured cracks and erosion on upstream rock ledge north end. See North Abutment Plan on page 28 for location.

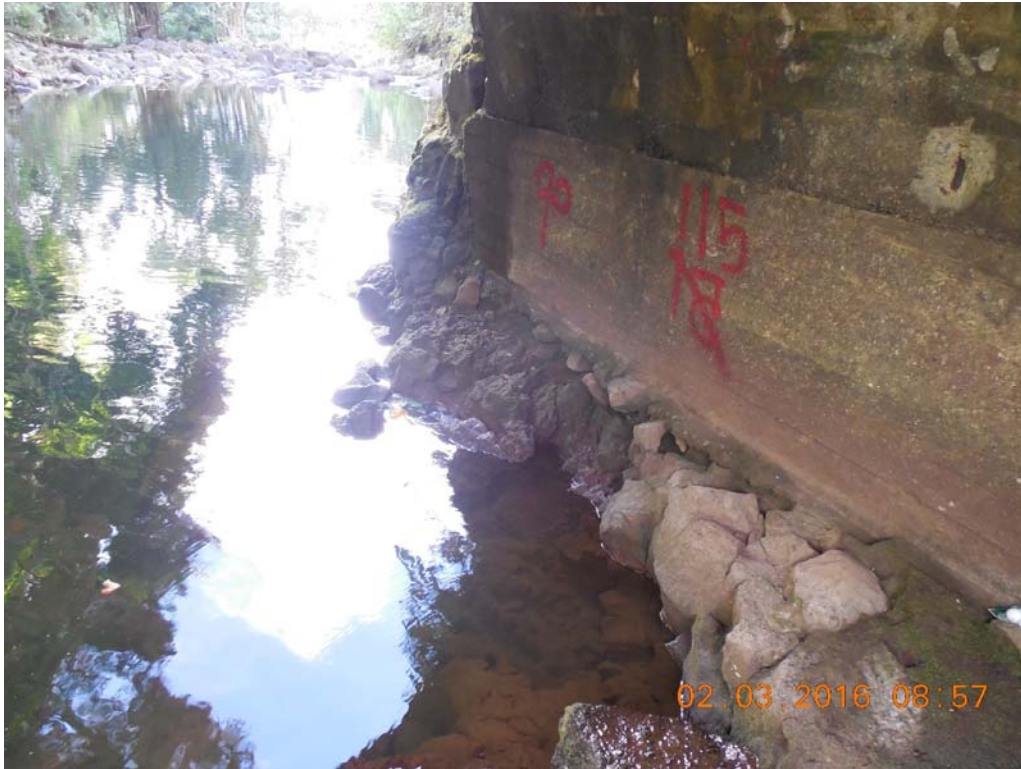
B15: Signs of minor scouring/erosion at the downstream side on the south rock ledge.
