PRELIMINARY PRIORITY RANKING
FOR
DEPARTMENT OF ENVIRONMENTAL MANAGEMENT
WASTEWATER DIVISION
ISLAND OF HAWAI'I, HAWAI'I

County of Hawai'i
Department of Environmental Management
Wastewater Division
345 Kekūanāo'a, Suite 41
Hilo, Hawai'i 96720

JULY 2024

Preliminary Priority Ranking

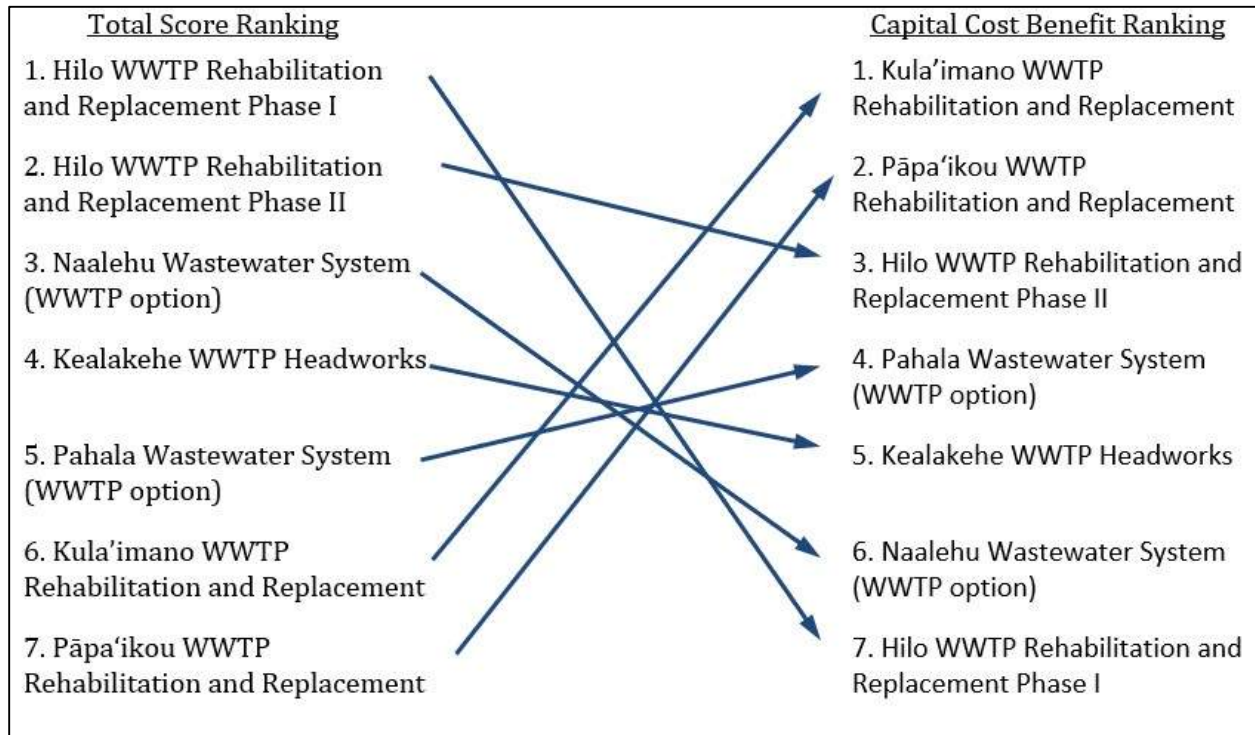
Figure 4. Comparison of WWTP Projects' Total Score Ranking and Capital Cost Benefit Ranking.

Figure 4 compares 2023 CIP Total Scores and Ranking and Capital Costs Benefit Scores and Rankings for just the WWTP projects. Note that the Pahala and Naalehu wastewater system projects

involve constructing new WWTPs and new collection systems. In general, WWTP projects are more costly and result in greater benefits than collection system projects, so the Pahala and Naalehu projects have been categorized as WWTP projects for the purposes of this comparison.

Figure 4. Comparison of WWTP Projects' Total Score Ranking and Capital Cost Benefit Ranking Figure 4 shows that the Total Score Rankings and Capital Cost Benefit Rankings are essentially reversed for WWTP projects, with the highest Total Score Ranking also having the lowest Capital Cost Benefit Score Rankings, and vis versa. Note that the Hilo WWTP Rehabilitation and Replacement Phase II project does not follow this trend, ranking as the second highest Total Score and the third highest Capital Cost Benefit Score. The Hilo WWTP Rehabilitation and Replacement Phase II project is also unique in that it relies on the prior implementation of one of the other projects (Hilo WWTP Rehabilitation and Replacement Phase I).

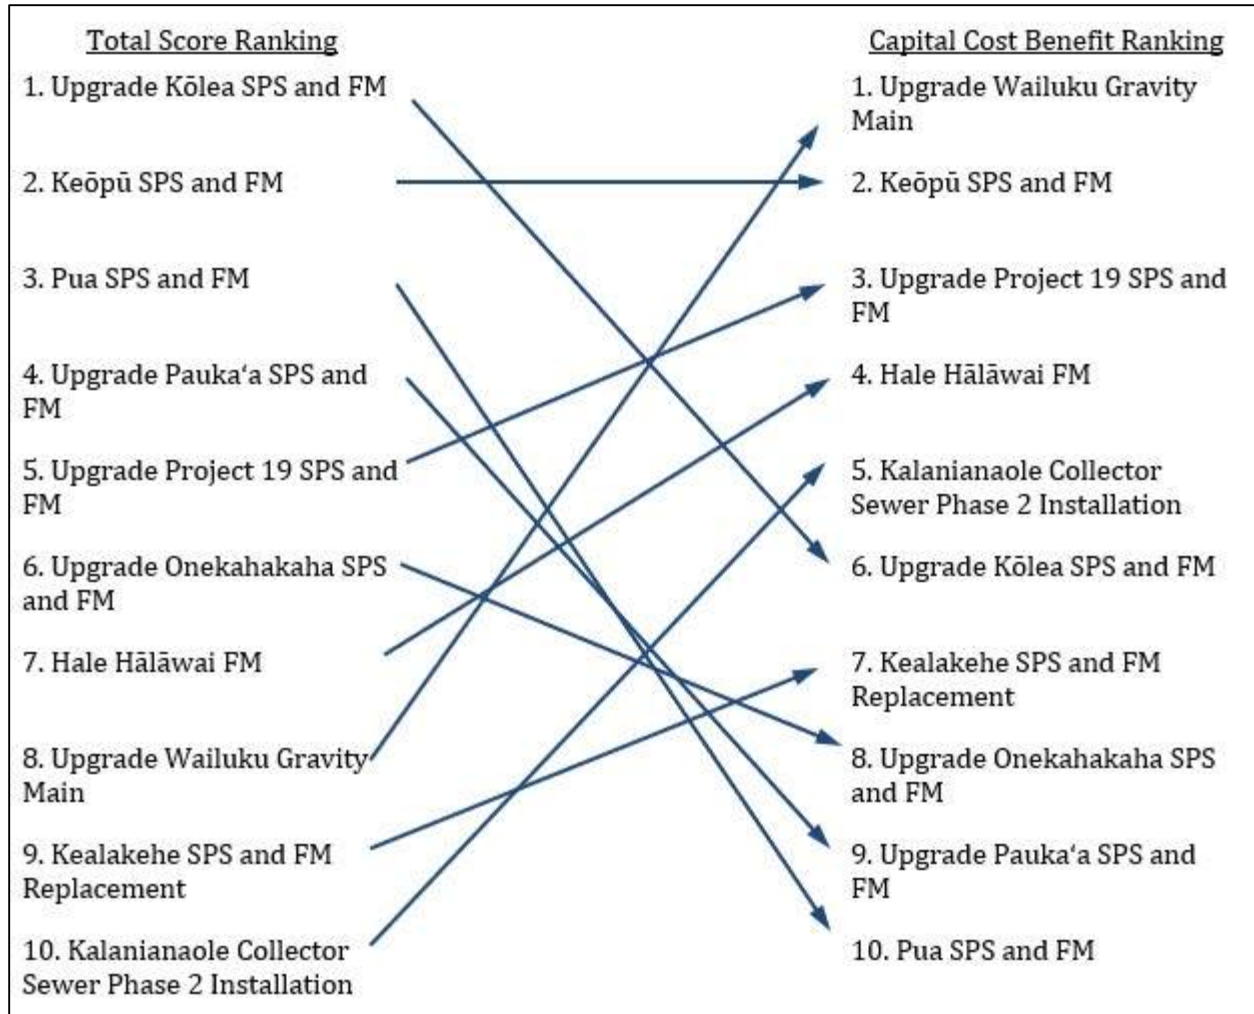
Figure 5. Comparison of Collection System Projects' Total Score Ranking and Capital Cost Benefit Ranking.

Figure 5 compares the 2023 CIP Total Score Rankings and Capital Costs Benefit Rankings for just the collection system projects.

Much like the comparison of the WWTP projects' Total Score Ranking and Capital Cost Benefit Ranking, the Total Score Rankings and Capital Cost Benefit Rankings have an inverse relationship; most of the collection system projects with the highest Total Score Rankings also having the lowest Capital Cost Benefit Score Rankings, and vis versa. However, the Keōpū and Project 19 projects stand out as having favorable rankings in both Total Score and Capital Cost Benefit Score.

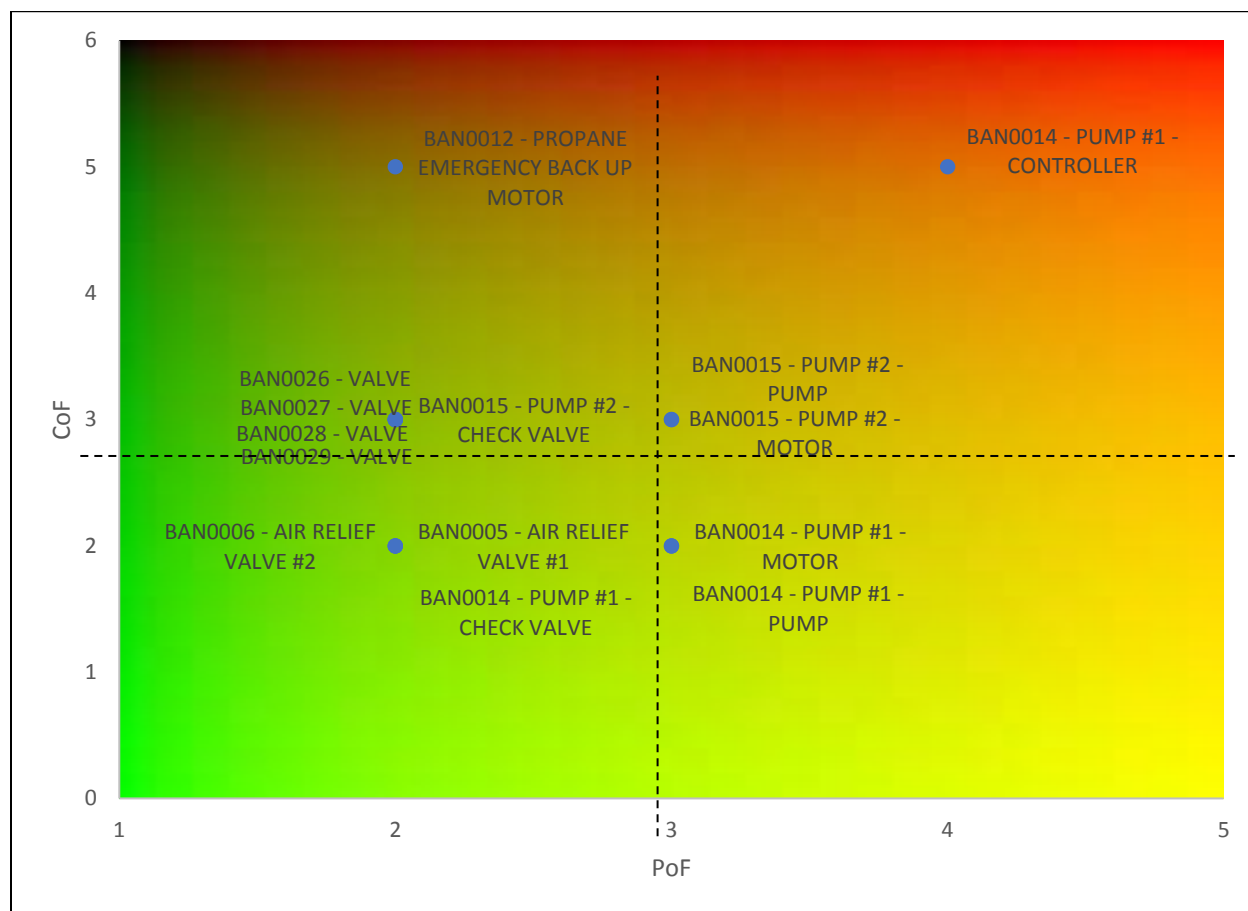
Figure 2. Banyan SPS asset risk.

The third example of risk visualization, a quad chart, is shown in Table 4. The highest risk assets are shown in the upper right and the lowest risk assets are shown in the lower left corner.

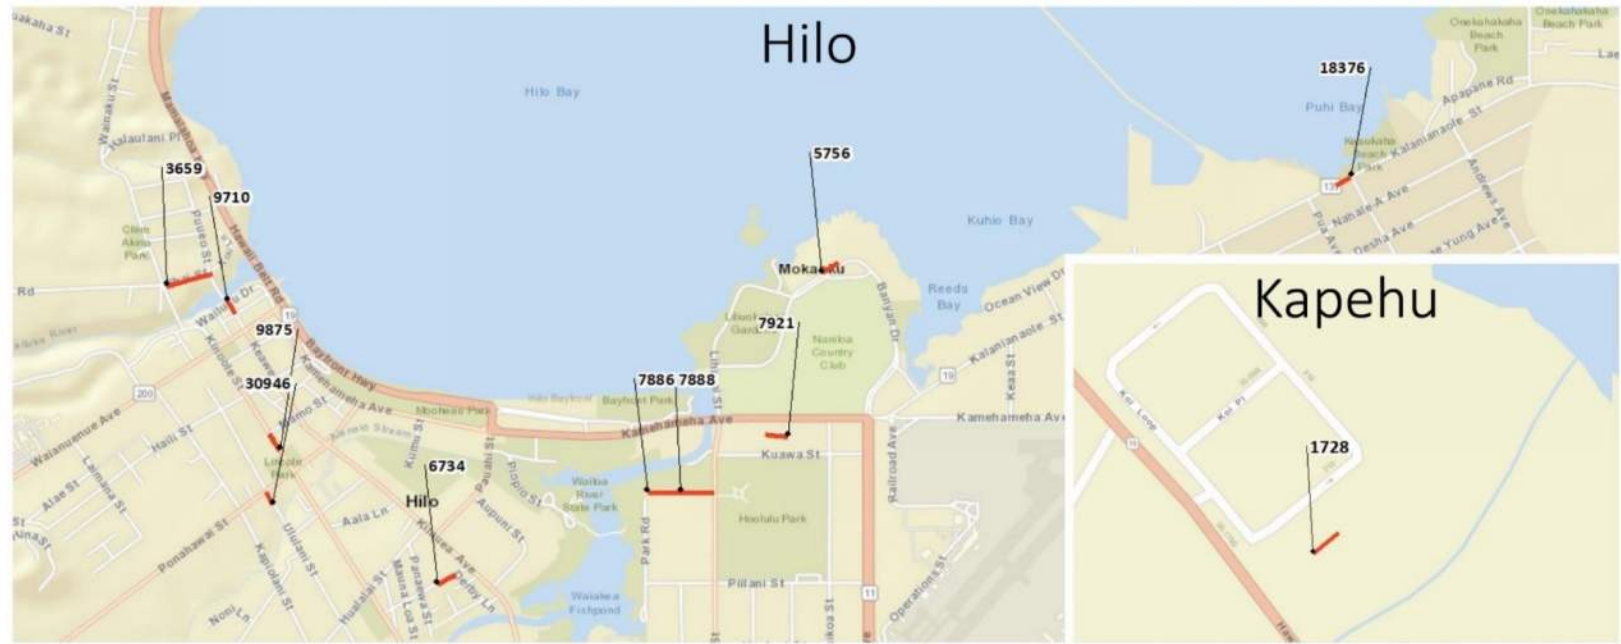
Figure 2: Map of High POF Pipe from CCTV Data

A summary table and map are presented in Figure 2. The map shows locations of the 12 pipe segments with a high POF score.
